INEEL/EXT-99-00282

April 1999

**Supplemental  
Response to the  
Type A Accident  
Investigation Board  
Report of the July 28,  
1998, Fatality and  
Multiple Injuries  
Resulting from  
Release of Carbon  
Dioxide at Building  
648, Test Reactor  
Area, Idaho National  
Engineering and  
Environmental  
Laboratory**

**LMITCO Supplemental Response  
to the DOE Type A Investigation Report  
of the TRA-648 CO<sub>2</sub> Accident**

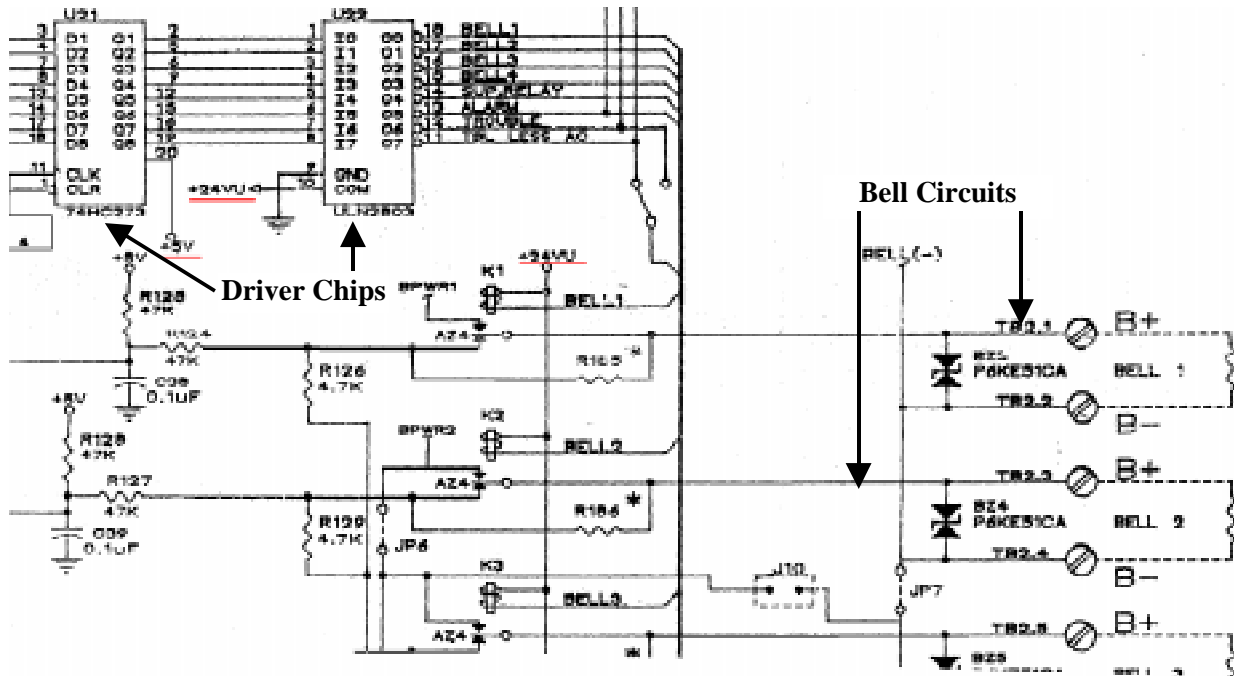
**Figure 2-1.** Bell circuit and driver chips.

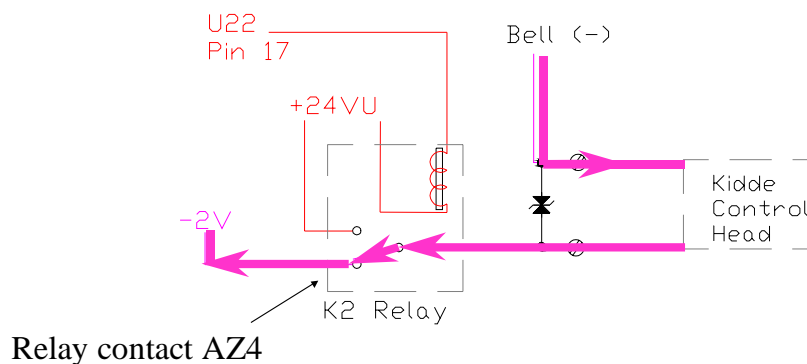
Under normal conditions (120 volts AC power supplied to the panel, no alarm condition), a small supervisory current flows from the terminals on the output circuits to the device (Kidde control heads for the CO<sub>2</sub> at TRA-648) connected to the output circuit terminals. Figure 2-2 shows that relay K2 is deenergized and contact AZ4 is connected to a source of supervisory voltage (~ -2 V). The fire panel monitors the continuity of the wiring connection between the terminals and the CO<sub>2</sub> system actuator by this current flow. An open circuit between the terminals and the actuator will prevent flow of the supervisory current and cause a “trouble” or “supervisory” alarm at the control panel.

**Figure 2-2.** Bell Circuit 2 in normal supervisory condition—no alarm. Relay K2 is deenergized.

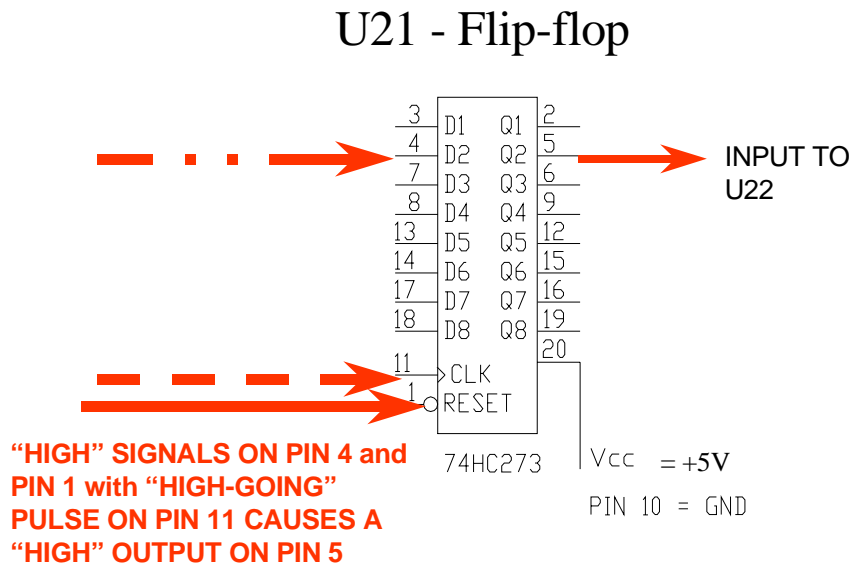
To activate a bell circuit, a high signal must exist on an input data pin of U21, simultaneously with a high signal on Pin 1 of U21, and simultaneously with a high-going pulse on Pin 11 of U21. With these three high pulses present, the voltage on the related output pin of U21 will go high and stay high until chip U21 is reset. In other words, the circuit latches. The high output signal from U21 is applied to the connected input pin of U22 causing the related transistor in U22 to operate. Key points of the U21 flip-flop include:

- Specified operating voltage +2 to +6 volts direct current (DC)
- High output signal occurs when (1) high signal on reset pin, (2) high signal on data pin (3) high-going signal on clock pin occur simultaneously
- High output signal latches until chip is reset.

**Figure 2-3.** Operation of U21 flip-flop circuit

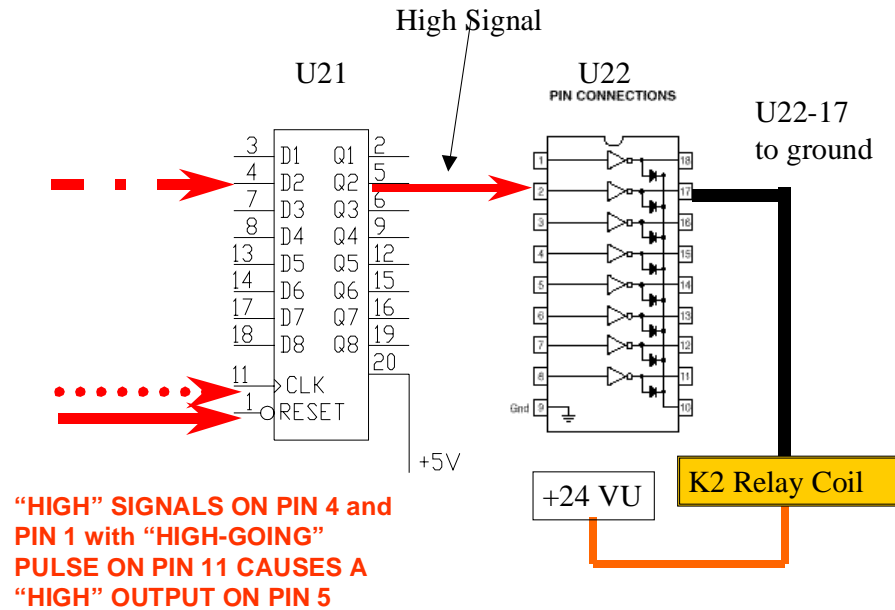
Figure 2-4 shows U21 and U22 activating Bell Circuit 2. High signals at U21 provide the input signal to U22. The U22 output lead is connected to ground. Current flows through the relay coil and the relay operates.

**Figure 2-4.** U21 and U22 activate Bell Circuit 2.

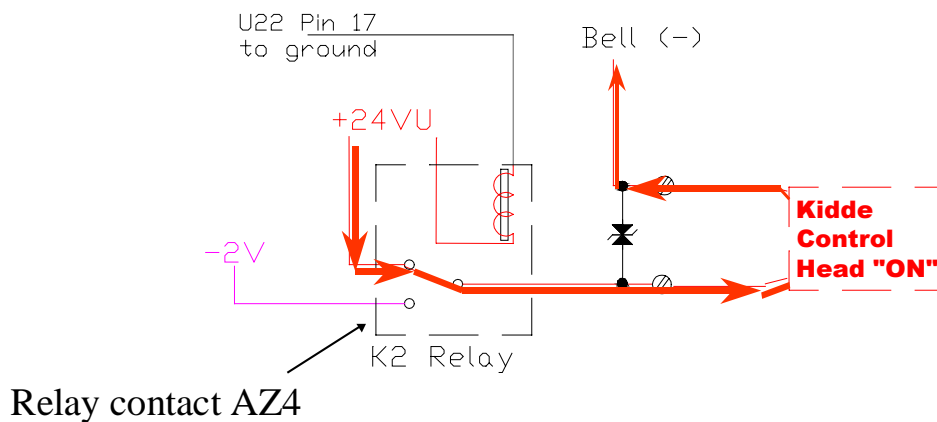
Figure 2-5 shows Bell Circuit 2 activated. When the Darlington transistor in U22 operates, Pin 17 pulls one side of the K2 relay coil to ground while the other side of the relay coil is connected to +24 volts (+24 VU). The coil is energized and the AZ4 relay contact is transferred. Terminal TB2.3 is now connected to +24 VU and the solenoid coil in the Kidde control head on Bell Circuit 2 is energized.

**Figure 2-5.** Relay K2 is energized activating Bell Circuit 2.

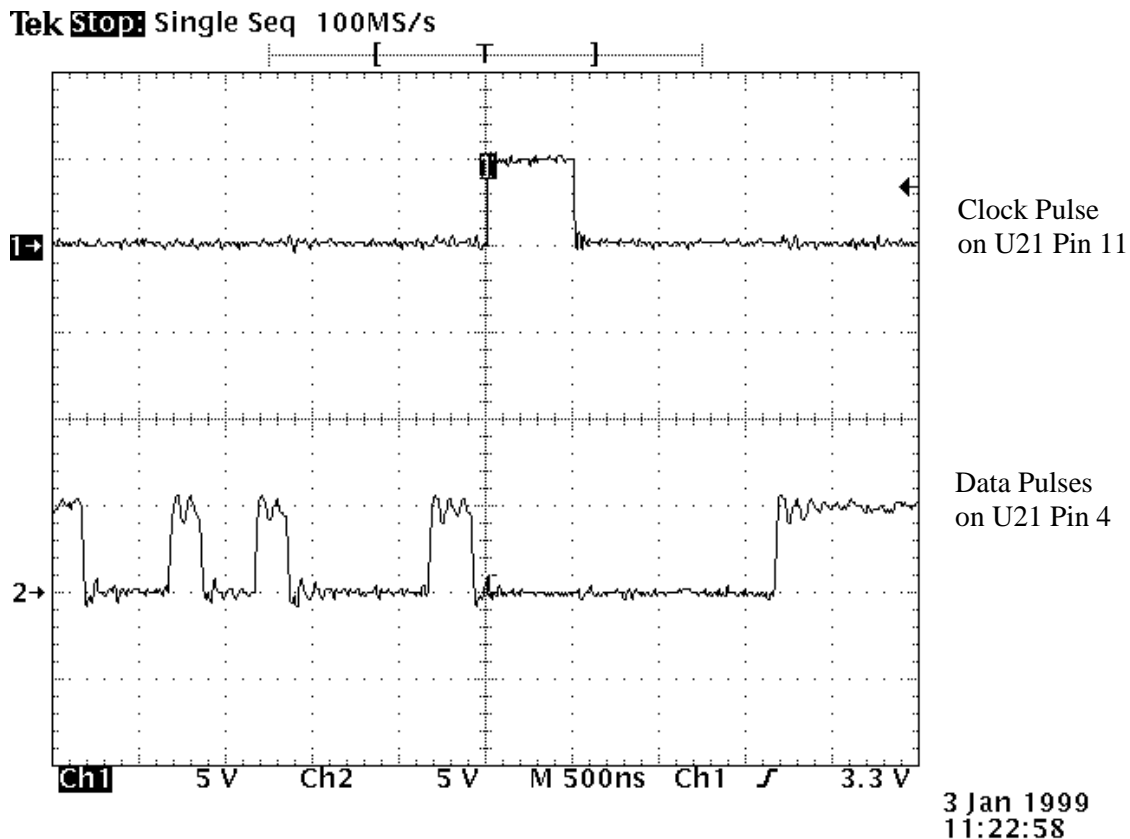
**2.2.2.1 Normal Standby Operation.** Figure 2-6 is a recording of pulses from the clock pin (Pin 11) of U21 and a data pin (Pin 4) of U21. These pulses are typical of those recorded when the AFP-200 panel is in normal, standby operation with no alarm. The high-going clock pulses occur every 250 milliseconds but do not occur simultaneously with the data pulses.<sup>8</sup>

**Figure 2-6.** Oscilloscope recording of typical pulses in a normal (no alarm) condition.

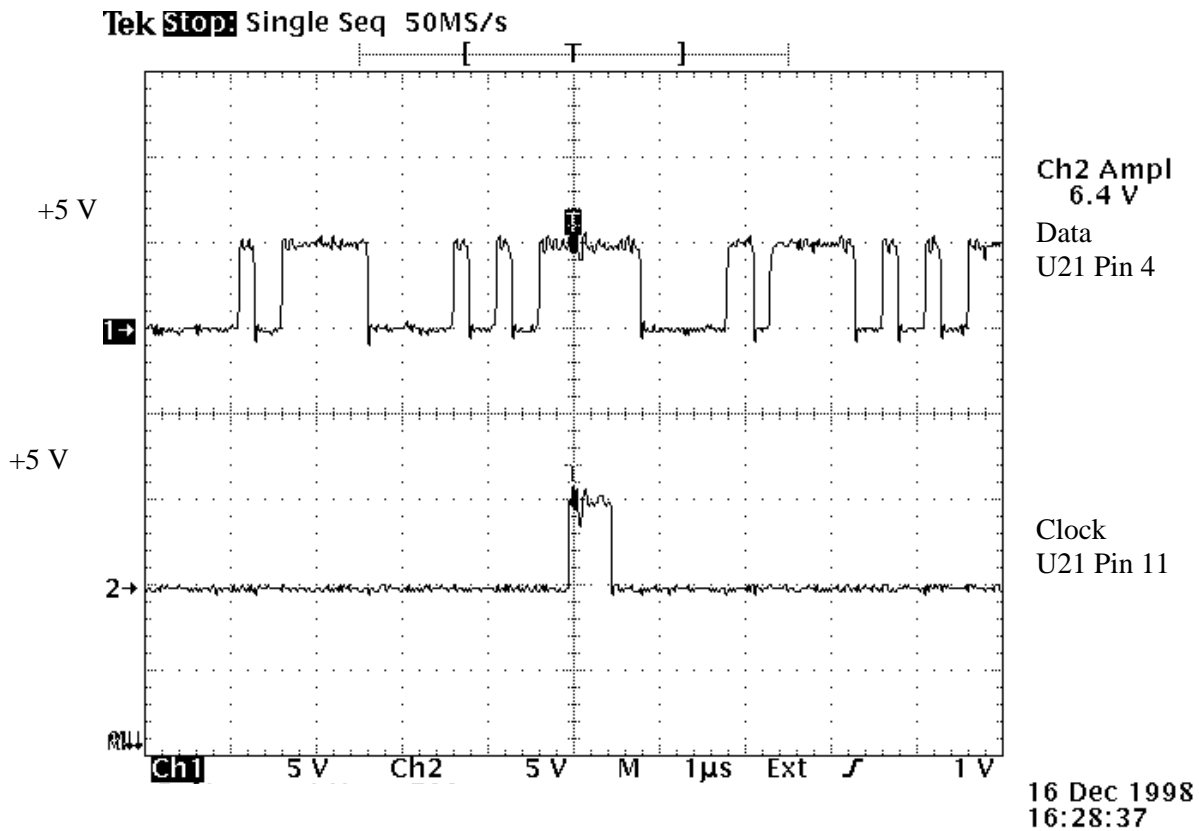
Figure 2-7 is a recording of pulses on the clock pin (Pin 11) of U21 (lower trace) and a data pin (Pin 4) of U21 (upper trace). These pulses are typical of those recorded as a manual station or detection device activates a bell circuit. Note that the high-going clock pulse occurs simultaneously with a data pulse. Also note that the peak voltage on the pulses is approximately 5 volts. The reset pin of U21 (Pin 1) is also high and a high signal on the associated output, Pin 5, of U21 results. The transistor connected to Pin 17 of U22 operates, energizing Relay K2 to energize Bell Circuit 2. These pulses were recorded when the bell circuit was activated by operation of a manual station connected to the TRA-648 fire alarm control panel.

**Figure 2-7.** Oscilloscope recording of pulses during activation of Kidde electric release heads initiated by operation of a manual station.

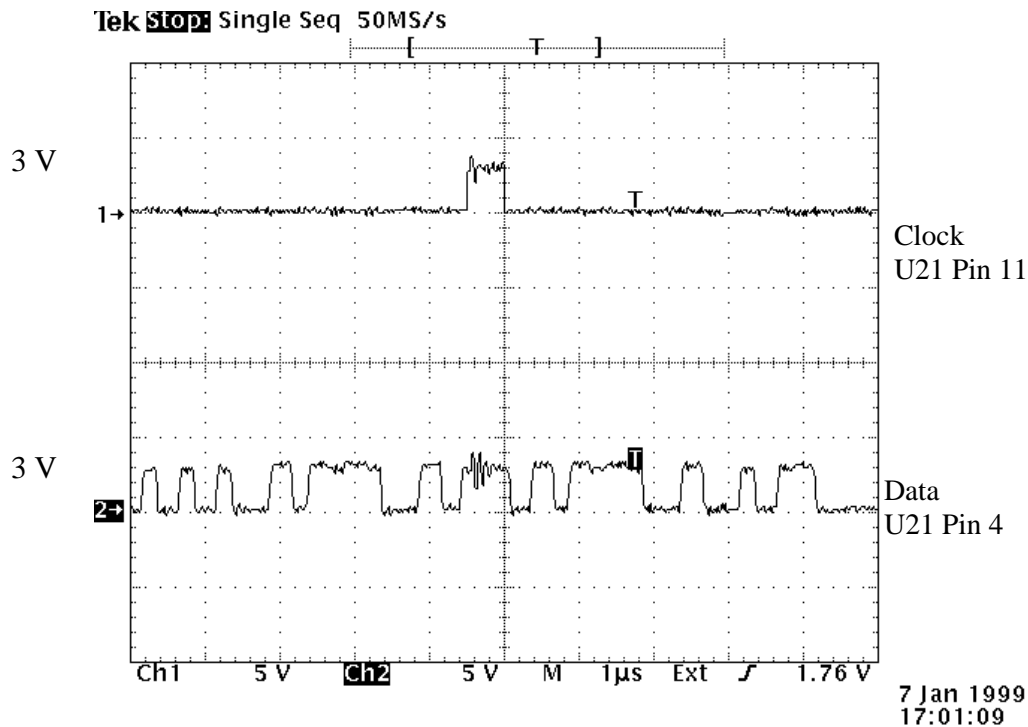
**2.2.2.3 Unexpected, Undesired, Dangerous Operation of Bell Circuit Initiated by AC Power Loss.** Figures 2-8 and 2-9 were taken at Tronamix, Inc. laboratory during unexpected, unwanted operations of Bell Circuit 2 that activated the Kidde electric control head 24 VDC (part number 890181) installed on Bell Circuit 2. In each case:

- The undesirable operation was initiated when AC power was disconnected from an AFP-200 panel
- Simultaneous high signal on a data pin of U21 coincided with a high-going signal on the clock pin of U21
- No detectors or manual stations were in alarm
- Solenoid circuits were software disabled
- Standby batteries were connected to a NR45 external battery charger installed with the AFP-200 panel per Notifier instructions<sup>9</sup>
- Peak signals were 3 volts or less (corresponding to the voltage on the +5 volt power bus at the time of activation).

**Figure 2-8.** Oscilloscope traces when Bell Circuit 2 activated after AC power was disconnected.

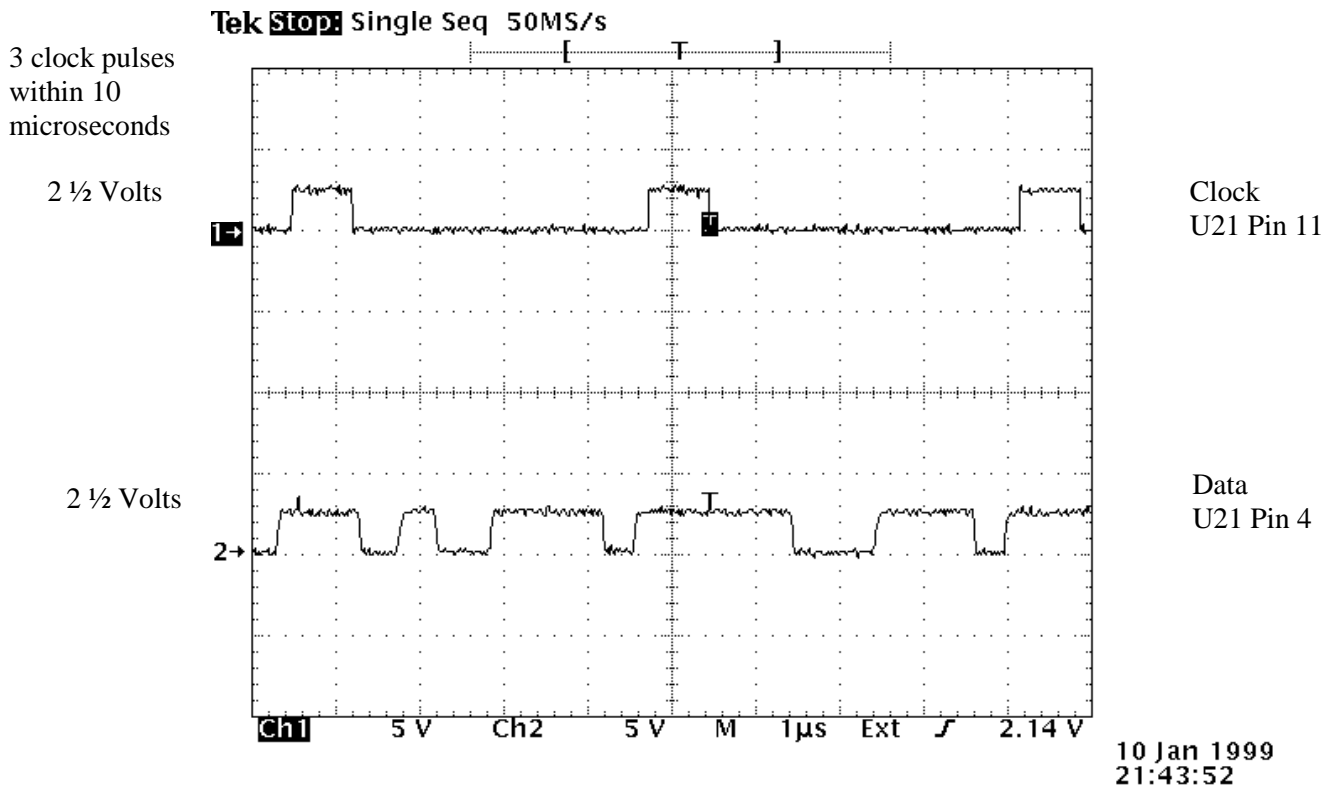
**Figure 2-9.** Oscilloscope traces show three clock pulses within 10 microseconds.

In Figure 2-9, spurious signals occur on the clock pin—three high clock signals are noted within 10 microseconds. Normal clock pulse spacing was measured on the subject AFP-200 panel as 250 milliseconds. The lower trace is the data bus to Pin 4 of chip U21; the upper trace is the signal on Pin 11 (clock pin) of chip U21. The spurious signals followed removal of AC power from the AFP-200 panel and caused operation of the Kidde electric release connected to Bell Circuit 2.

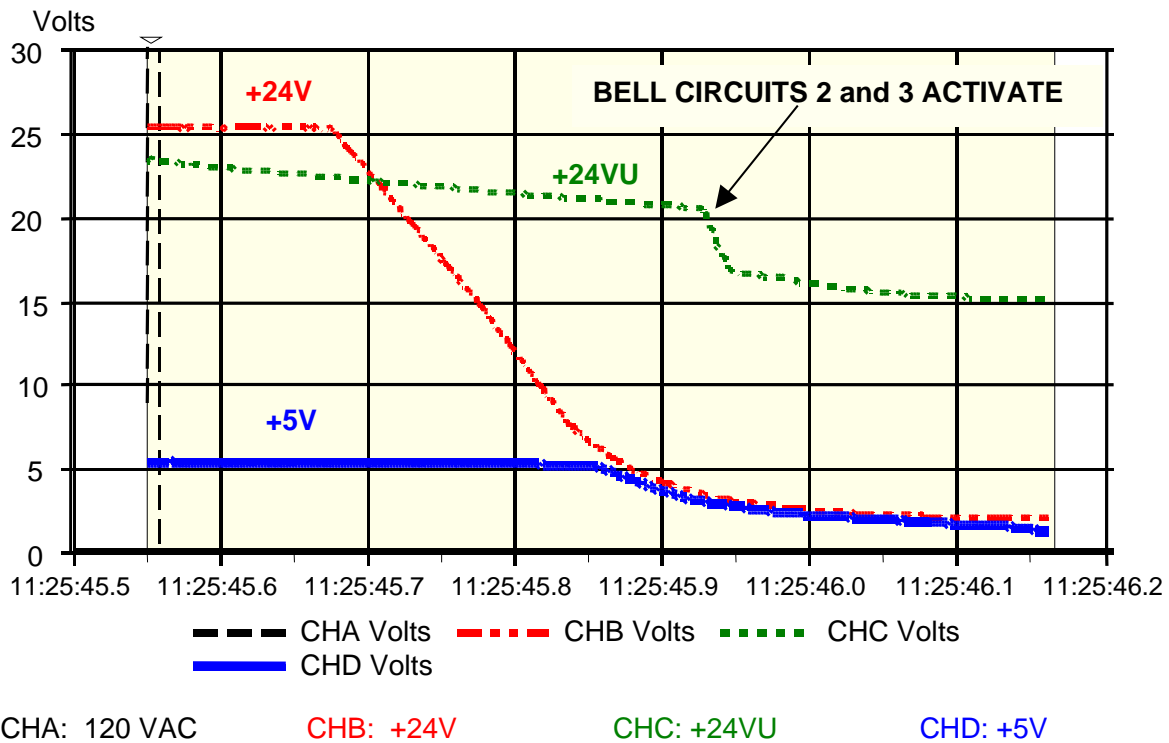
**2.2.3.1 Recording of DC Voltages After Loss of AC Power.** Figure 2-10 shows a Dranetz meter recording taken from the AFP-200 panel at TRA-648 configured with standby batteries connected to an external battery charger. The 120 volts AC power to the panel was disconnected and drops to zero volts at approximately 11 hours 25 minutes 45.55 seconds. In less than one-half second after AC voltage to the panel is zero, Bell Circuits 2 and 3 activated. The Kidde control heads connected to Bell Circuits 2 and 3 operated.

**Figure 2-10.** Dranetz recording shows decay of DC voltages after AC power loss with external charger installed. Bell circuits activate.

The bell circuit activation was initiated solely by disconnecting AC power to the AFP-200 system. No detectors, manual stations, or other initiating devices in the system were in alarm.

Note that voltage on the +24 V bus decayed to about 4 volts at the time of the bell circuit activation. The +5 V bus had decreased to approximately 3 volts at the time the Kidde control heads operated. Note also that the voltage on the +24 VU bus was over 20 volts at the time of the activation.

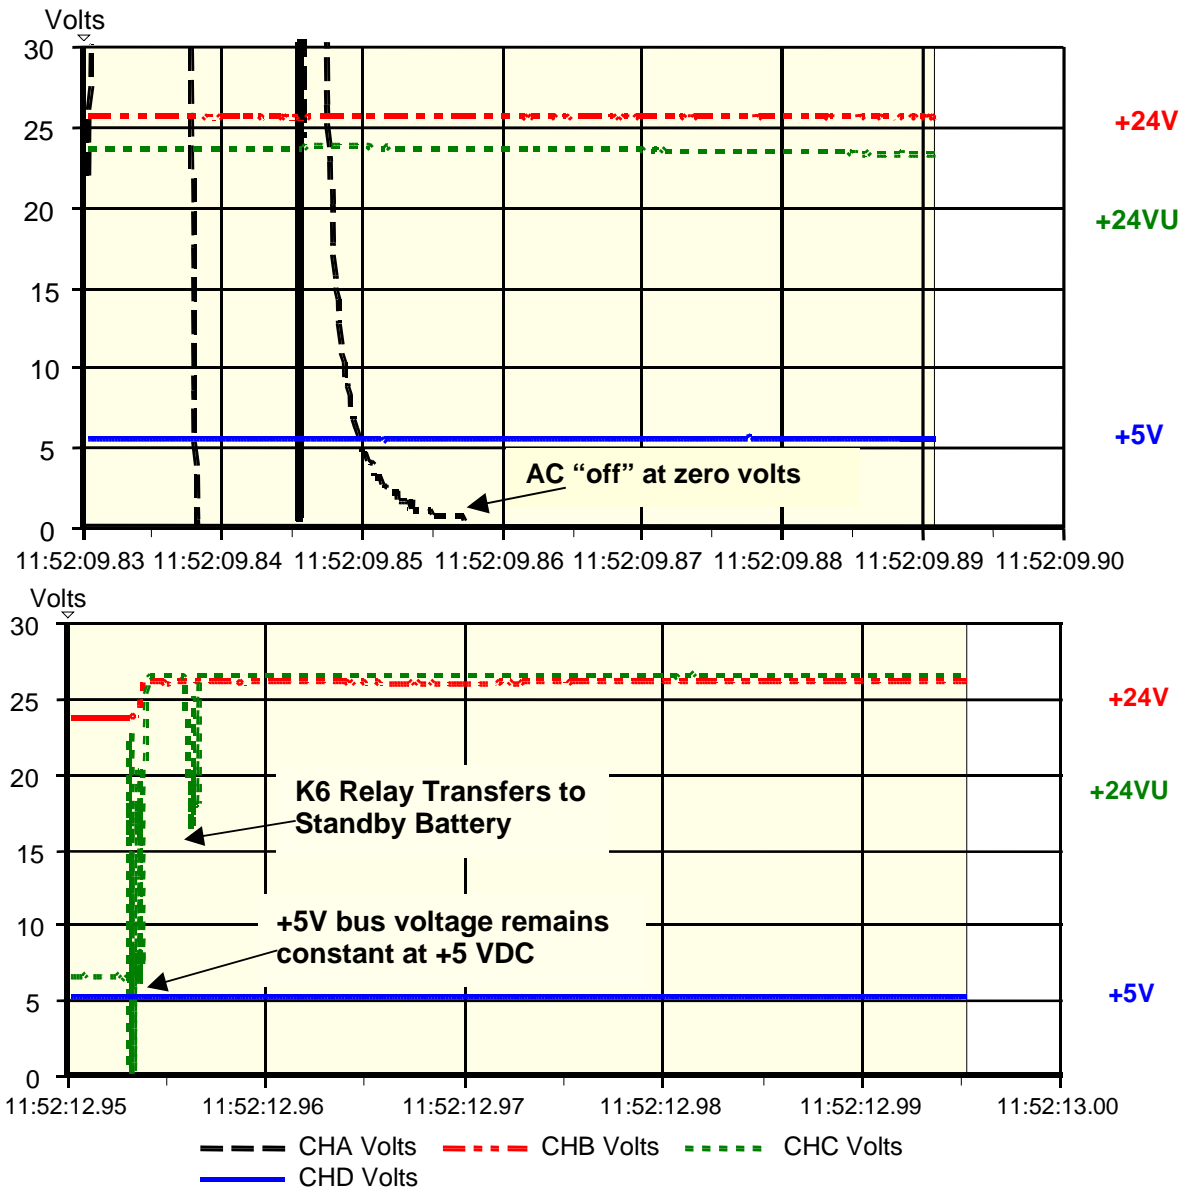
A Dranetz meter recording of the DC voltages within the AFP-200 panel with a good charged standby battery connected to the internal charger is shown in Figure 2-11.

### Standby Battery Connected to Internal Charger; JP2 Intact

If a good, charged standby battery is connected directly to the internal battery charger in the AFP-200 panel (no external battery charger installed), a slight decay in the +24 V voltage was observed but no decay in the +5 V voltage was measured. Since the +5 V voltage remains normal, the microprocessor is not subjected to lower than specified operating voltages. Random activation of the bell circuits was not observed in this panel configuration.

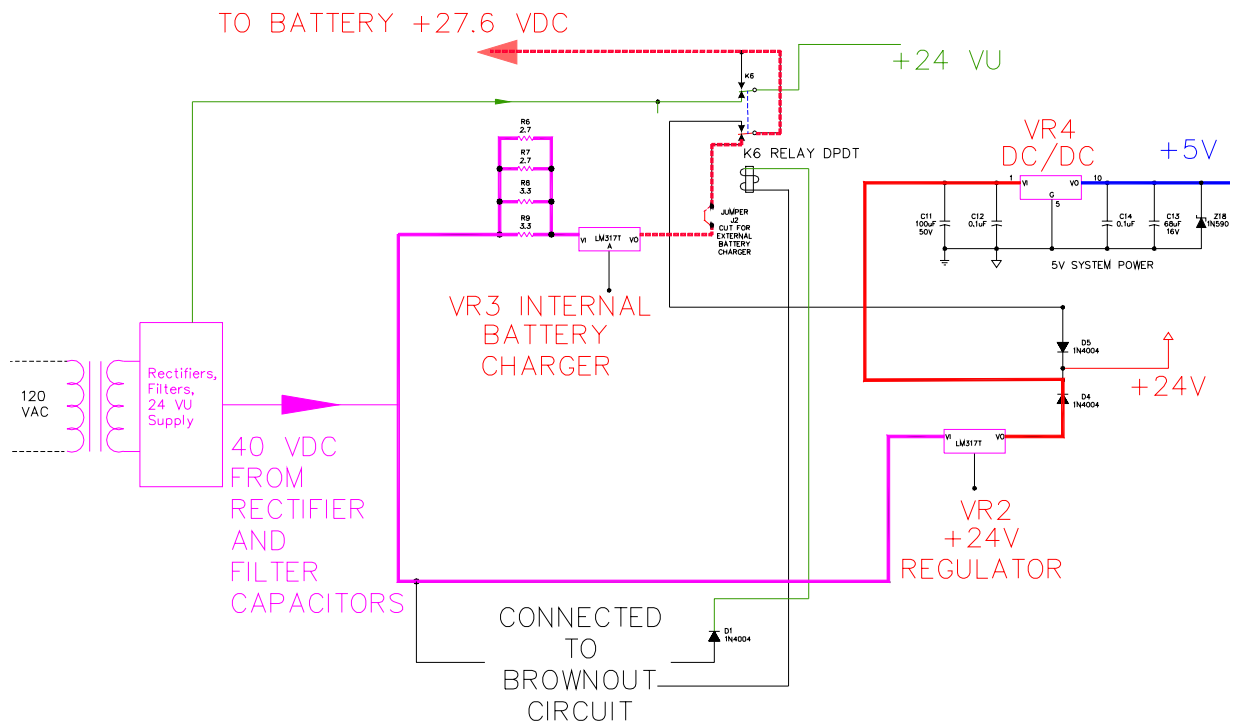
**Figure 2-12.** Simplified diagram of internal power supply section of AFP-200 panel.

A power transformer reduces the 120 volts AC voltage, and sets of rectifiers convert the low voltage AC to DC. Some of the DC is filtered and supplied to the input side of voltage regulators VR2 and VR3. In Figure 2-12, this voltage is labeled “40 VDC FROM RECTIFIER AND FILTER CAPACITORS.”

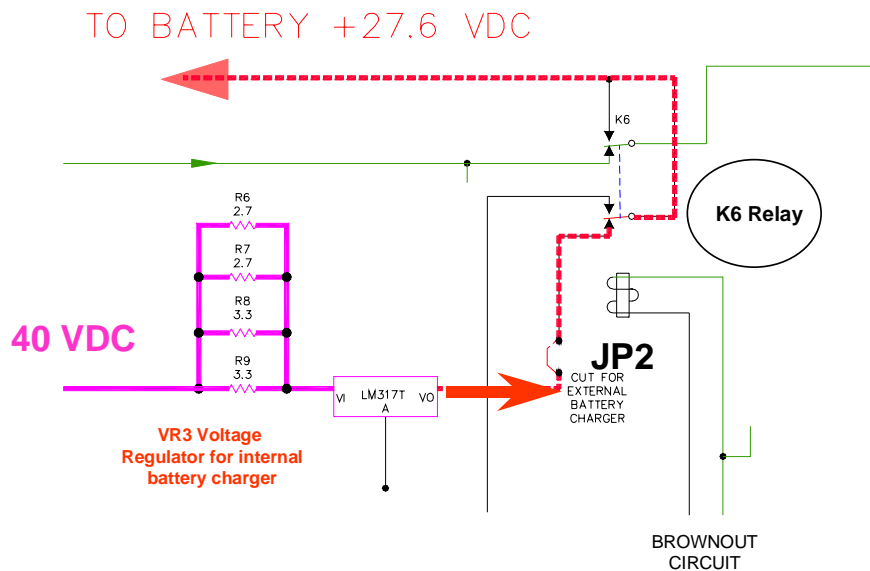
Figure 2-13 is an enlarged view of the internal battery charger circuit showing the battery transfer relay K6 in an energized condition (sufficient AC power connected).

**Figure 2-13.** Enlarged view of the internal battery charger circuit.

**2.2.3.3 Brownout Circuit.** When nominal 120 volts AC is supplied to the control panel, the brownout circuit keeps relay K6 energized. This condition is shown in Figure 2-13. If AC line voltage falls to an unacceptably low level (approximately 100 volts or 85% of the nominal rated voltage), a brownout circuit acts to de-energize relay K6 and permit its contacts to transfer. When K6 is deenergized, the relay contacts connect the standby battery to the internal power supply circuits in the AFP-200 panel.

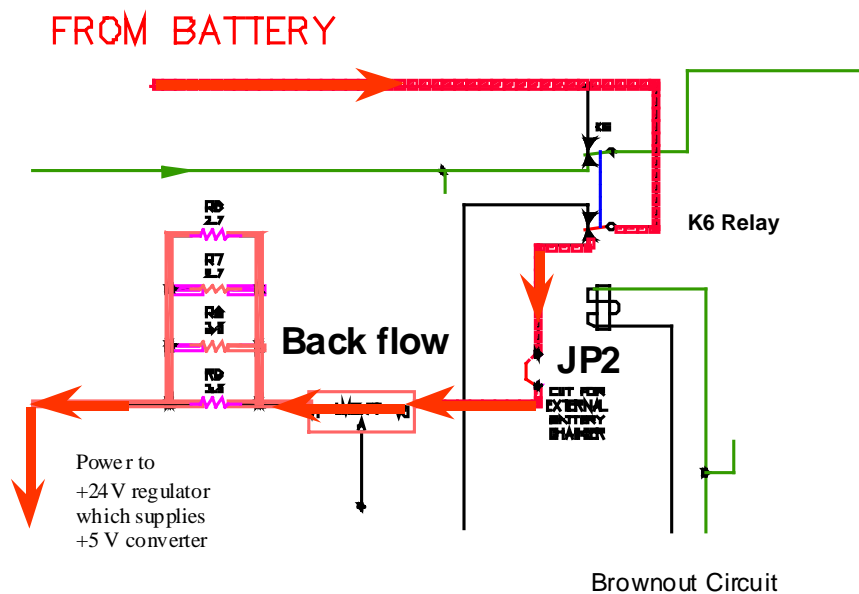
With nominal 120 volts AC supplying the AFP-200 panel, approximately 40 volts DC is supplied by the power supply rectifier/filter circuits to the input leads on voltage regulators VR2 and VR3. When AC power is disconnected, the input voltage to these regulators decreases. As the voltage from the rectifier circuits decrease, with the panel configured as shown in Figure 2-14, current from the standby batteries back-flows through VR3 and thence to the input lead on VR2, the 24 volt supply regulator. This back-flow maintains the input voltage to VR2 at or above a nominal 24 volts—VR2 is able to maintain a nominal 24 volt level on the input pin of VR4. VR4 is able to maintain 5 volts to the microprocessor circuitry and other semiconductor components. No spurious signals were observed under these conditions.

**Figure 2-14.** Internal battery charger—AC disconnected—K6 has not yet transferred its contacts.

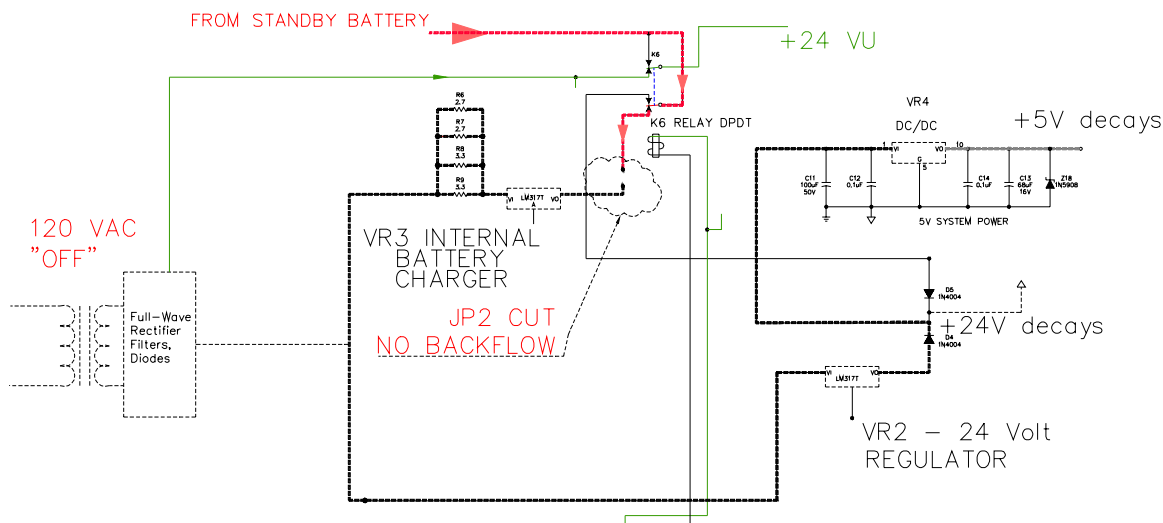
With JP2 cut, the back-flow path from standby battery to the input of VR2 is broken (see Figure 2-15). The voltage decay described above occurs after AC power is lost before relay K6 transfers. The spurious signals described above are generated. Undesired activation of the bell circuits occurs on a random basis. The occurrence of activation is random because the signal generation by the microprocessor circuits under low voltage conditions becomes erratic.

**Figure 2-15.** With JP2 cut, the back-flow path from standby battery to the input of VR2, the 24 volt DC regulator, is eliminated.

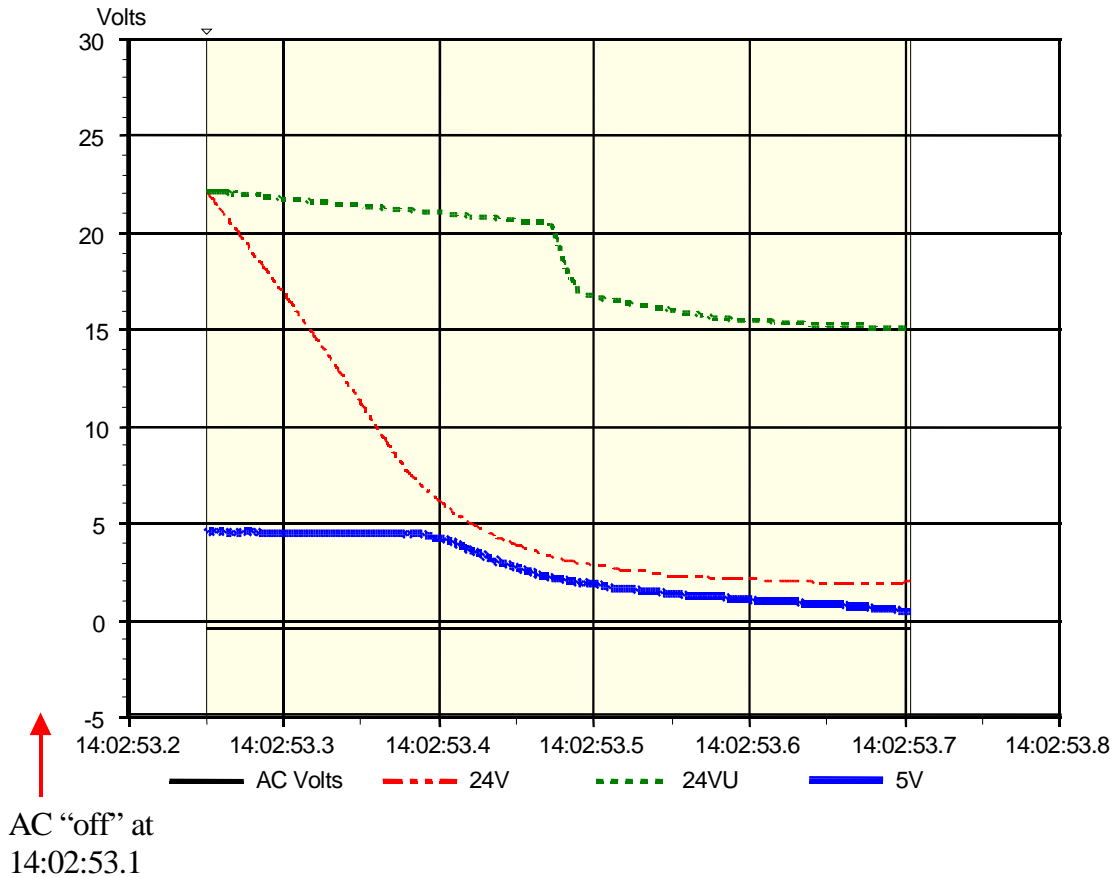
Figure 2-16 shows that within a fraction of a second (0.15 sec) after AC power goes to zero volts, decay of the voltage on the +24 V bus is evident. As the +24 V bus drops below about 7 volts, decay of the voltage on the +5 V bus is evident. As +5 V decays to approximately 3 volts, spurious signals are observed on U21 pins (see Figure 2-17). The +24 VU decays slowly until the bell circuits are activated—the change in slope of the +24 VU decay curve indicates flow of electrical energy to the Kidde electric discharge heads.

**Figure 2-16.** Dranetz recording shows voltage decays.

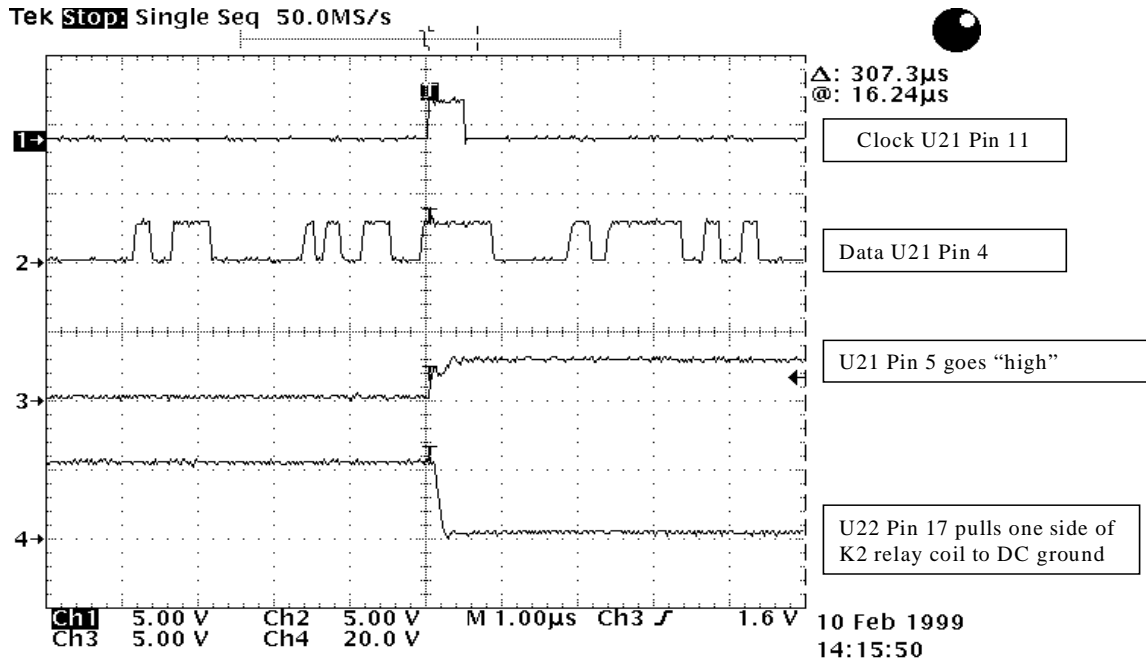
Figure 2-17 shows a high pulse on U21 Pin 4 coincident with a high-going pulse on U21 Pin 11. These pulses activate the associated flip-flop circuit in U21 causing U21 Pin 5 to go high. The high output on U21 Pin 5 is input to U22 Pin 2. The high signal on U22 Pin 2 causes U22 Pin 17 to pull one side of the K2 relay coil toward DC ground. This energizes relay K2.

**Figure 2-17.** Oscilloscope traces from AFP-200 panel in TRA-648.

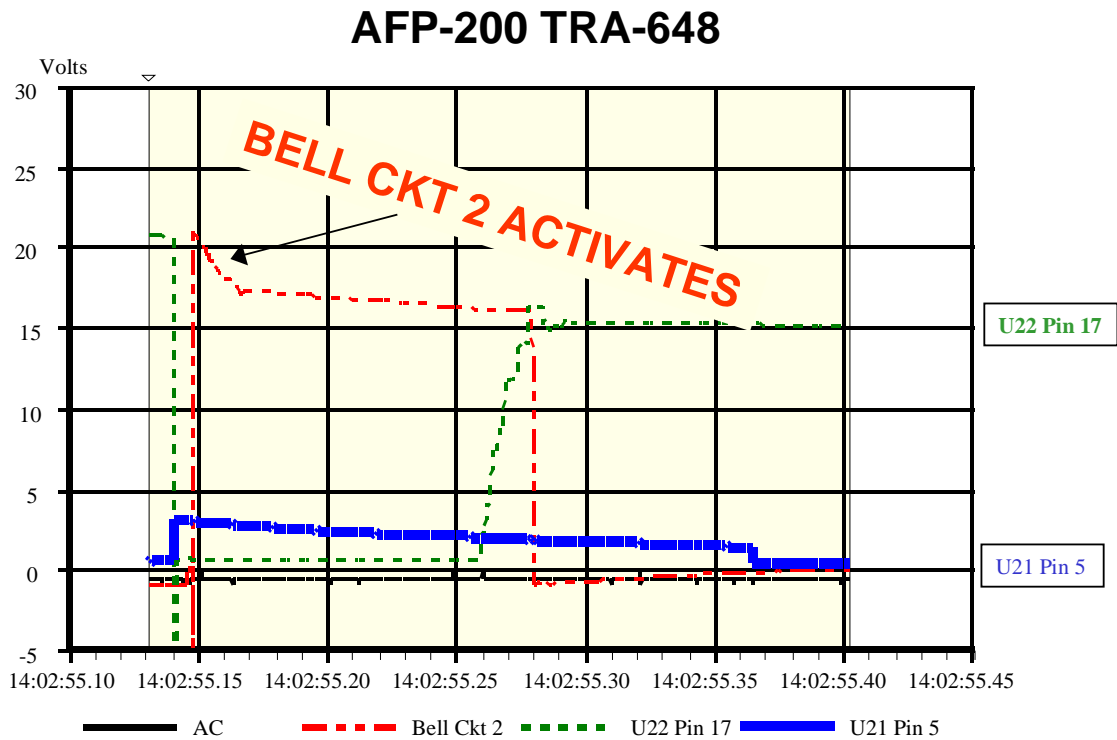
Figure 2-18 also records the high signal on U22 Pin 2 and the resulting signal on U22 Pin 17. The resulting activation of Bell Circuit 2 is likewise recorded. U21 Pin 5 output goes high causing U22 Pin 17 to pull one side of the K2 relay coil to DC ground. Voltage on Bell Circuit 2 reverses from approximately -2 volts supervisory status to +24 volts activated status. The high voltage pulse on Bell Circuit 2 lasts approximately one-eighth second. The strength and duration of the pulse is sufficient to activate the Kidde electric control head connected to Bell Circuit 2. The Kidde control head discharges the CO<sub>2</sub> system.

**Figure 2-18.** Dranetz recording shows Bell Circuit 2 activates.

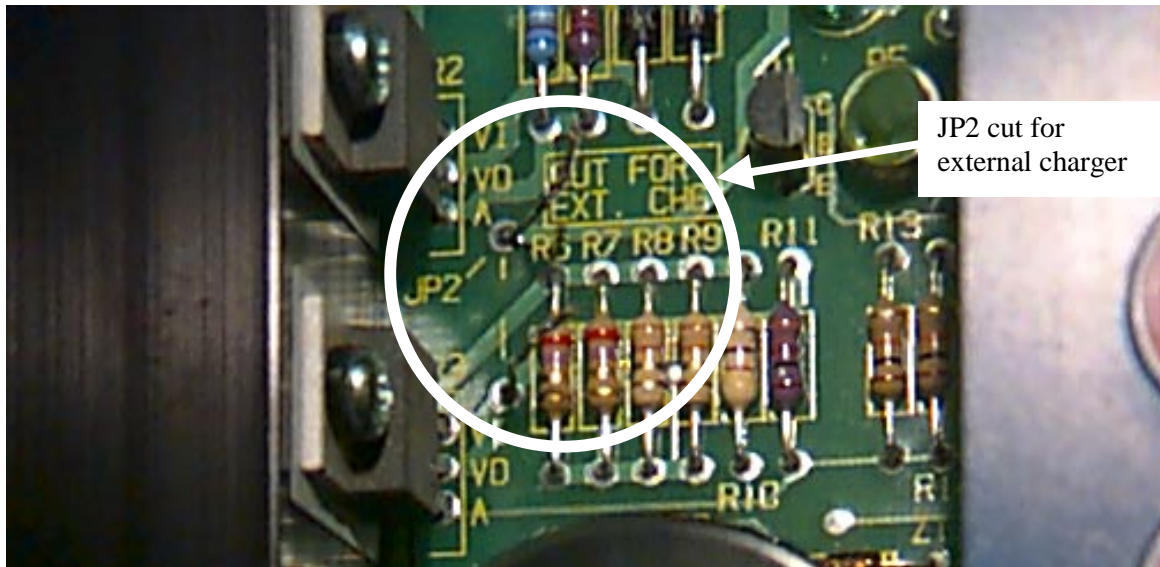
The AFP-200 panel printed-circuit board has “CUT FOR EXT. CHG” imprinted next to Jumper JP2 (see Figure 2-19).

**Figure 2-19.** The AFP-200 printed circuit board instructions to cut JP2.

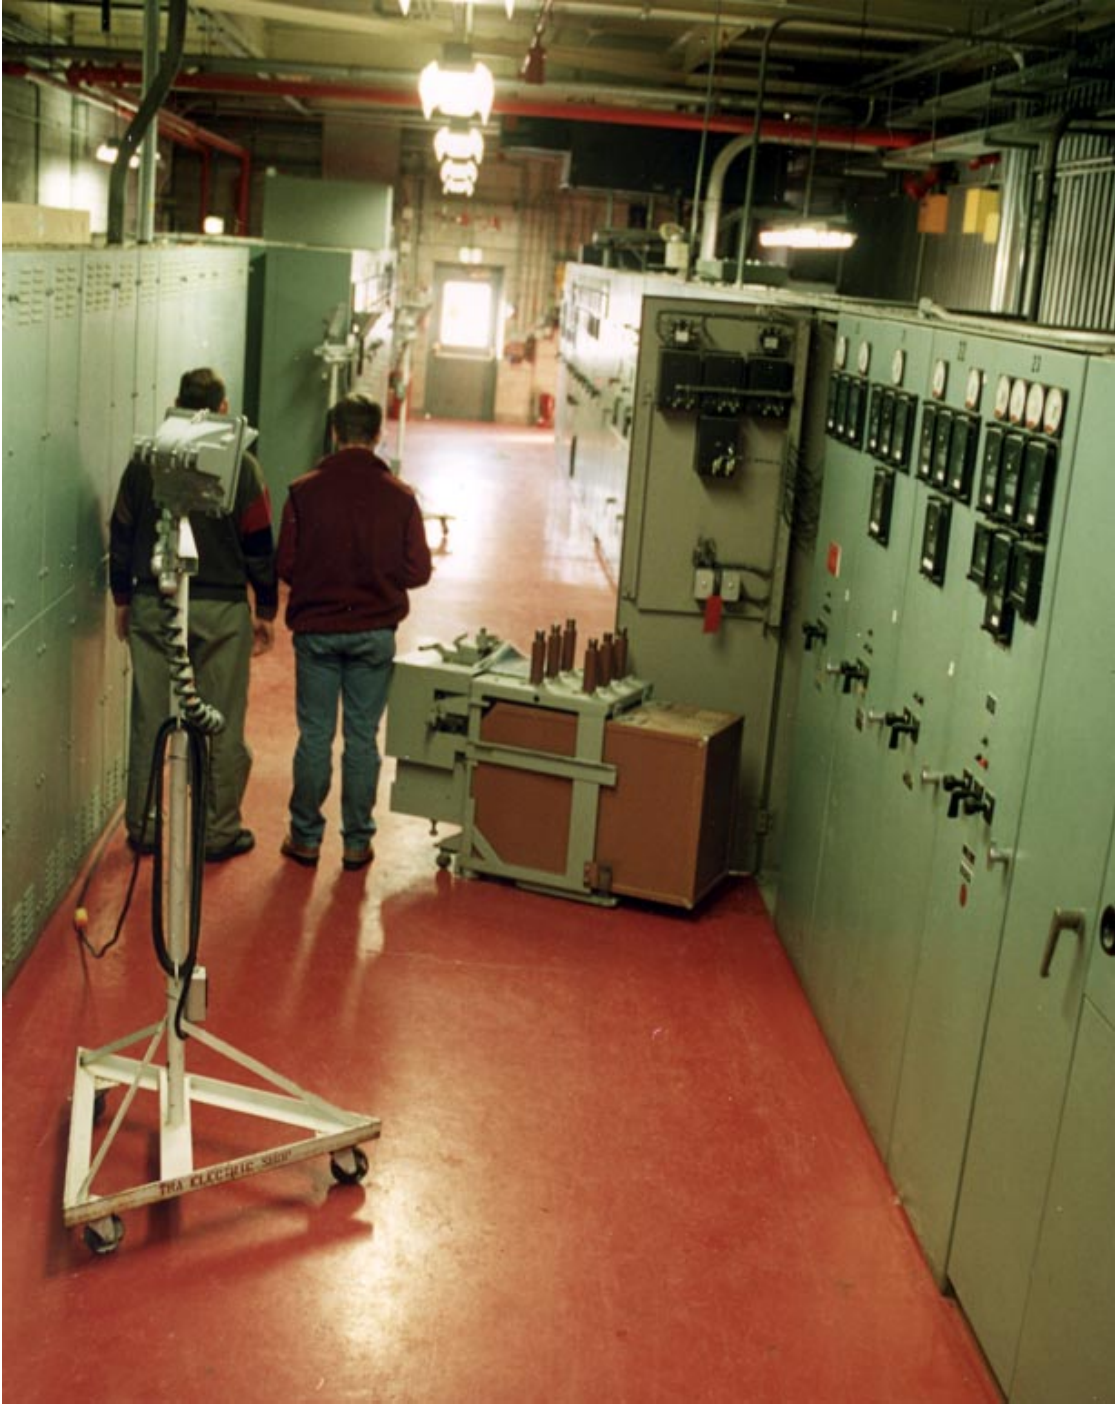
**Figure 3-1.** Clear egress path around electrical work equipment.

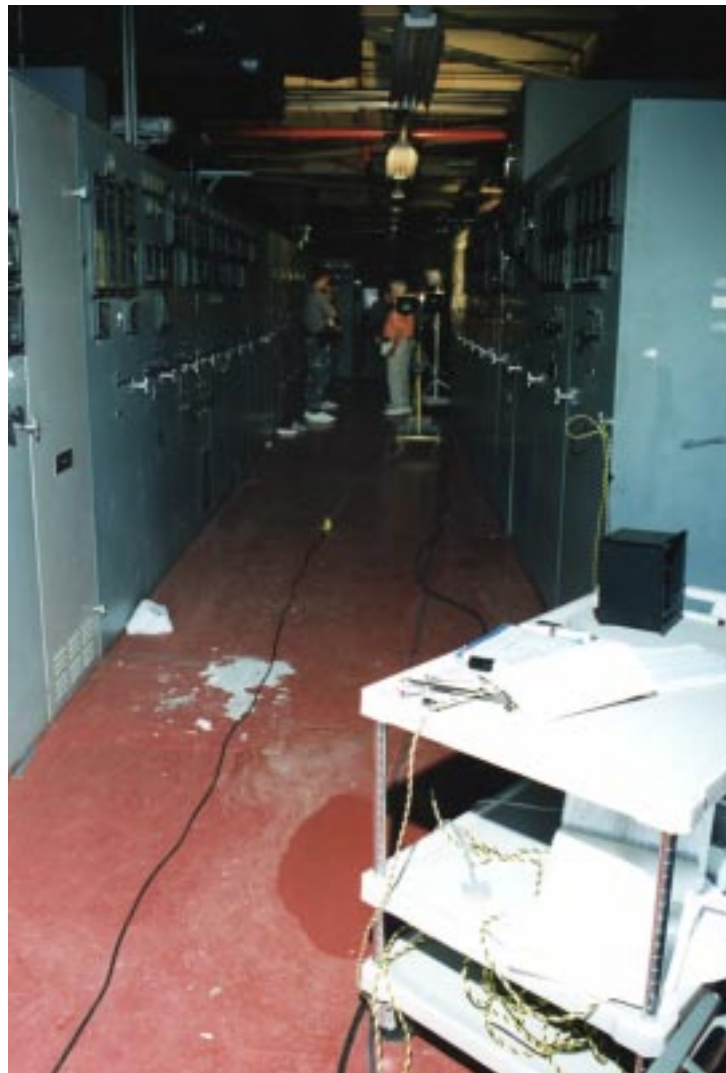
Looking at Exhibit 2-5 in the Investigation Report, a reader might infer that the egress path to the west door was blocked. Such an inference would be incorrect for two reasons. First, the equipment carts, papers, and cables shown in the Investigation Report Exhibit were dragged to the area south of the west door when the fire engineer and a security guard rescued a worker.<sup>42</sup> This equipment was positioned out of the egress pathway when the work was being performed. Second, even after the equipment had been dragged to the area south of the west door, the main aisle still provided a clear egress path. Figure 3-2, taken at about the same time as Exhibit 2-5 in the Investigation Report, looking in from the west door, shows the clear egress path down the main aisle. As is evident from Figure 3-2, the egress path to the west door met the requirements of 29 CFR 1910 Subpart E.

**Figure 3-2.** Clear egress path to west door remains even after equipment was moved during the rescue.

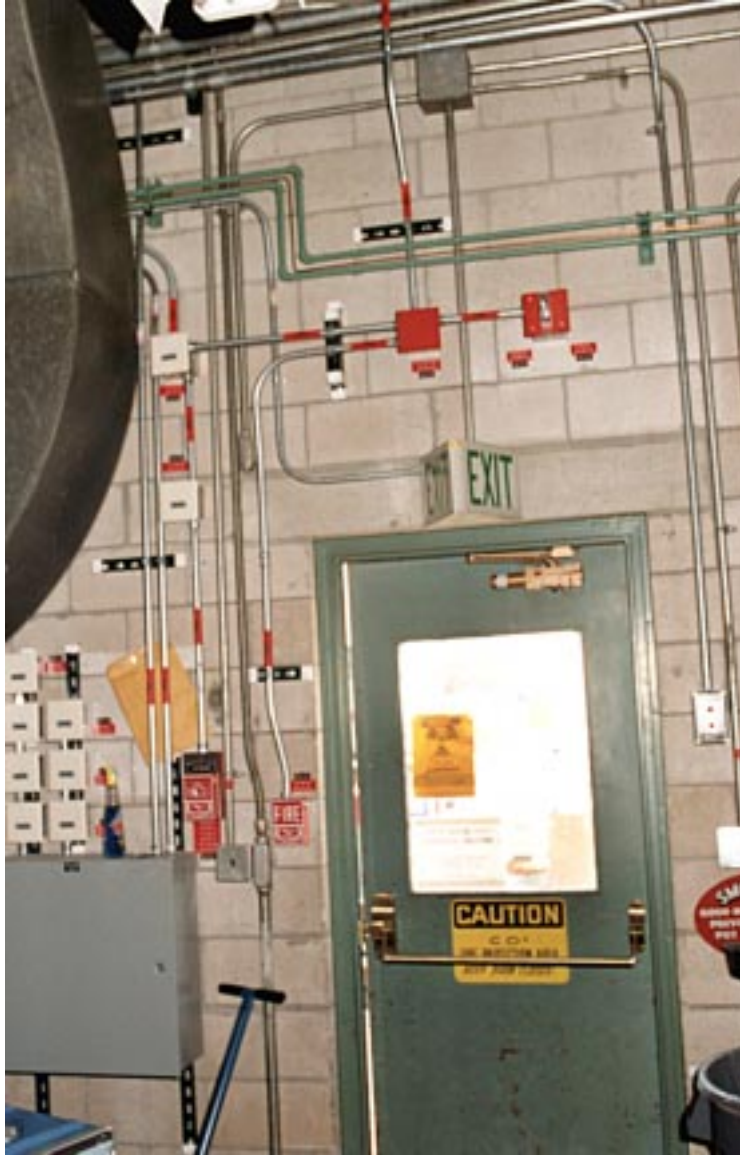
**Figure 3-3.** “Panic hardware” installed on TRA-648 emergency exits.
