INEEL/EXT-99-00669

June 1999

Identification of the Specific Mechanism by which the CO₂ System in Building TRA-648 Accidentally Discharged

Idaho National Engineering and Environmental Laboratory

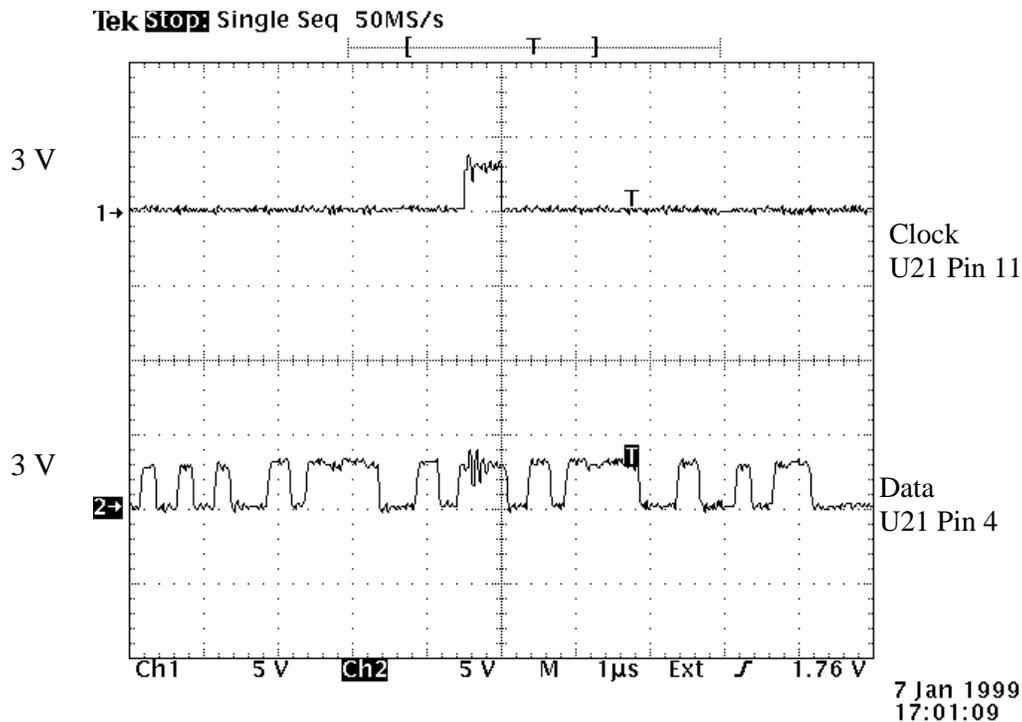
- The undesirable operation was initiated when AC power was disconnected from an AFP-200 panel
- Simultaneous high signal on a data pin of U21 coincided with a high-going signal on the clock pin of U21
- No detectors or manual stations were in alarm
- Solenoid circuits were software disabled
- Standby batteries were connected to a NR45 external battery charger installed with the AFP-200 panel per Notifier instructions⁹
- Peak signals were 3 volts or less (corresponding to the voltage on the +5 volt power bus at the time of activation).

Figure 2-8. Oscilloscope traces when Bell Circuit 2 activated after AC power was disconnected.

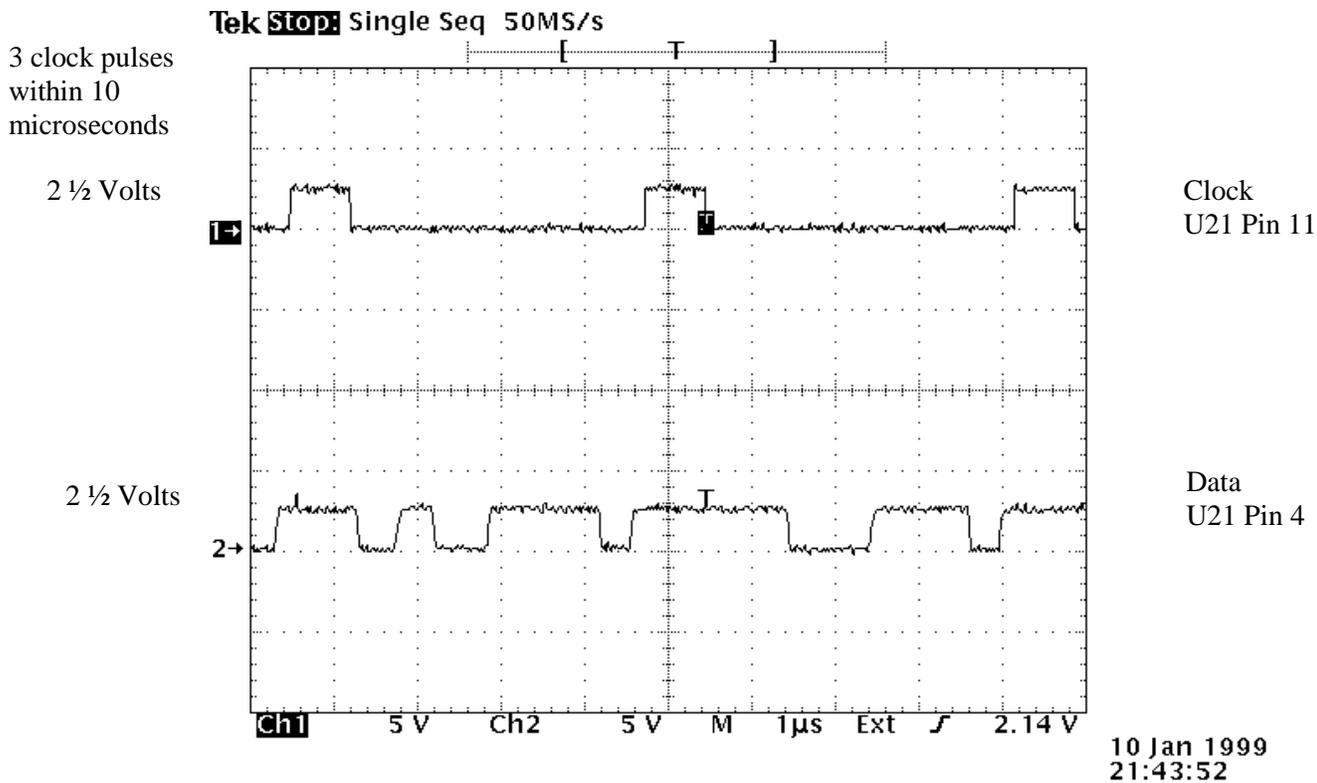
Figure 2-9. Oscilloscope traces show three clock pulses within 10 microseconds.

In Figure 2-9, spurious signals occur on the clock pin—three high clock signals are noted within 10 microseconds. Normal clock pulse spacing was measured on the subject AFP-200 panel as 250 milliseconds. The lower trace is the data bus to Pin 4 of chip U21; the upper trace is the signal on Pin 11 (clock pin) of chip U21. The spurious signals followed removal of AC power from the AFP-200 panel and caused operation of the Kidde electric release connected to Bell Circuit 2.

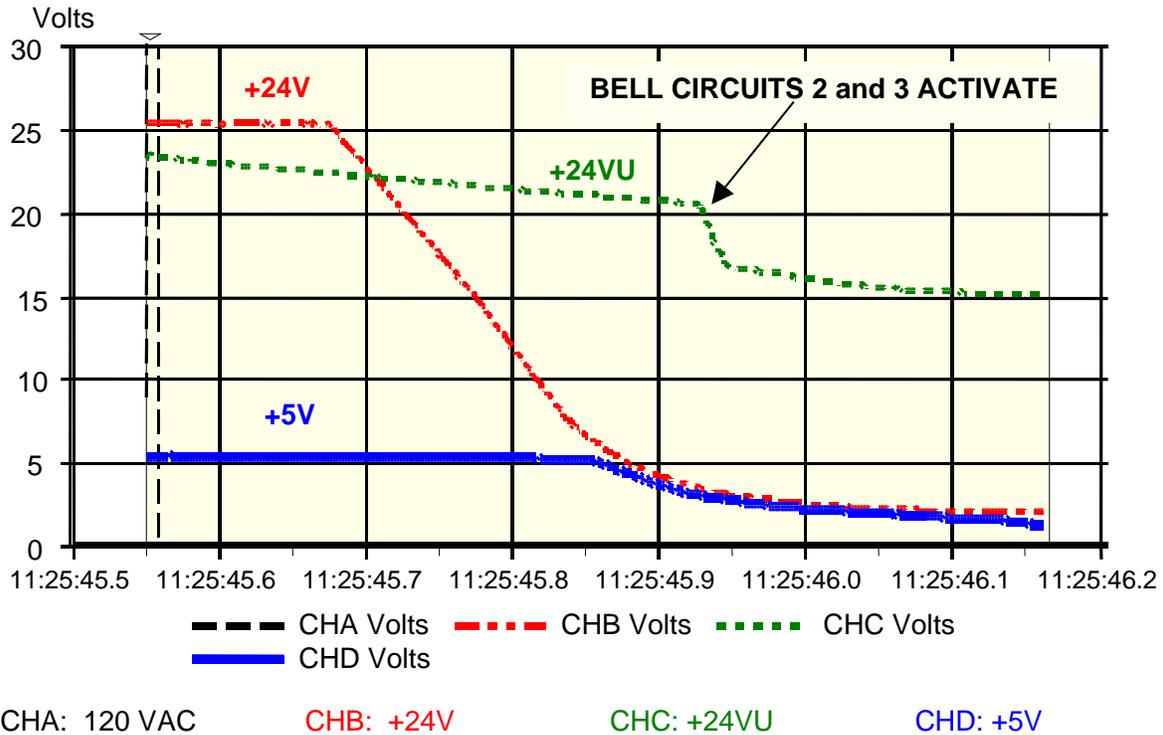
Figure 2-10. Dranetz recording shows decay of DC voltages after AC power loss with external charger installed. Bell circuits activate.

The bell circuit activation was initiated solely by disconnecting AC power to the AFP-200 system. No detectors, manual stations, or other initiating devices in the system were in alarm.

Note that voltage on the +24 V bus decayed to about 4 volts at the time of the bell circuit activation. The +5 V bus had decreased to approximately 3 volts at the time the Kidde control heads operated. Note also that the voltage on the +24 VU bus was over 20 volts at the time of the activation.

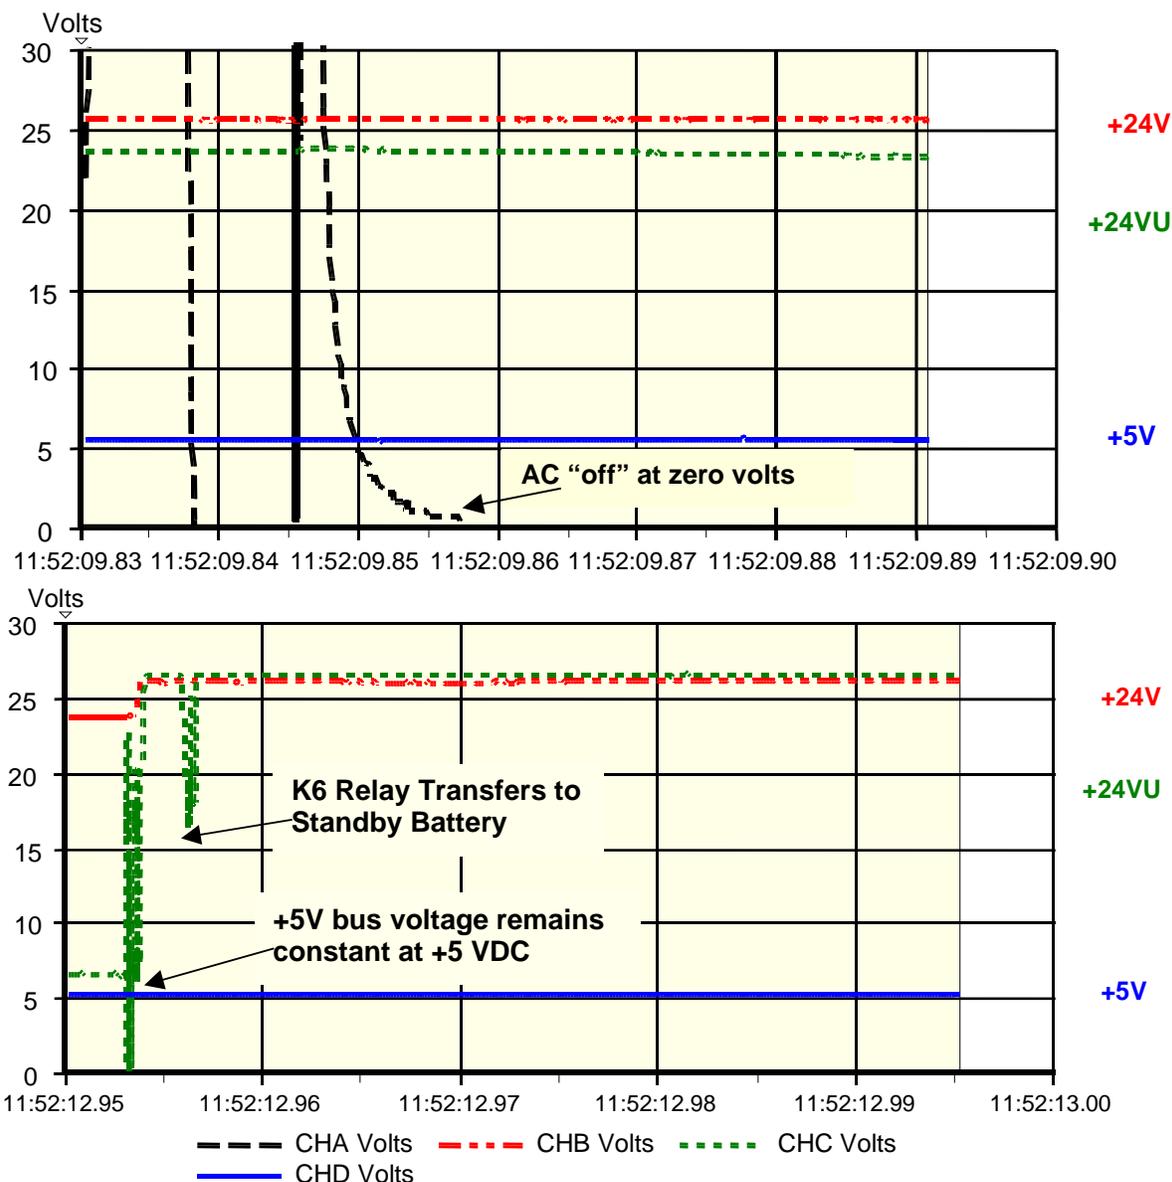
Standby Battery Connected to Internal Charger; JP2 Intact

If a good, charged standby battery is connected directly to the internal battery charger in the AFP-200 panel (no external battery charger installed), a slight decay in the +24 V voltage was observed but no decay in the +5 V voltage was measured. Since the +5 V voltage remains normal, the microprocessor is not subjected to lower than specified operating voltages. Random activation of the bell circuits was not observed in this panel configuration.

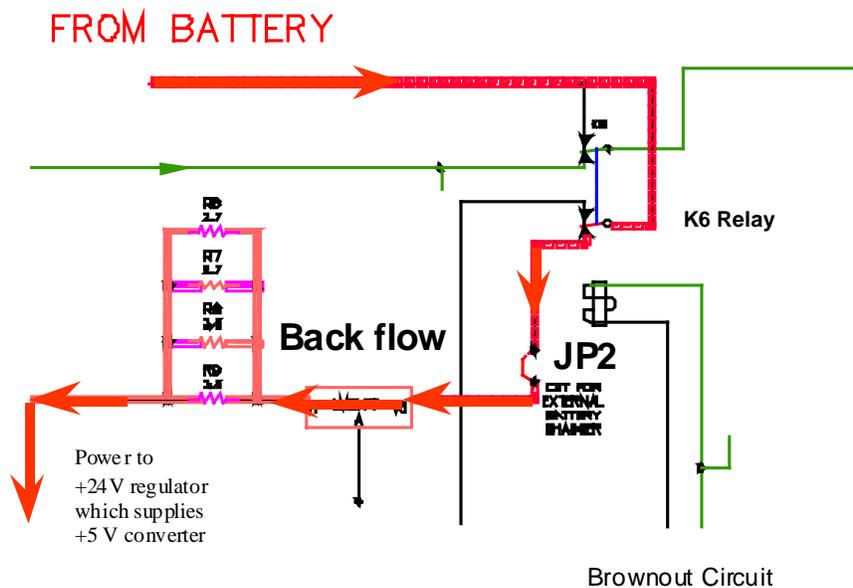
With nominal 120 volts AC supplying the AFP-200 panel, approximately 40 volts DC is supplied by the power supply rectifier/filter circuits to the input leads on voltage regulators VR2 and VR3. When AC power is disconnected, the input voltage to these regulators decreases. As the voltage from the rectifier circuits decrease, with the panel configured as shown in Figure 2-14, current from the standby batteries back-flows through VR3 and thence to the input lead on VR2, the 24 volt supply regulator. This back-flow maintains the input voltage to VR2 at or above a nominal 24 volts—VR2 is able to maintain a nominal 24 volt level on the input pin of VR4. VR4 is able to maintain 5 volts to the microprocessor circuitry and other semiconductor components. No spurious signals were observed under these conditions.

Figure 2-14. Internal battery charger—AC disconnected—K6 has not yet transferred its contacts.

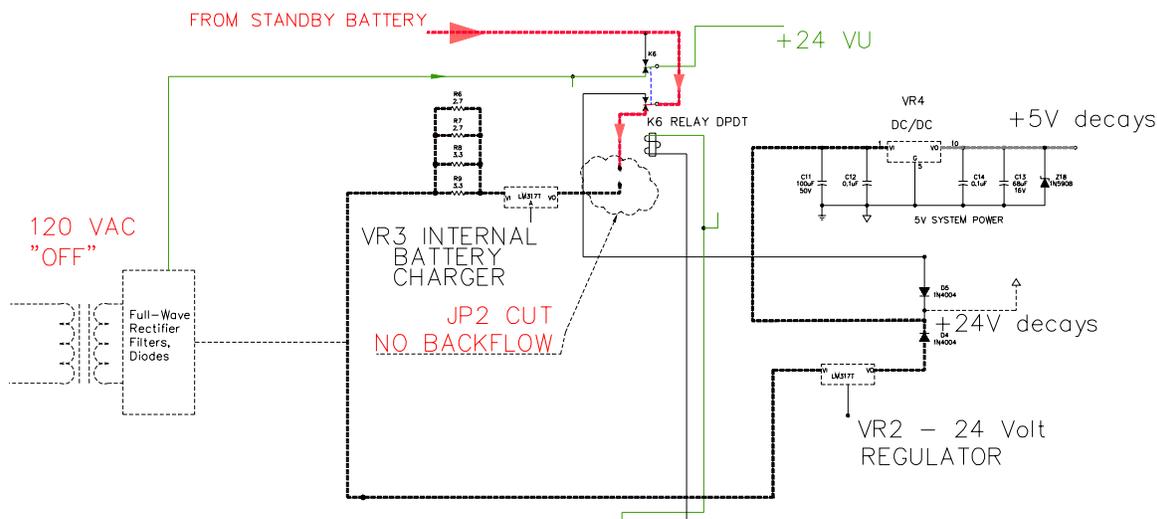
With JP2 cut, the back-flow path from standby battery to the input of VR2 is broken (see Figure 2-15). The voltage decay described above occurs after AC power is lost before relay K6 transfers. The spurious signals described above are generated. Undesired activation of the bell circuits occurs on a random basis. The occurrence of activation is random because the signal generation by the microprocessor circuits under low voltage conditions becomes erratic.

Figure 2-15. With JP2 cut, the back-flow path from standby battery to the input of VR2, the 24 volt DC regulator, is eliminated.

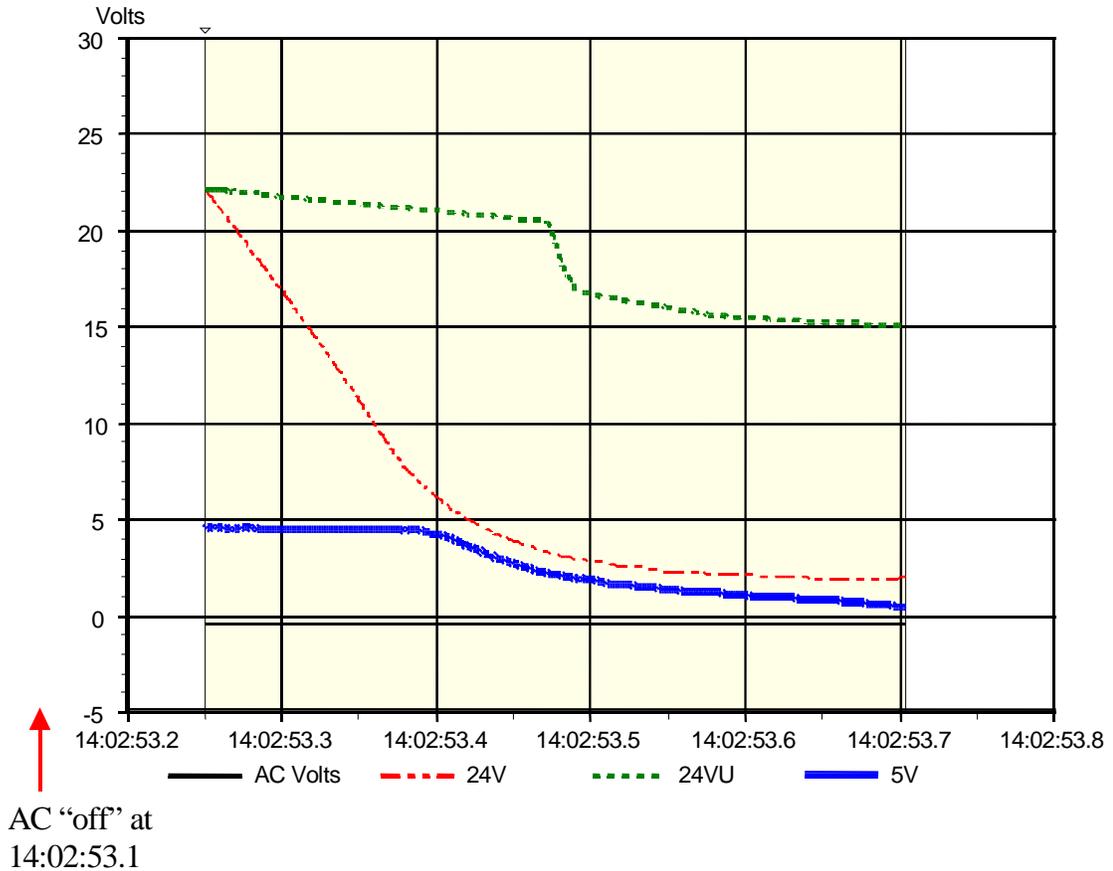
Figure 2-16 shows that within a fraction of a second (0.15 sec) after AC power goes to zero volts, decay of the voltage on the +24 V bus is evident. As the +24 V bus drops below about 7 volts, decay of the voltage on the +5 V bus is evident. As +5 V decays to approximately 3 volts, spurious signals are observed on U21 pins (see Figure 2-17). The +24 VU decays slowly until the bell circuits are activated—the change in slope of the +24 VU decay curve indicates flow of electrical energy to the Kidde electric discharge heads.

Figure 2-16. Dranetz recording shows voltage decays.

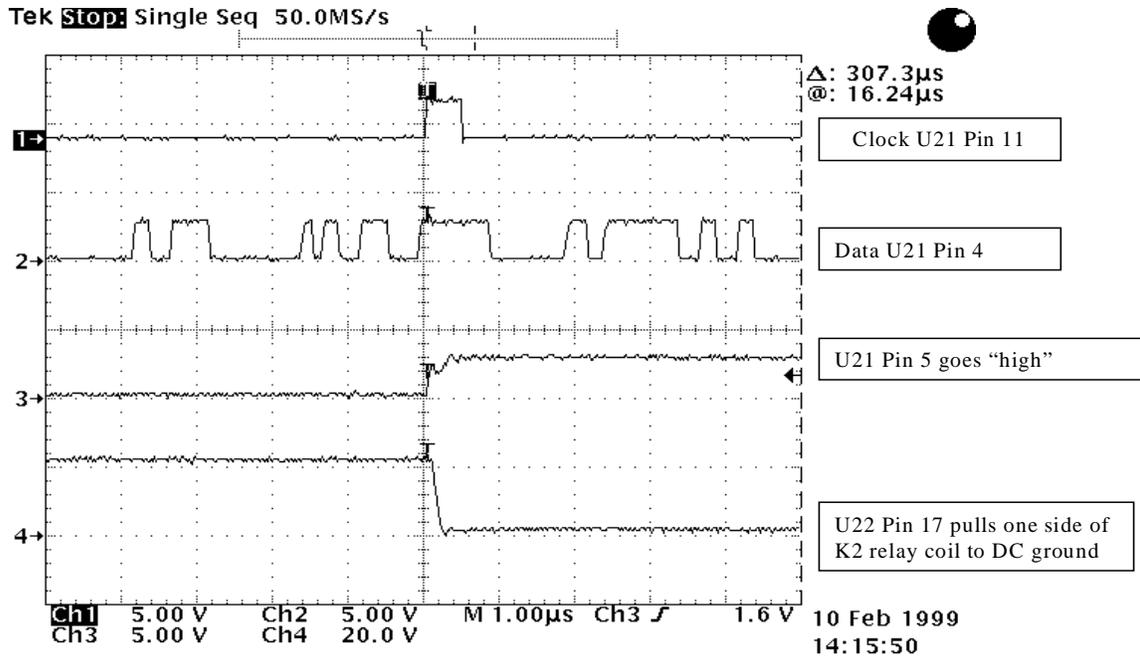
Figure 2-17 shows a high pulse on U21 Pin 4 coincident with a high-going pulse on U21 Pin 11. These pulses activate the associated flip-flop circuit in U21 causing U21 Pin 5 to go high. The high output on U21 Pin 5 is input to U22 Pin 2. The high signal on U22 Pin 2 causes U22 Pin 17 to pull one side of the K2 relay coil toward DC ground. This energizes relay K2.

Figure 2-17. Oscilloscope traces from AFP-200 panel in TRA-648.

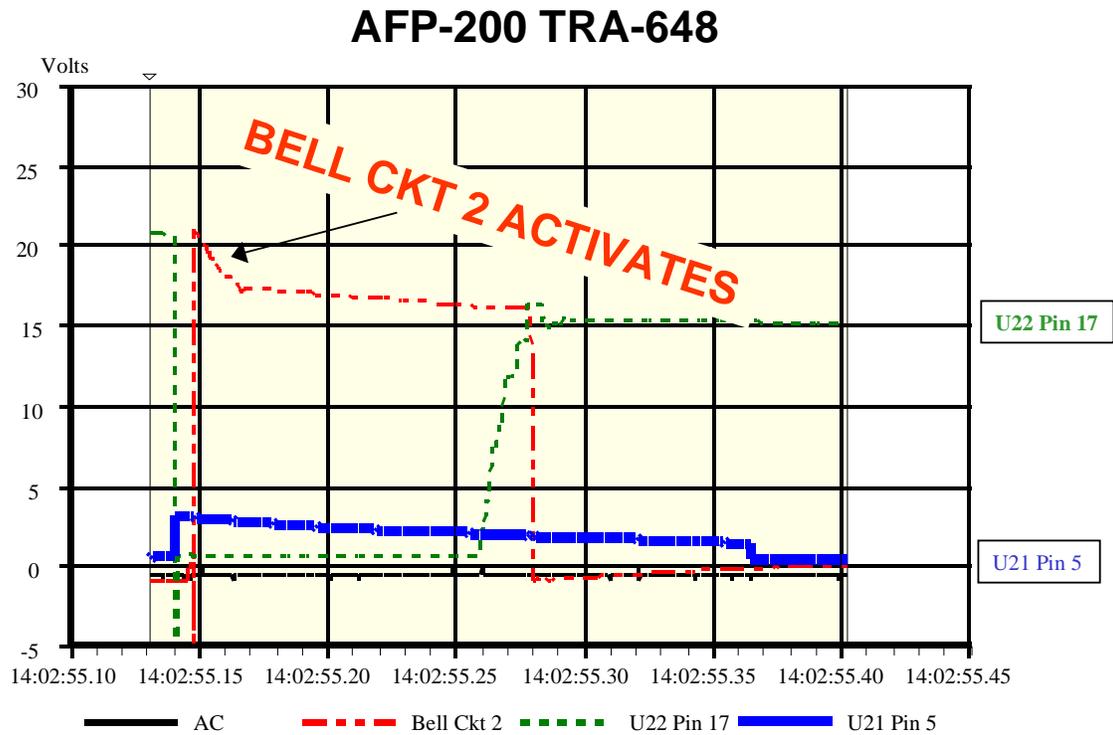
Figure 2-18 also records the high signal on U22 Pin 2 and the resulting signal on U22 Pin 17. The resulting activation of Bell Circuit 2 is likewise recorded. U21 Pin 5 output goes high causing U22 Pin 17 to pull one side of the K2 relay coil to DC ground. Voltage on Bell Circuit 2 reverses from approximately -2 volts supervisory status to +24 volts activated status. The high voltage pulse on Bell Circuit 2 lasts approximately one-eighth second. The strength and duration of the pulse is sufficient to activate the Kidde electric control head connected to Bell Circuit 2. The Kidde control head discharges the CO₂ system.

Figure 2-18. Dranetz recording shows Bell Circuit 2 activates.

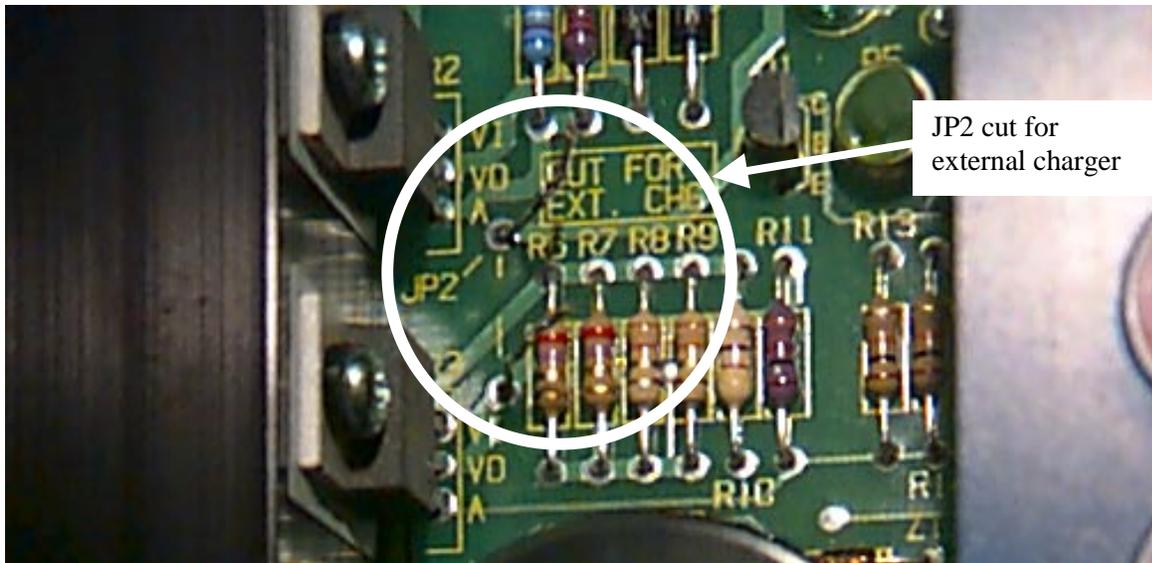
The AFP-200 panel printed-circuit board has “CUT FOR EXT. CHG” imprinted next to Jumper JP2 (see Figure 2-19).

The Notifier factory trained installer of the AFP-200 panel cut Jumper JP2 to accommodate higher capacity batteries, in accordance with the Notifier instructions. The requirement to cut Jumper JP2 can be found in

Figure 2-19. The AFP-200 printed circuit board instructions to cut JP2.
