FINAL REPORT
OF
SL-1 RECOVERY OPERATION

SL-1 Project
Idaho Test Station
General Electric Company
July 27, 1962

ABSTRACT

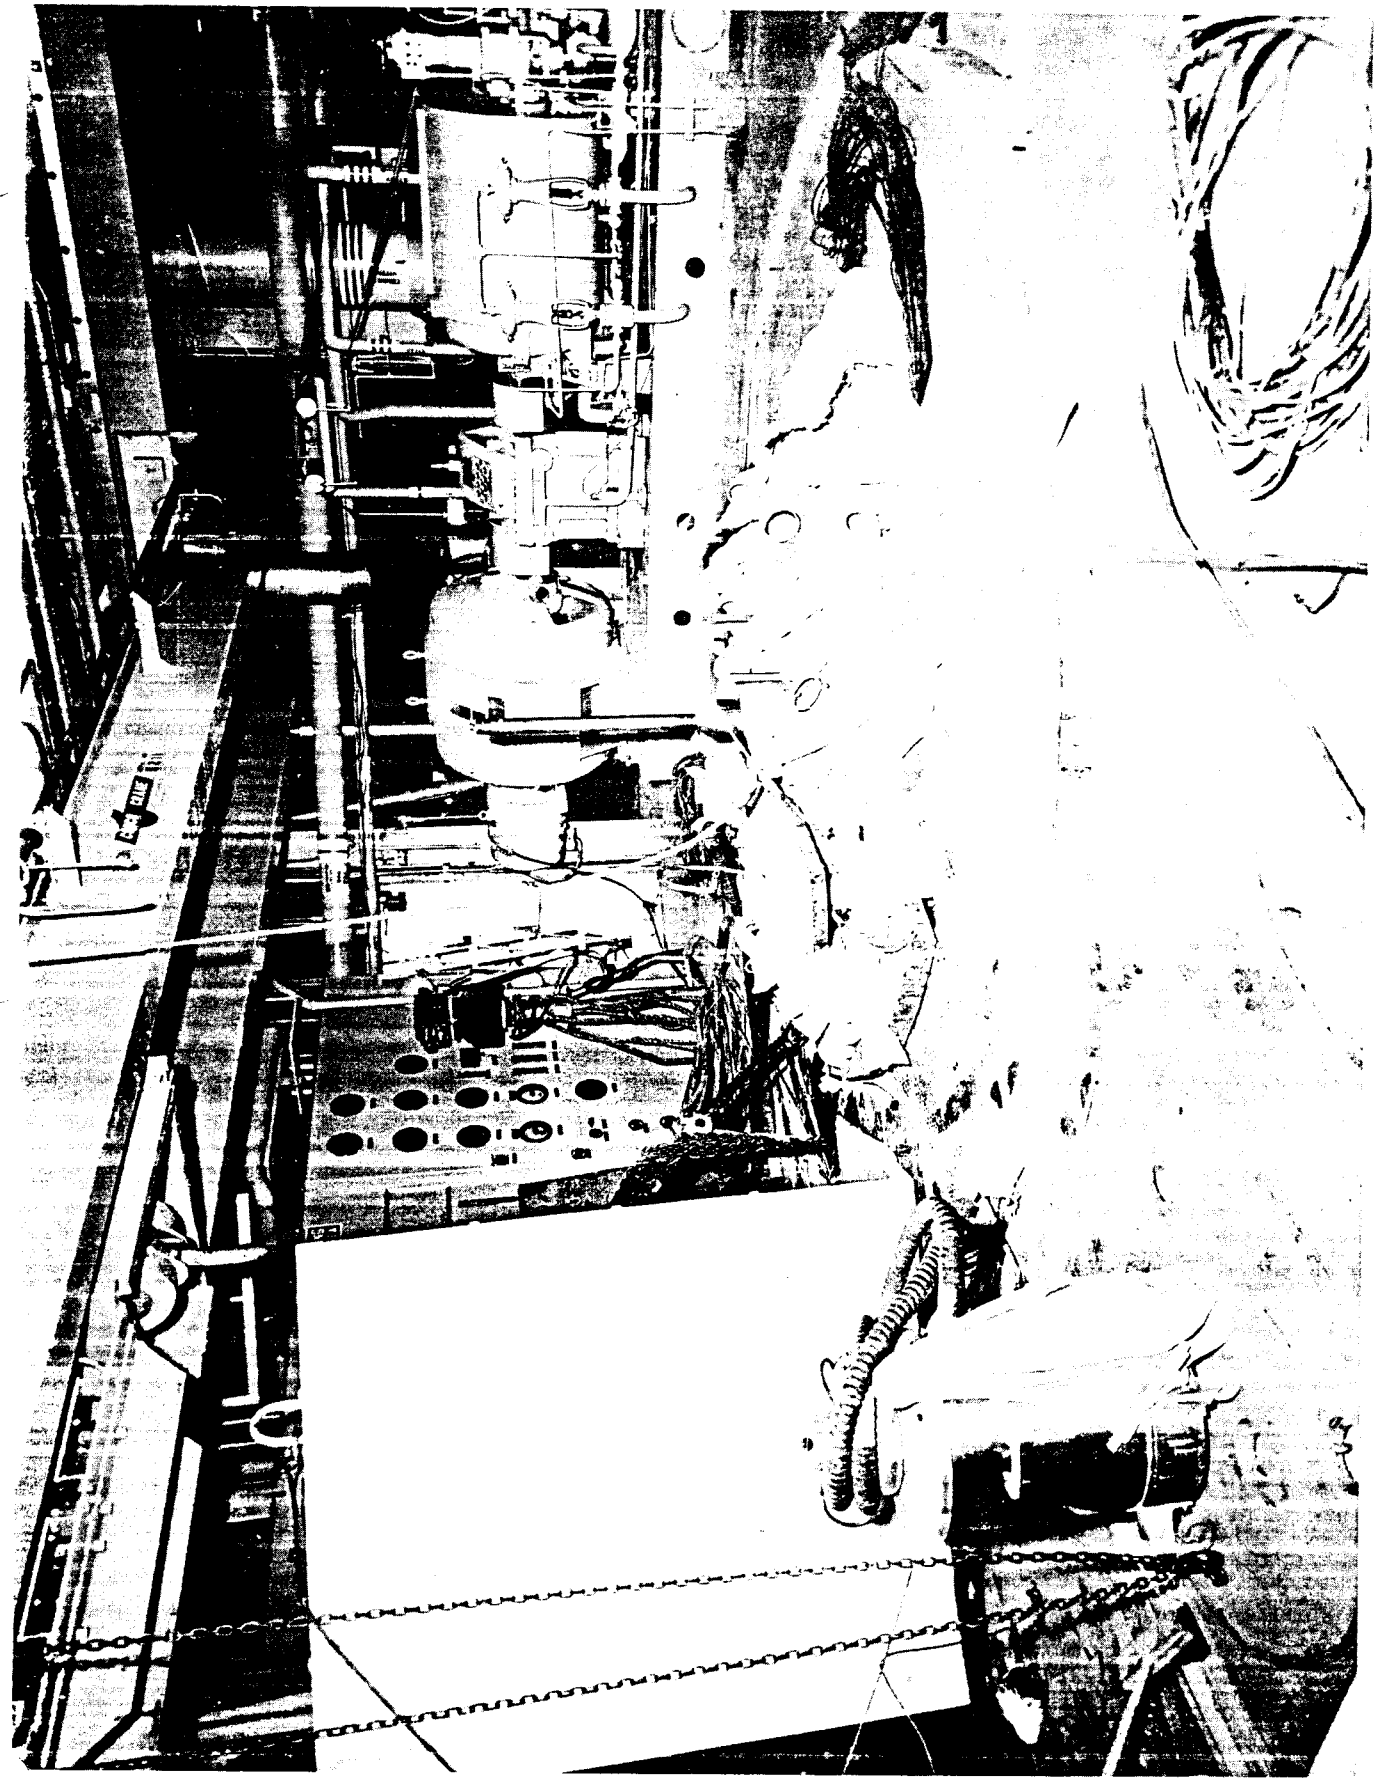
Figure II-9 Operating Room Floor

At this point a thorough manual radiation survey was taken. This survey revealed that there was a source under some of the steel floor plates where the contaminated water had leaked through the cracks between the plates. The center section of the fan room floor was also contributing materially to the radiation levels in the operating room. The vertical surfaces of the operating room were a third general source. From these surveys it was apparent that any further significant reduction of the radiation field in the operating room would involve a large amount of effort. After some consideration it was concluded that the general field in the operating room was low enough that the dose received by the majority of the persons working on subsequent operations preparatory to removing the pressure vessel would be governed by the sources they were required to uncover and how they conducted themselves around these sources. Experience proved this to be so.

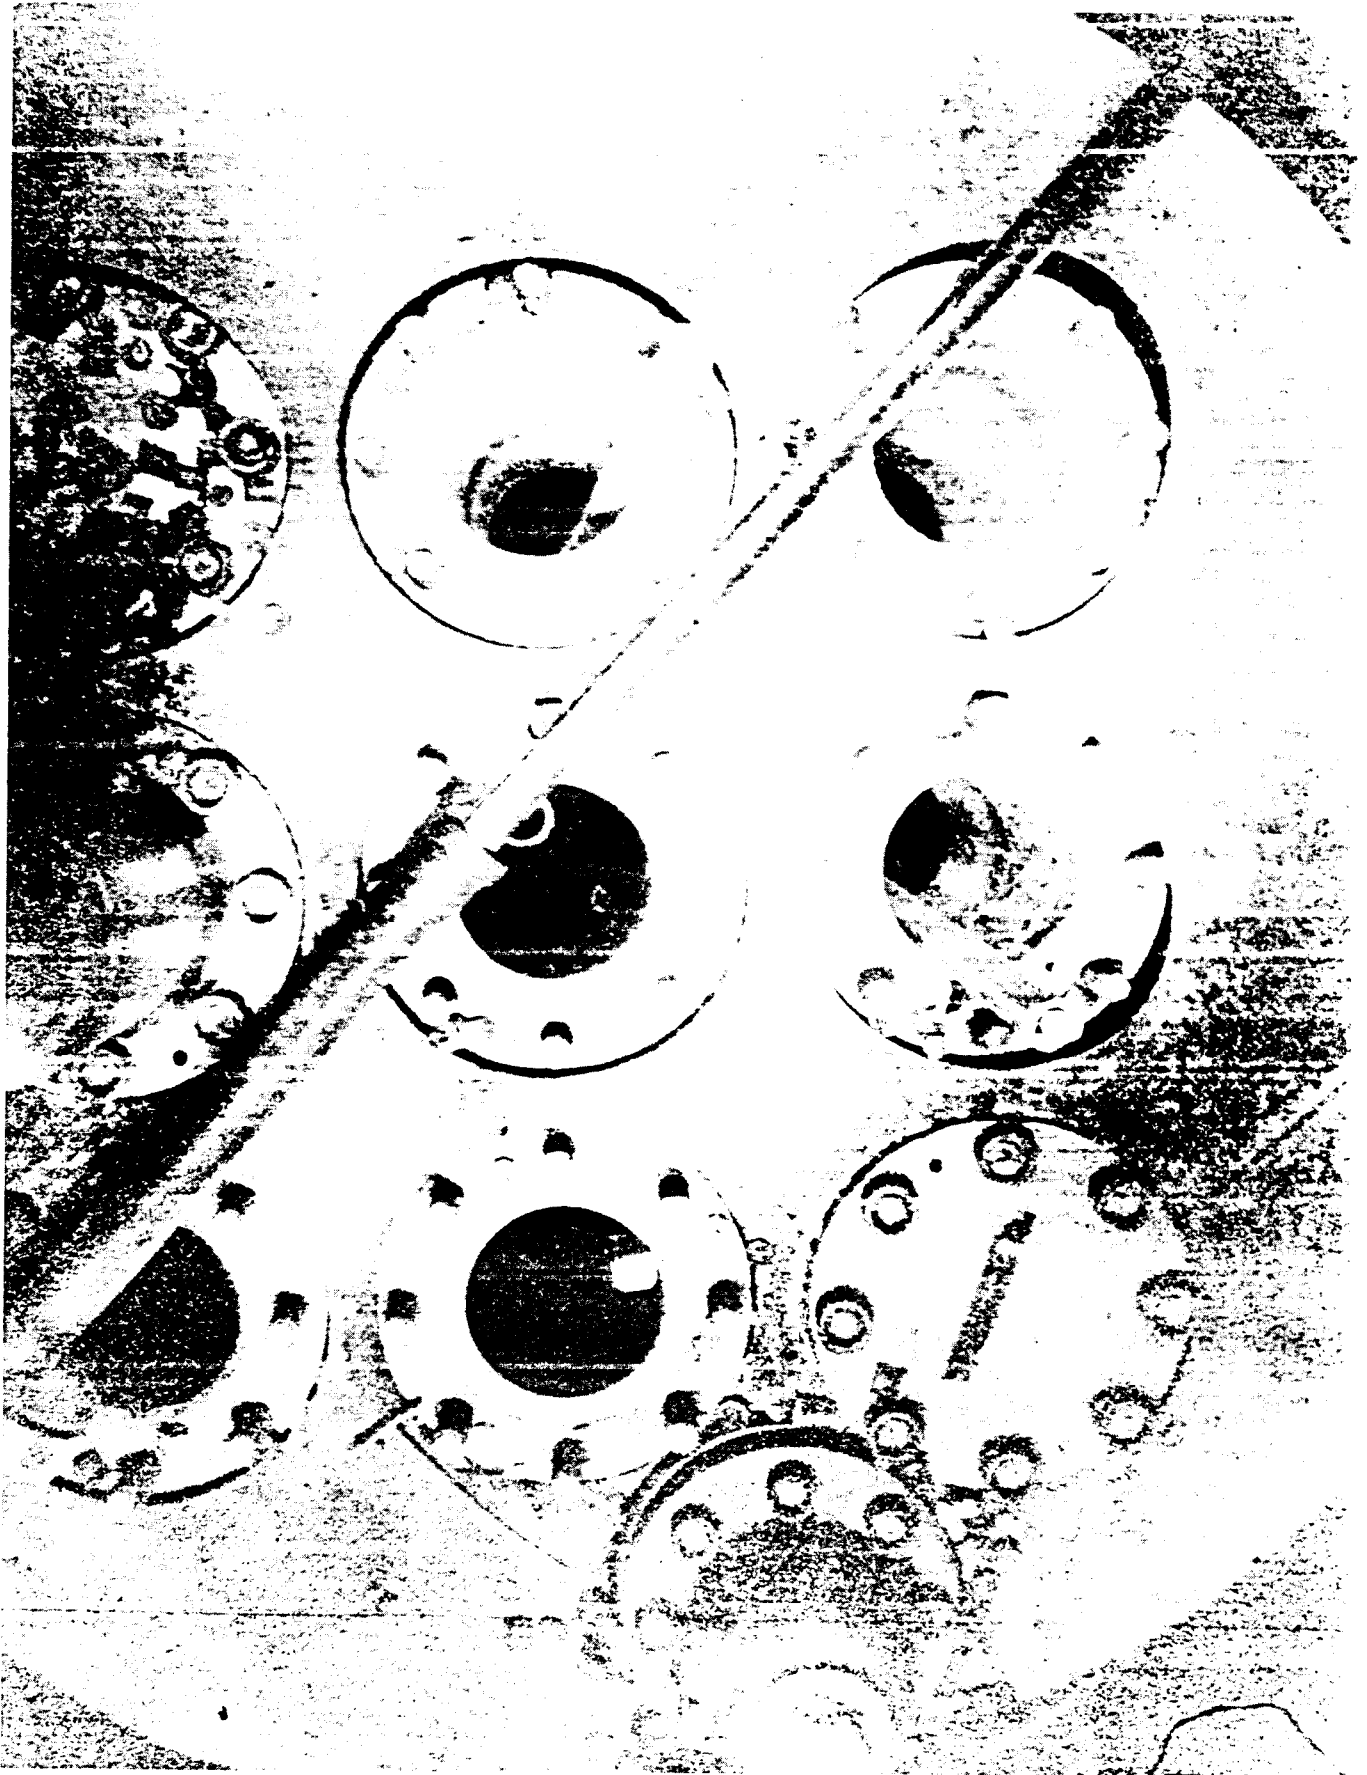
Figure III-2, Shield Plug Assembly #9 Lying
Across the Reactor Head Over Nozzles 4, 9 & 8

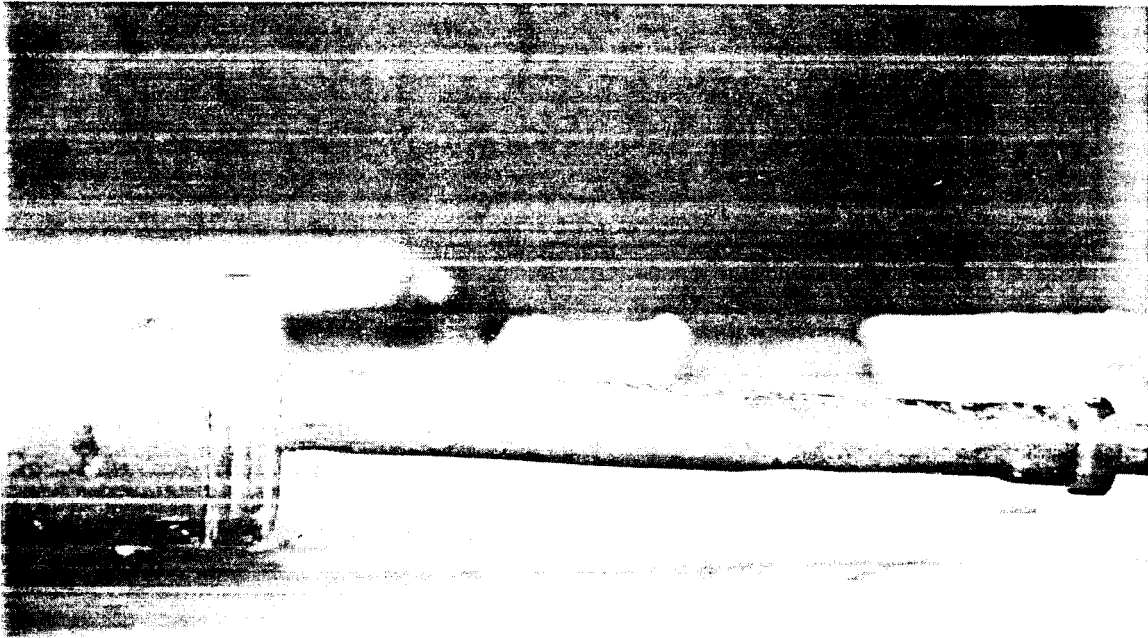
Fig. III-4, Shield Plug #9, guide tube collapse and white surface deposits.

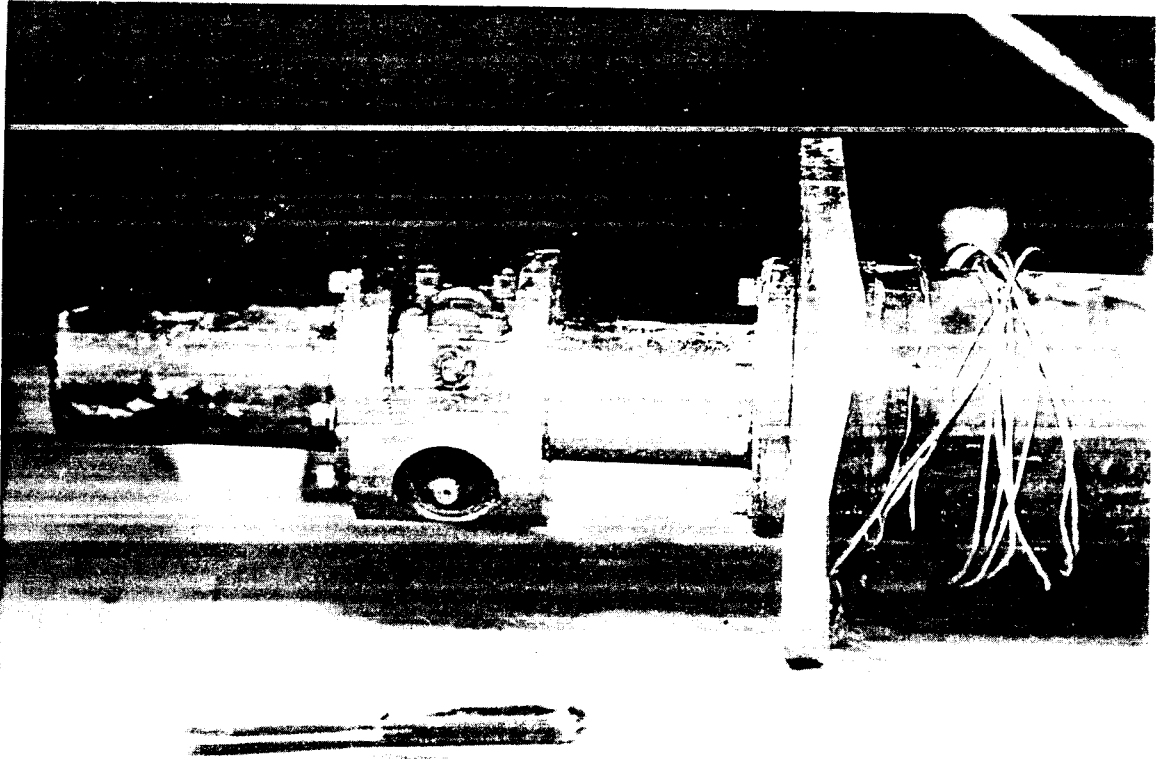
The 7/8" thick stainless steel shield plug flange sustained a permanent set deformation by impact in two diametrically separated areas. The maximum deflections were 9/16" at one edge and 1-7/16" at the other edge. Figure III-6 shows flange deformation, surface deposits and ruptured gaskets. Figure III-7 shows an imprint from impact. Severe distortion of the bolt holes occurred in each area of impact. Later reconstruction of the event and matching of the imprints with marks on

Fig. III-6, Shield Plug #9, upper section, showing flange deformation, surface deposit and ruptured gaskets.

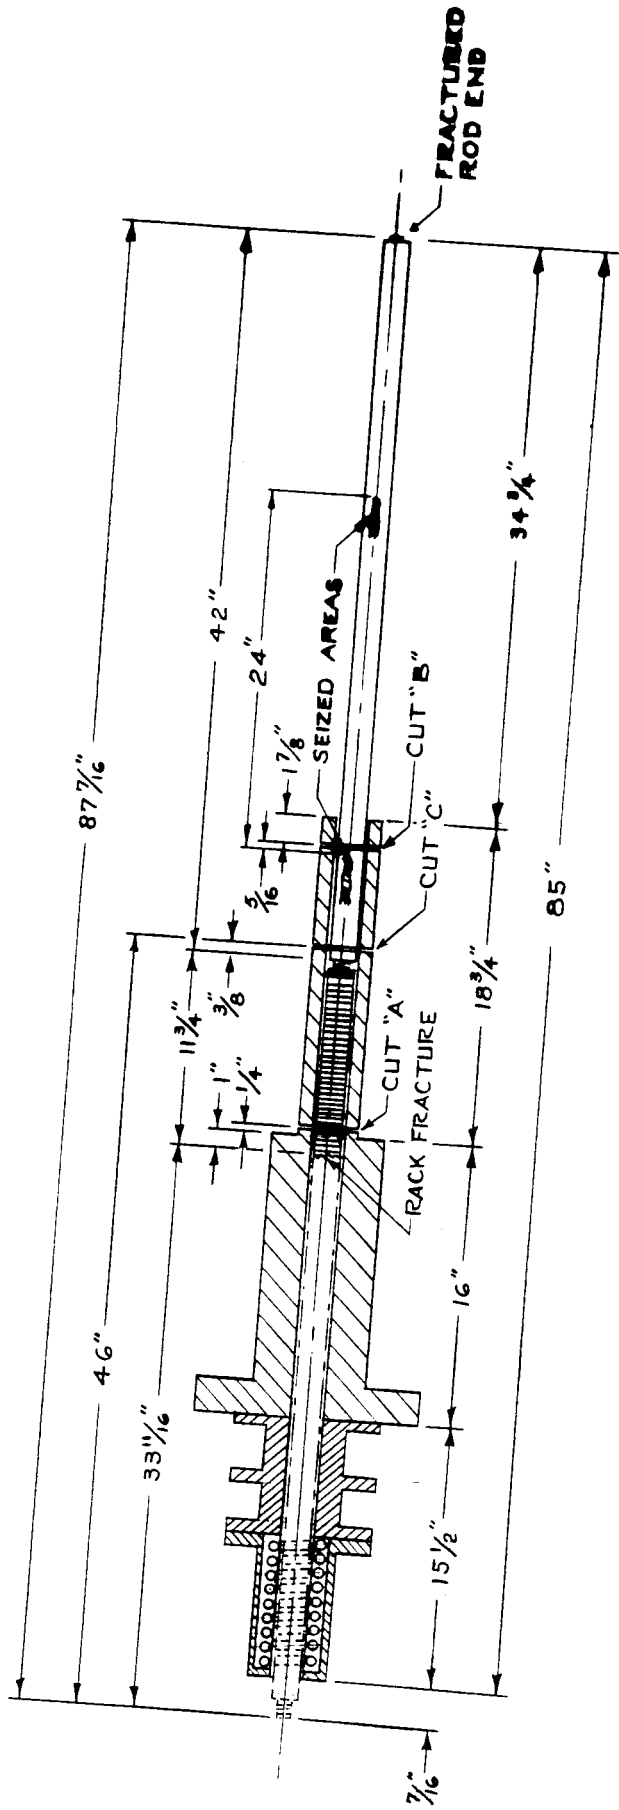
Zyglyo, dye penetrant and stereomicroscopy inspections revealed no surface cracks in the rod material. Rockwell hardness measurements were taken longitudinally along the rod and an average of $38 R_c$ was measured as against a specified hardness of $44 R_c$.

Fig. III-8, Shield Plug #9 Assembly - Sectioning and positions of rod during seizure.

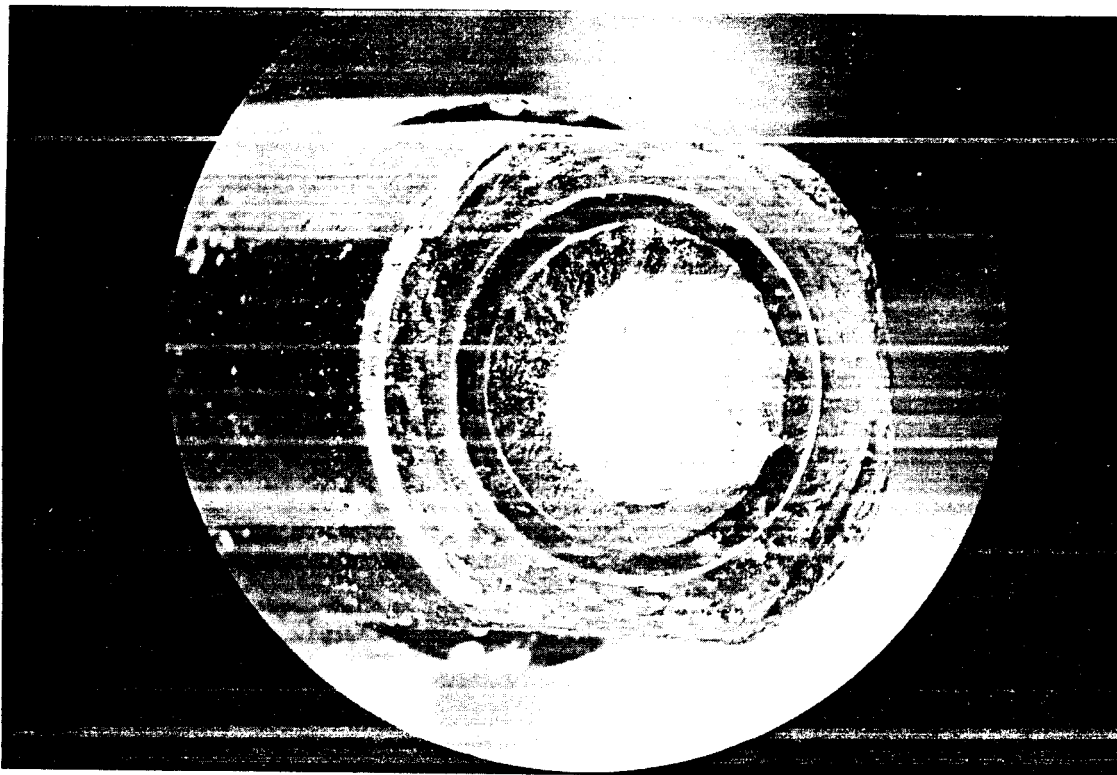
Fig. III-9, Shield Plug #9, extension rod, showing fatigue area and fracture.

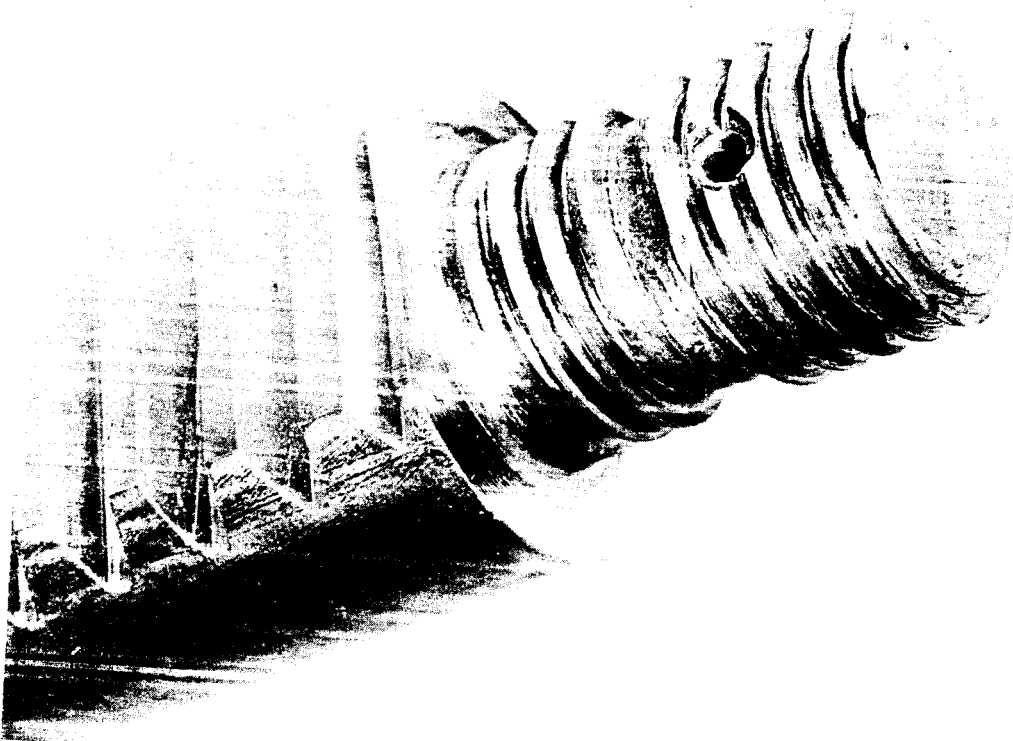
Fig. III-11, Shield Plug #9, top of rack, nut and washer. Galled thread (pre-incident) was one major identification feature.

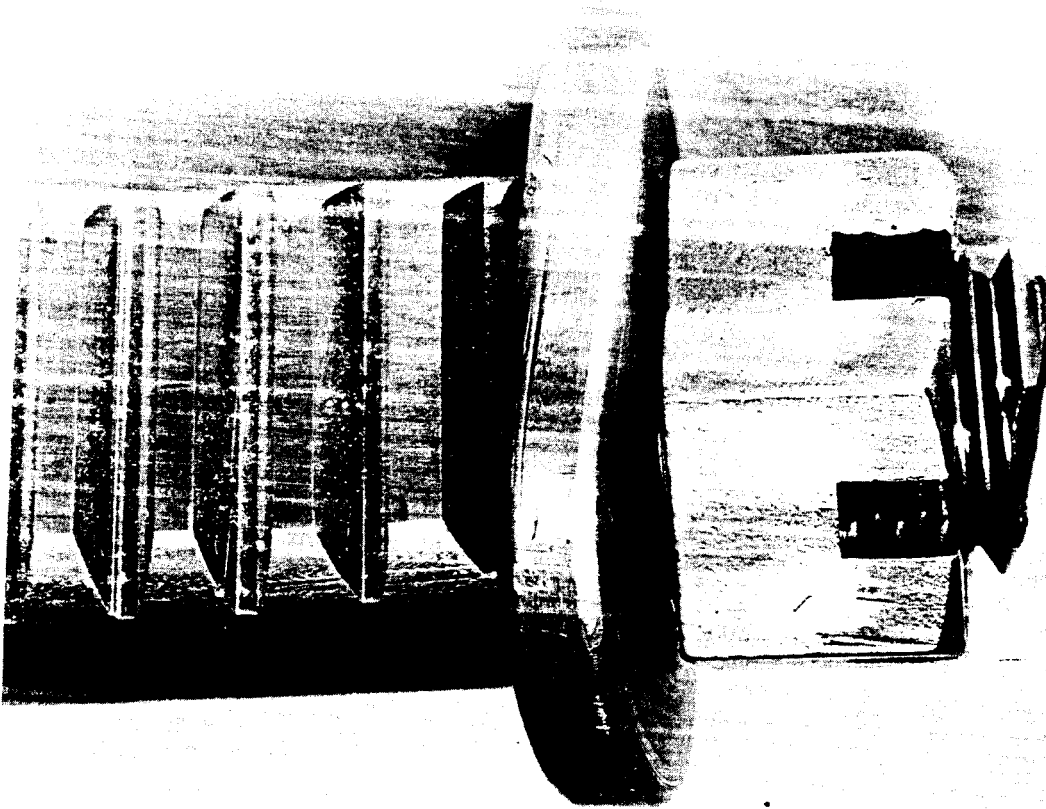
Fig. III-12, Handling tool with broken end of #9 gear rack stud retained in tool which was found embedded in fan room floor.

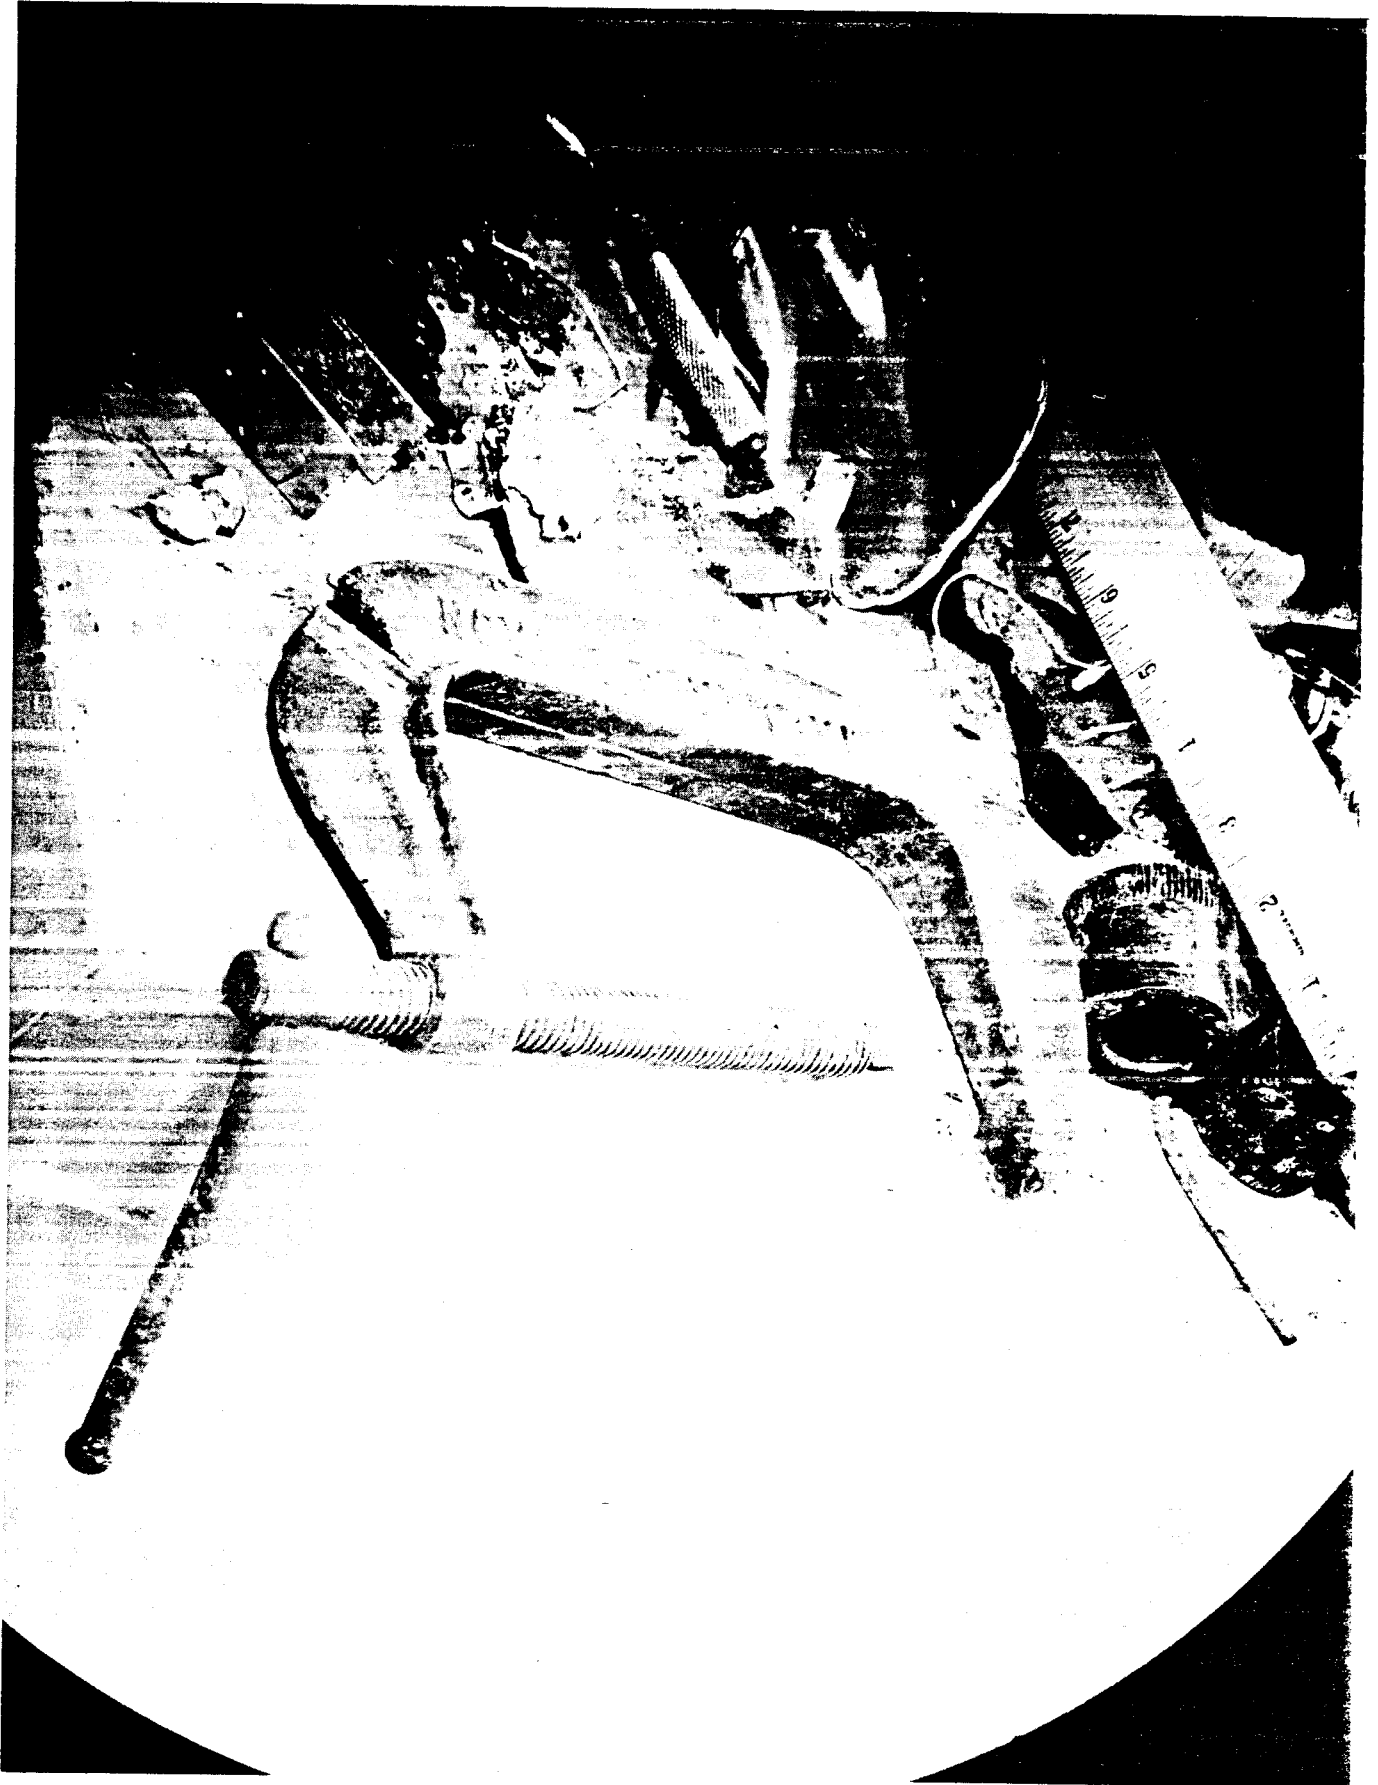
Figure III-18, Broken C-Clamp Recovered from Fan Room Floor

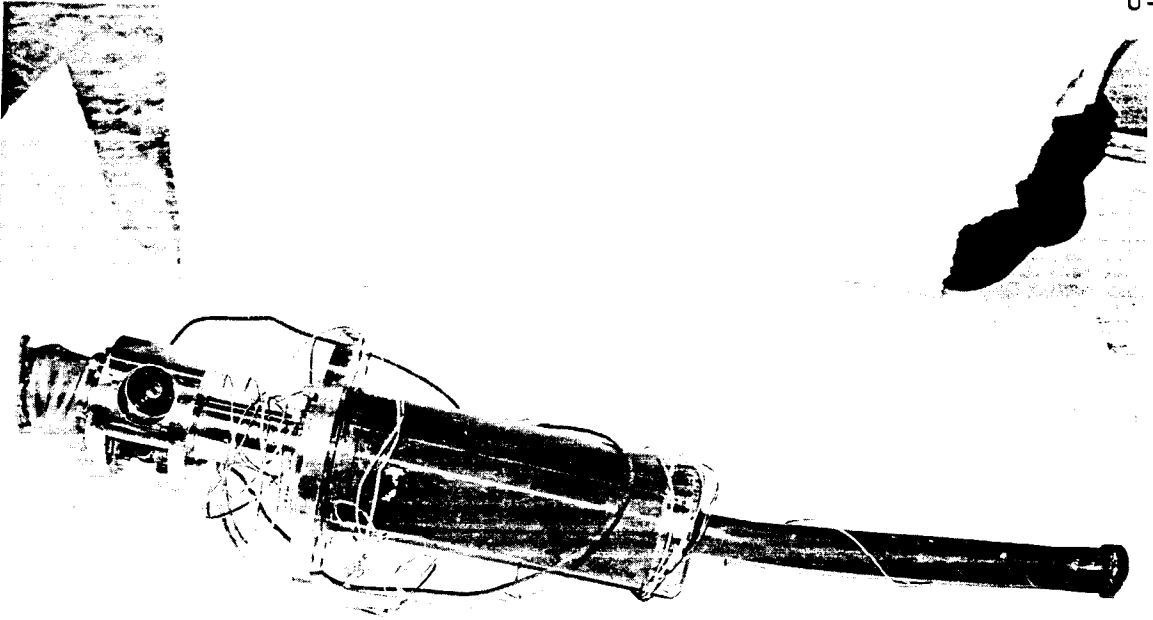
Figure III-19, Shield Plug #1, showing Damage to Spring Housing, Flexitallic Gaskets, and Guide Tube

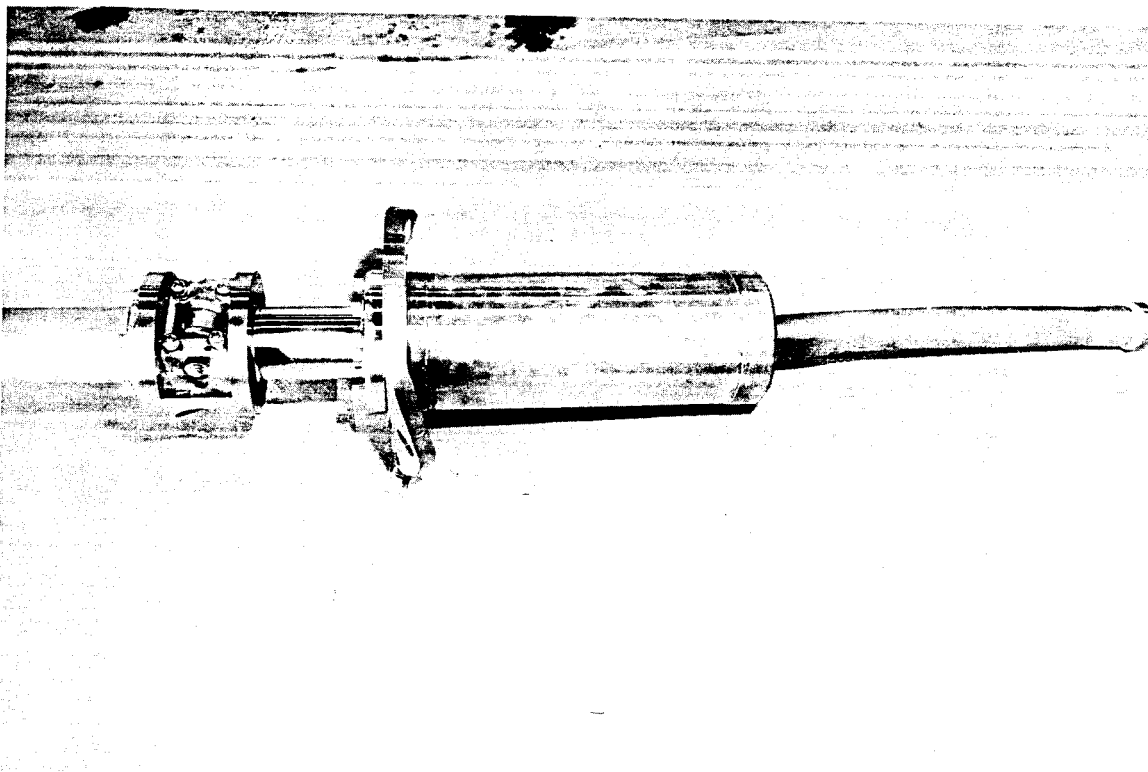
The flange was deformed on both sides due to impact (Figure III-22). Several scoring marks apparently made by the rack teeth are visible inside the guide tube. These marks lead to the postulation that the impact-bending break of the rack occurred while it was bound in the collapsed tube as a result of the severe tube deflection. The bottom piece of rack subsequently fell out on the fan room floor. A broken nut and stud recovered from the reactor operating room matched the broken thread end of the gear rack (Figure III-23).

Figure III-22, Shield Plug #3, Showing Deformation of Flange and Collapse of Guide Tube

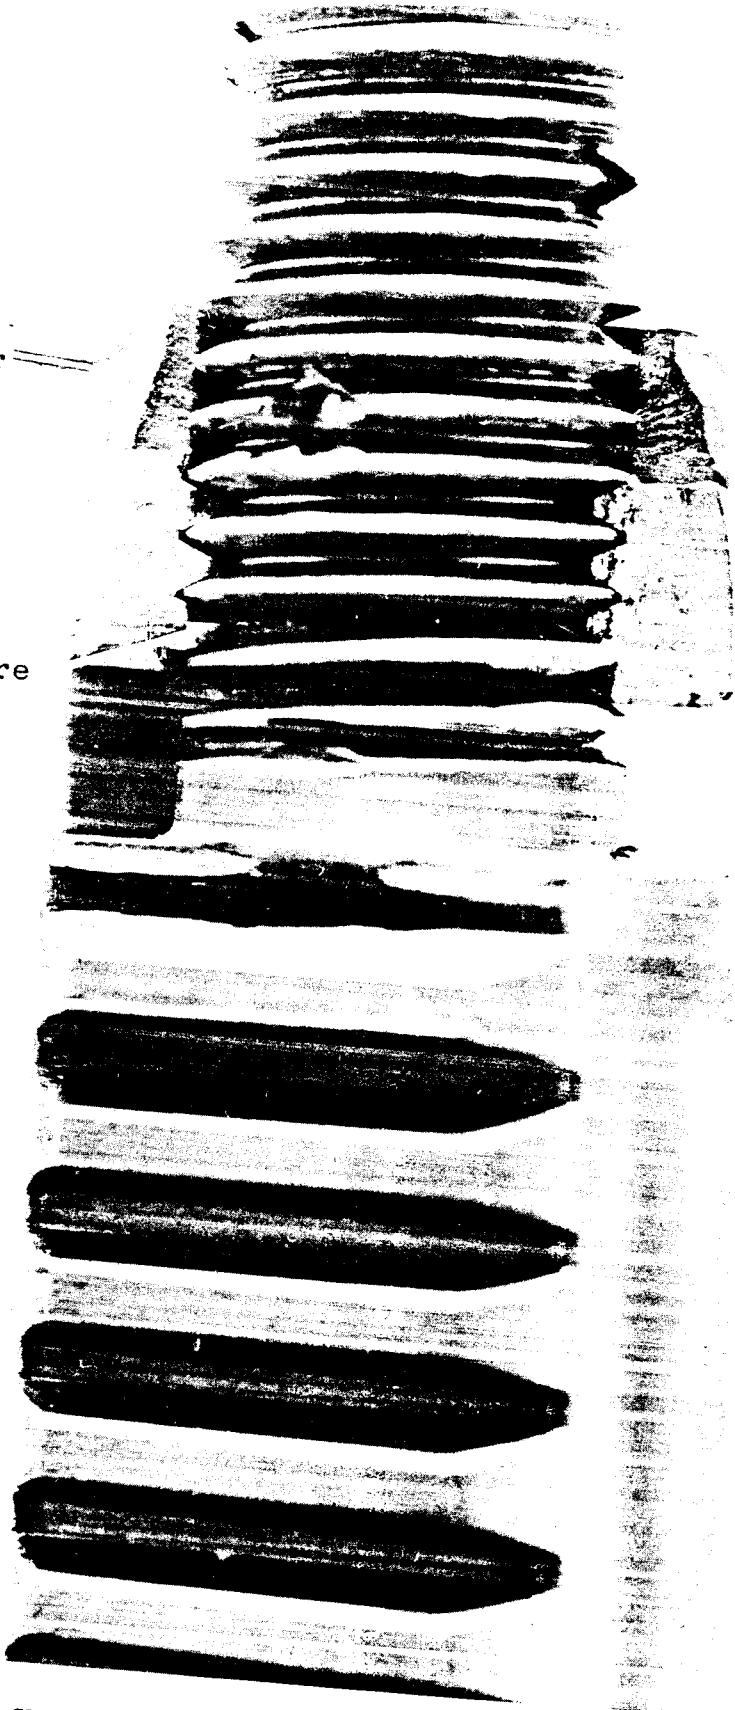
Figure III-23, Shield Plug #3, Mating of Fractured
Nut Retained in Stud with Fractured End of Gear Rack

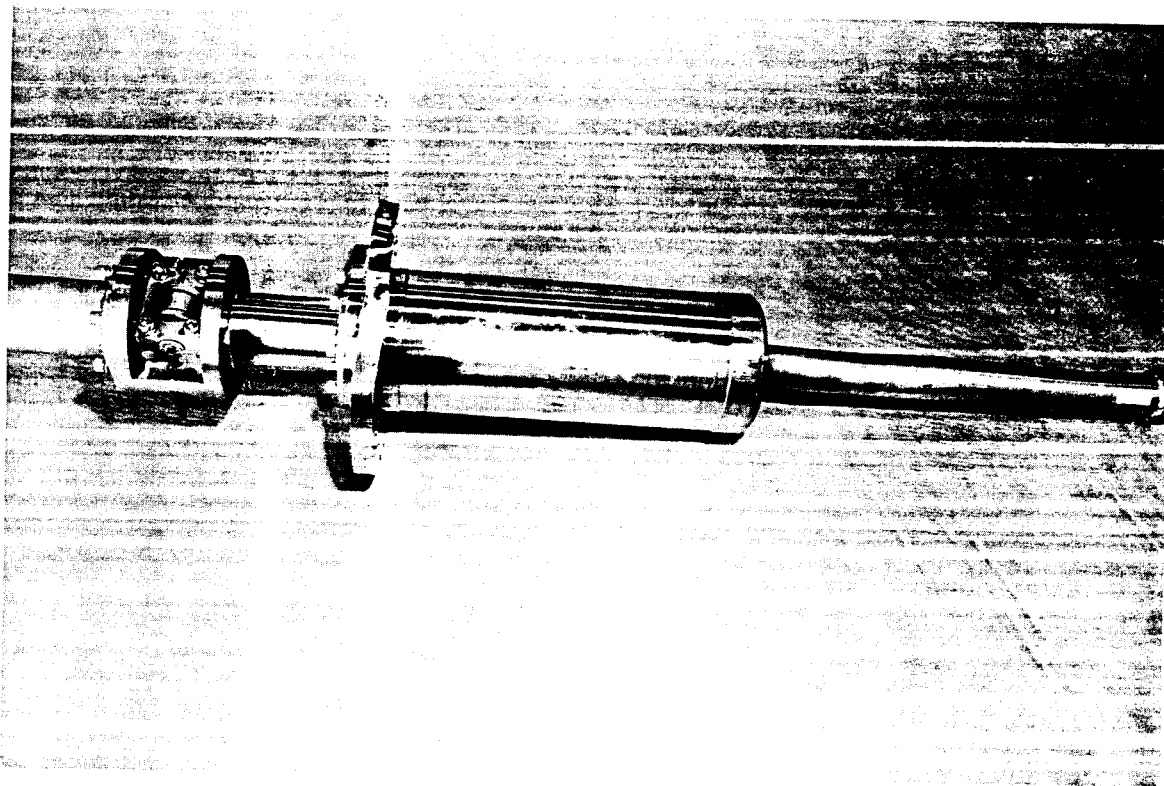
Figure III-24, Shield Plug #4, Showing Flange Deformation and Guide Tube Collapse

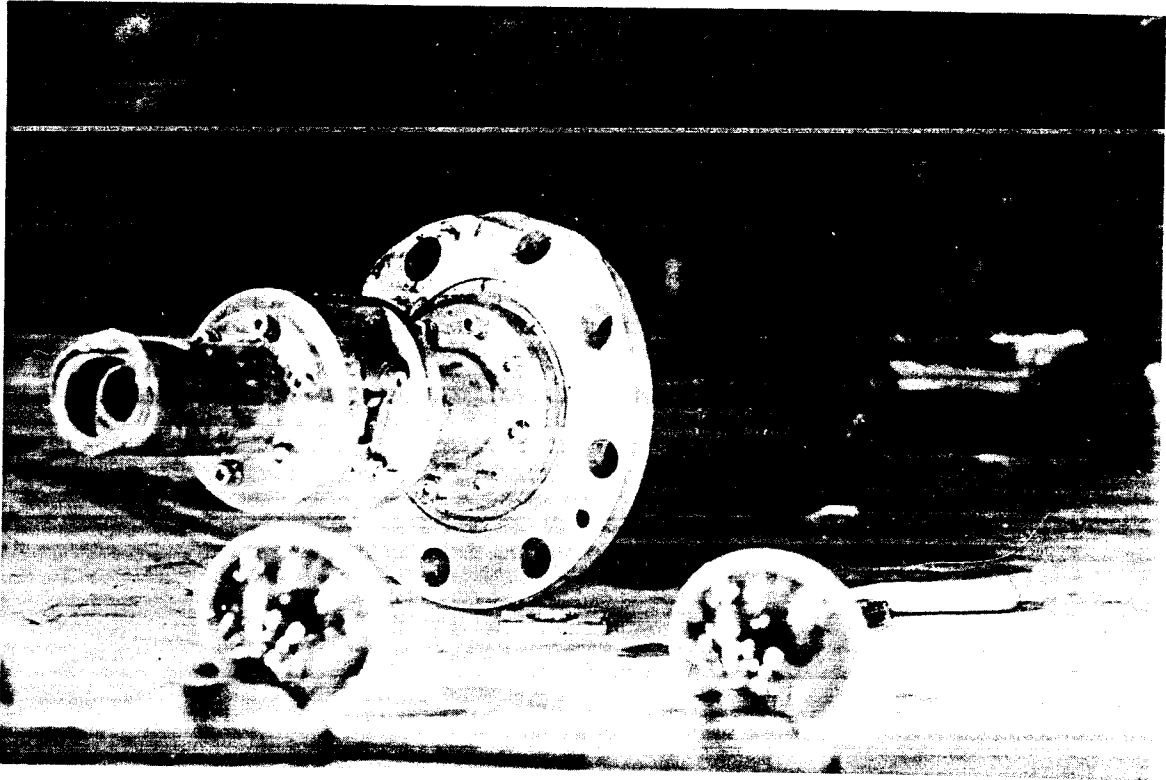
Figure III-26, Showing Spring Housing and Flange Deformation and Guide Tube Collapse

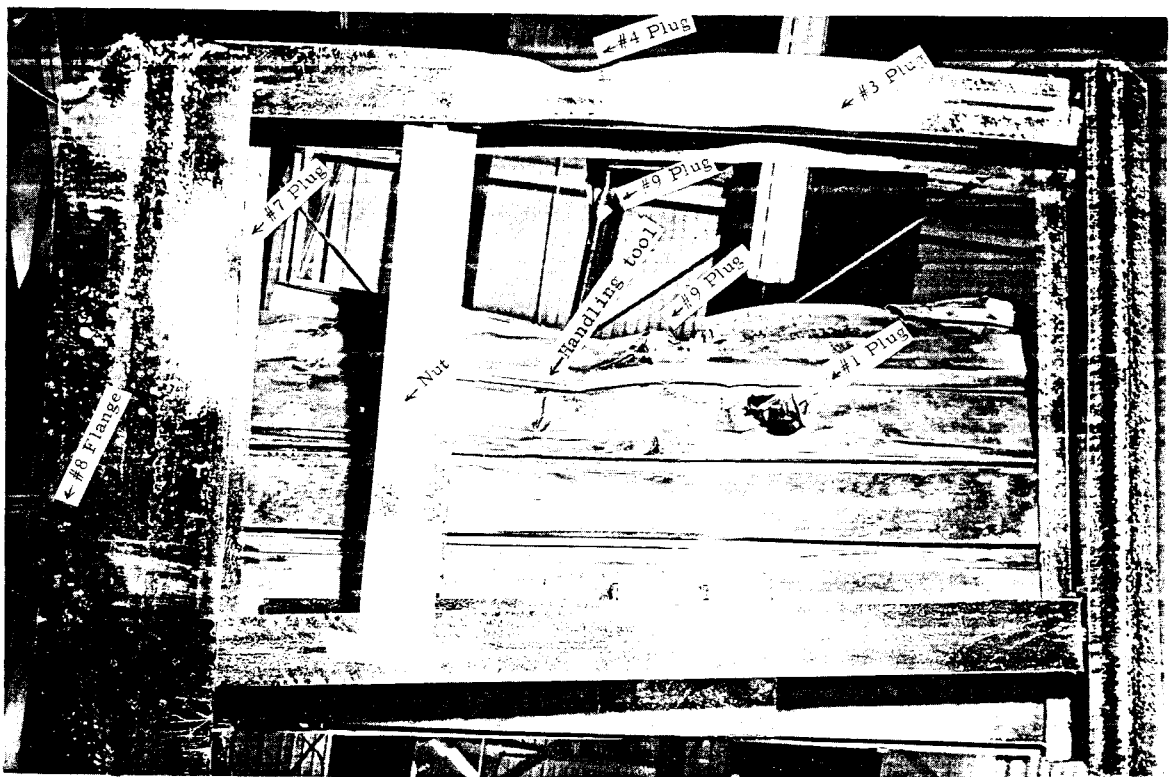
Fig. III-30, Section of fan room floor, showing areas of damage.

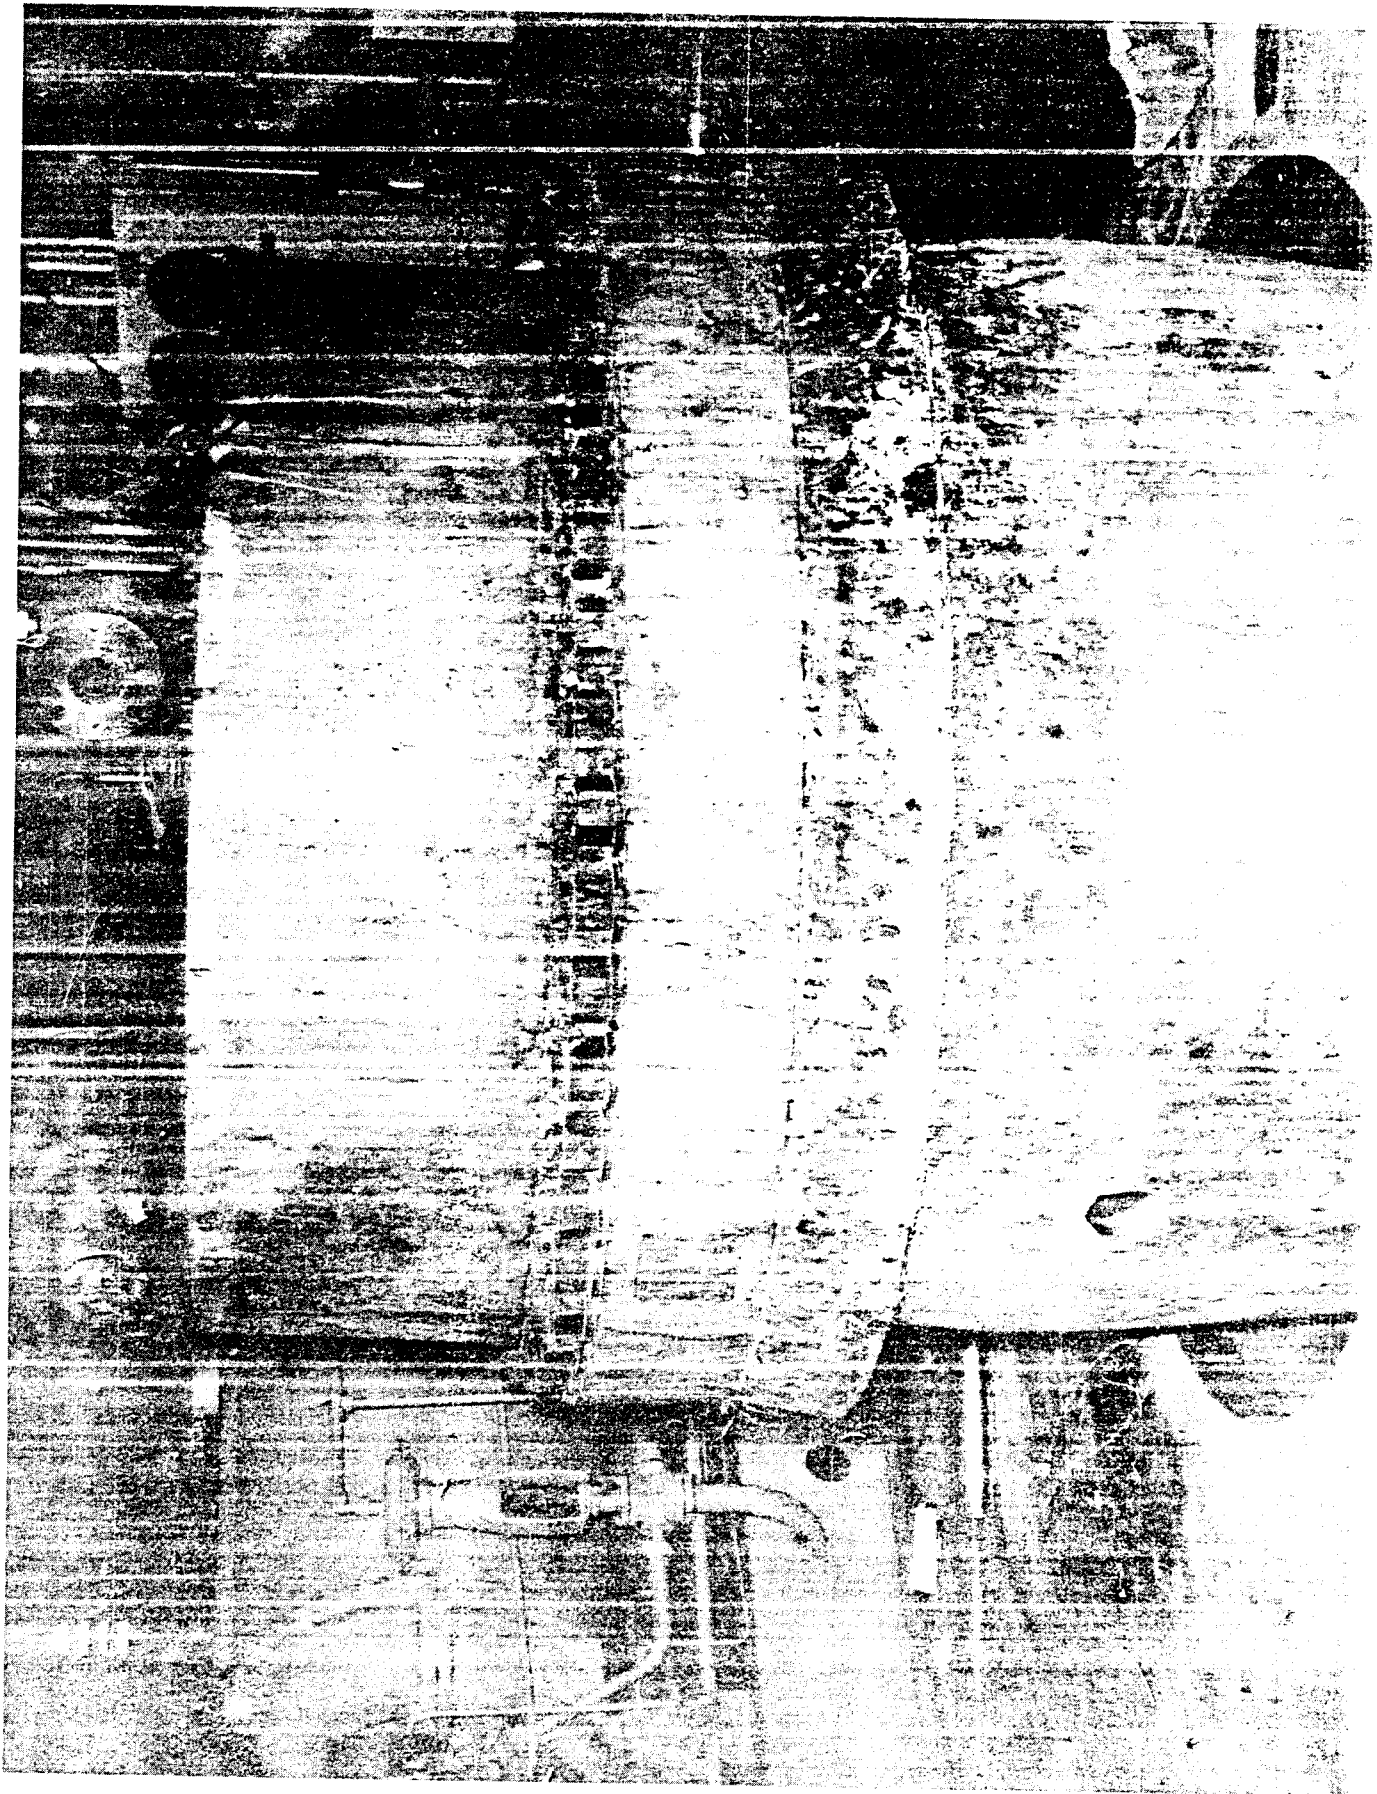
Figure III-36, Deformation of Flange and Vessel

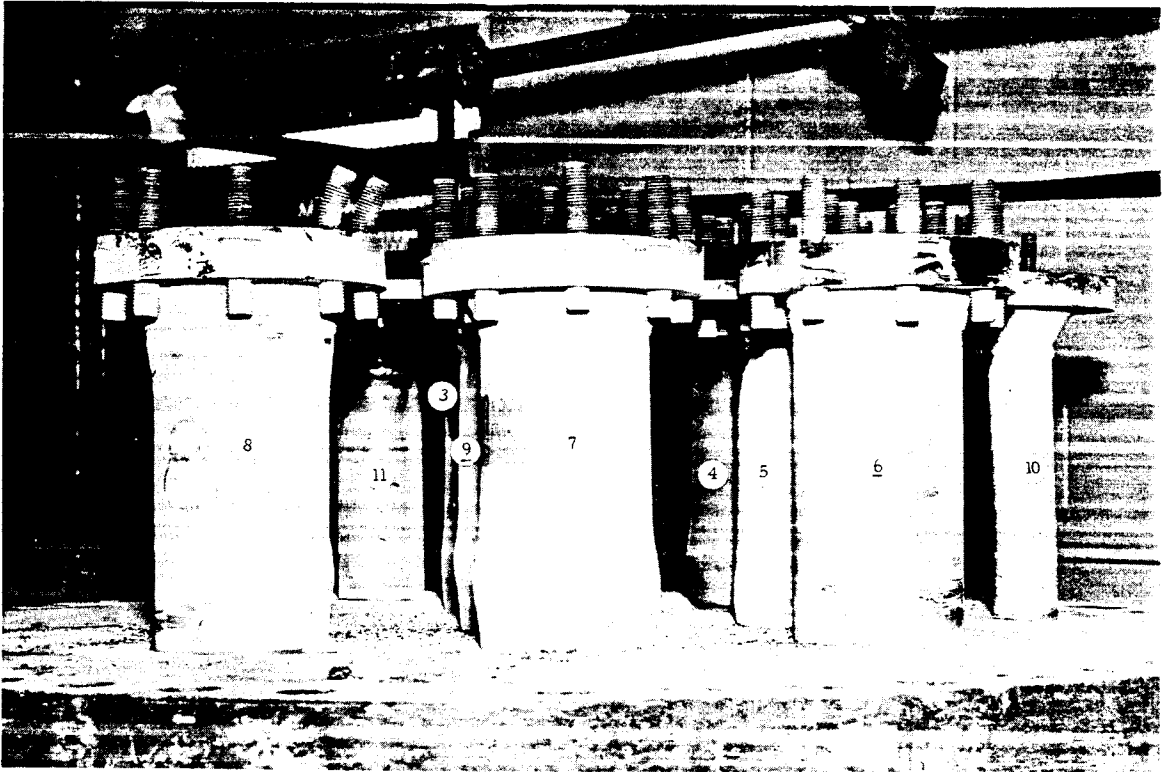
Figure III-37 Deformation of pressure vessel head nozzles

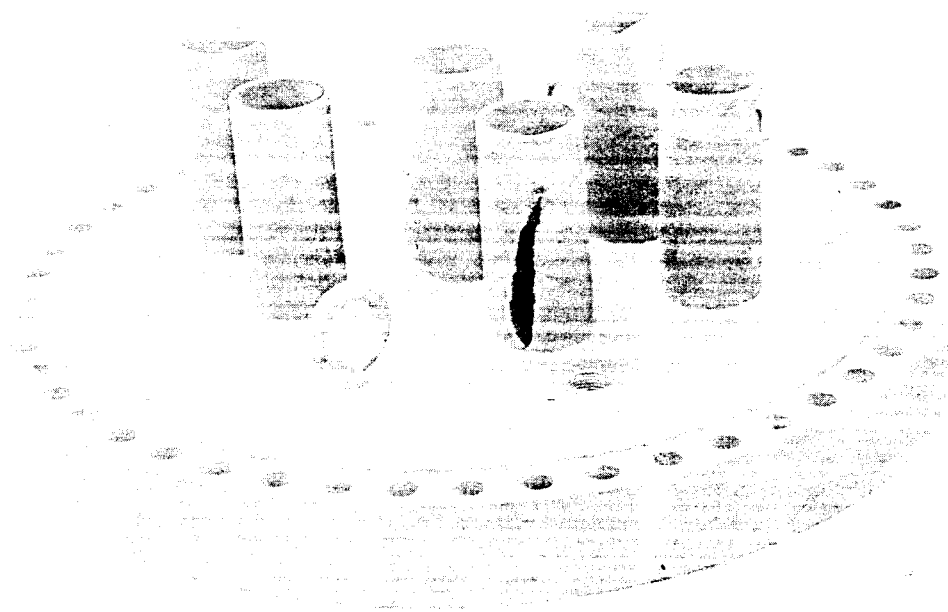
Figure III-40 1/4 scale model of pressure vessel head, showing damage to nozzles
