**TYPE A ACCIDENT INVESTIGATION BOARD REPORT
OF THE JULY 28, 1998
FATALITY AND MULTIPLE INJURIES
RESULTING FROM RELEASE OF CARBON DIOXIDE
AT BUILDING 648, TEST REACTOR AREA
IDAHO NATIONAL ENGINEERING AND ENVIRONMENTAL LABORATORY**

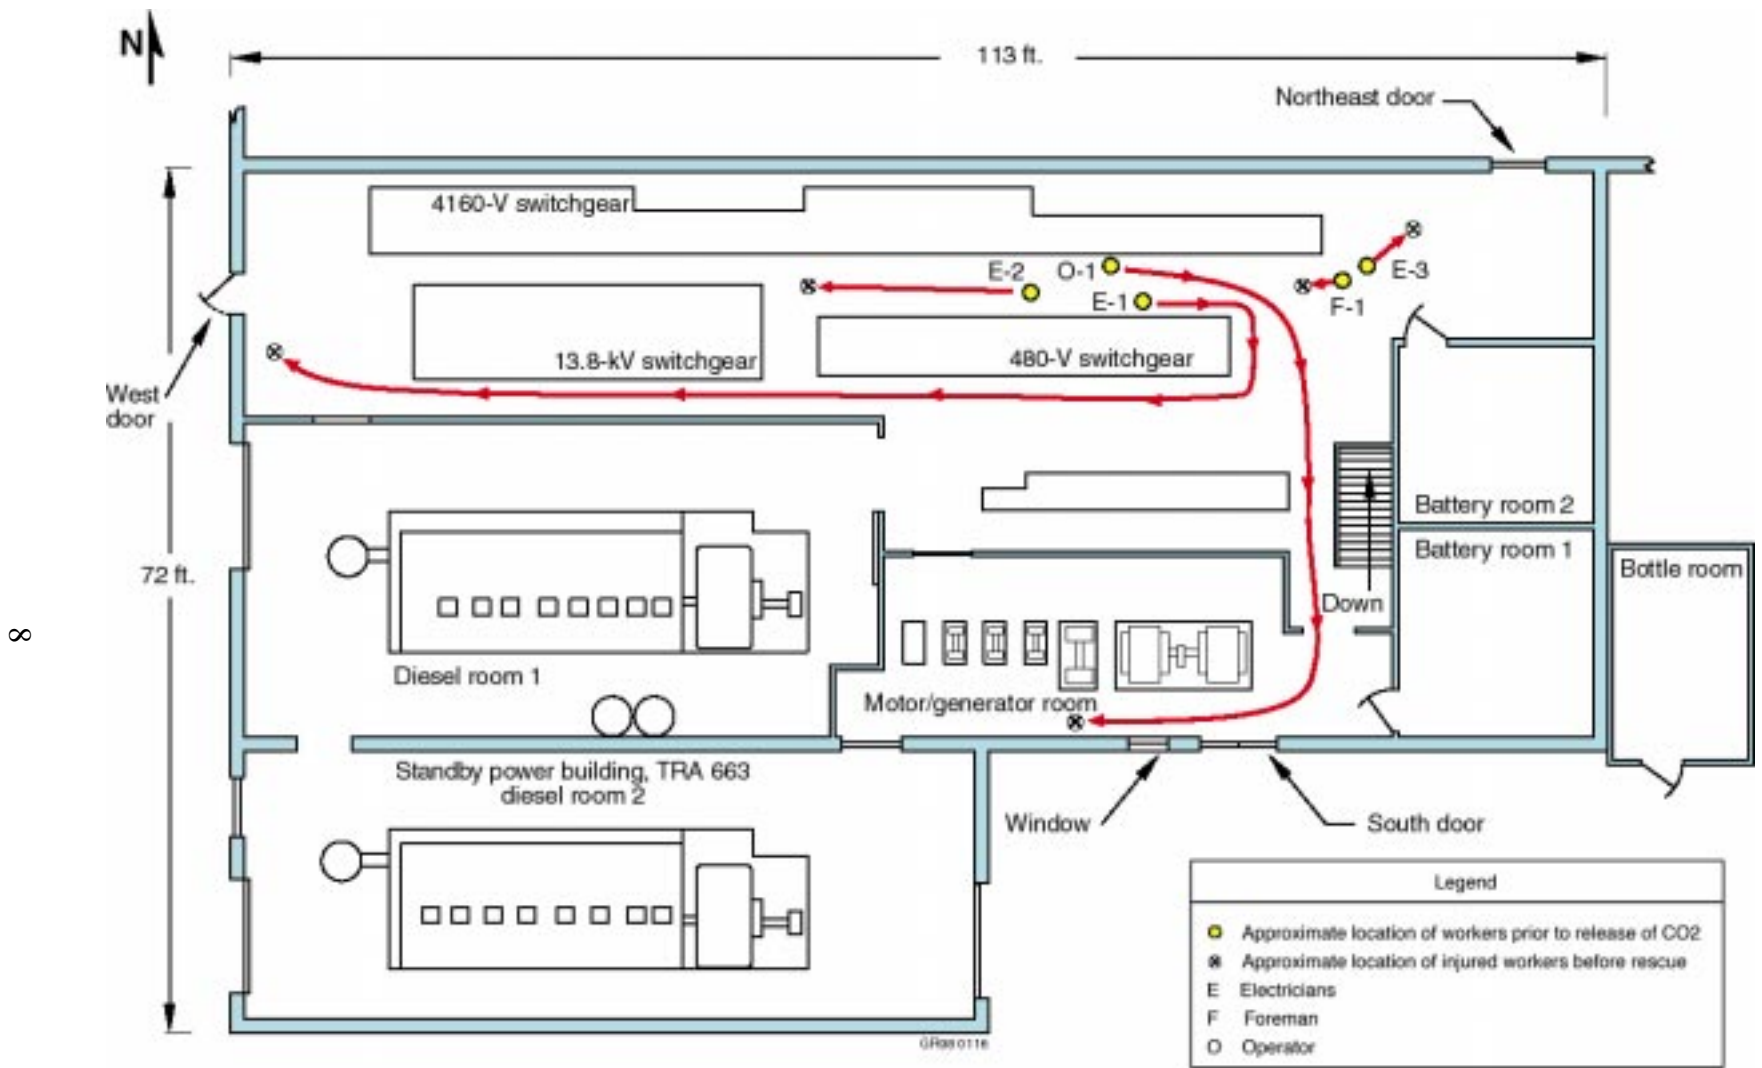
Exhibit 2-1. Building 648 Layout with Escape Routes of Five Injured Workers

One other individual (O-1) headed in a different direction, through the pump and motor generator room toward an exit door on the south side of the building (Exhibit 2-3). Unable to find the door in the whiteout conditions, he reached a window just past the door. In desperation, he put his hand through the thick glass window embedded with wire, sustaining severe arm lacerations and blood loss before losing consciousness (see Exhibit 2-4). Another individual (E-1) groped along switchgear, only to become entangled in an instrument cart and cable wires en route to the west door (Exhibit 2-5). He tripped, rolled, hit his head, and passed out inside the building.

By this time, eight individuals had escaped the potentially lethal CO₂ fog, and five unconscious individuals were still in the building. One was just south of the west door (E-1), one midway down the 4160 volt aisle (E-2), two at the east end of the 4160 volt bus (F-1 and E-3), and one in the pump and motor generator room on the south side of the building (O-1). (See Exhibit 2-1.)

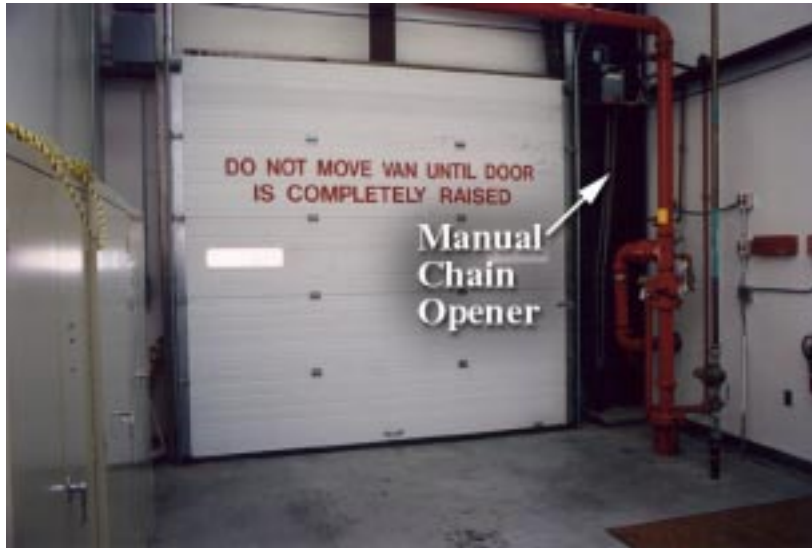
Exhibit 2-6. Emergency Control Center Door

Between the call to Central Facilities Area and arrival of the Fire Department, initial responders proceeded to make repeated attempts to locate and rescue co-workers still trapped in the building. As rescuers gathered at the west door, the hand of an individual appeared out of the fog and rescuers pulled him to safety, as he collapsed in their arms. Rescuers searched for self-contained breathing apparatus⁶ to facilitate safe search and rescue, but none were staged or available in the area. An operator was dispatched to the TRA Emergency Control Center to obtain the Incident Response Team van, which contained self-contained breathing apparatus. The power to the Emergency Control Center, however, had been shut off due to the preventive maintenance outage, and the diesel generator was disabled from automatic start. Thus, the garage door could not be opened electrically, and its manual chain opener was inoperable (see Exhibit 2-6). The diesel generator was started after approximately five minutes and the door opened electrically, but this caused a delay in getting self-contained breathing apparatus to the accident scene. Ultimately, the van arrived at Building 648 at 6:24 p.m. Additionally, eleven self-contained breathing apparatus in the Center's break room were not brought to the accident scene. The room used to store the apparatus was dark because of the power outage.

Self-contained breathing apparatus was not readily accessible to the initial responders.
