**Type A Accident  
Investigation Board Report  
of the July 28, 1998  
Fatality and Multiple Injuries  
Resulting From Release of  
Carbon Dioxide  
at  
Building 648, Test Reactor Area  
Idaho National Engineering and Environmental Laboratory  
Chapter 3**

### 3.0 DISCUSSION AND ANALYSIS

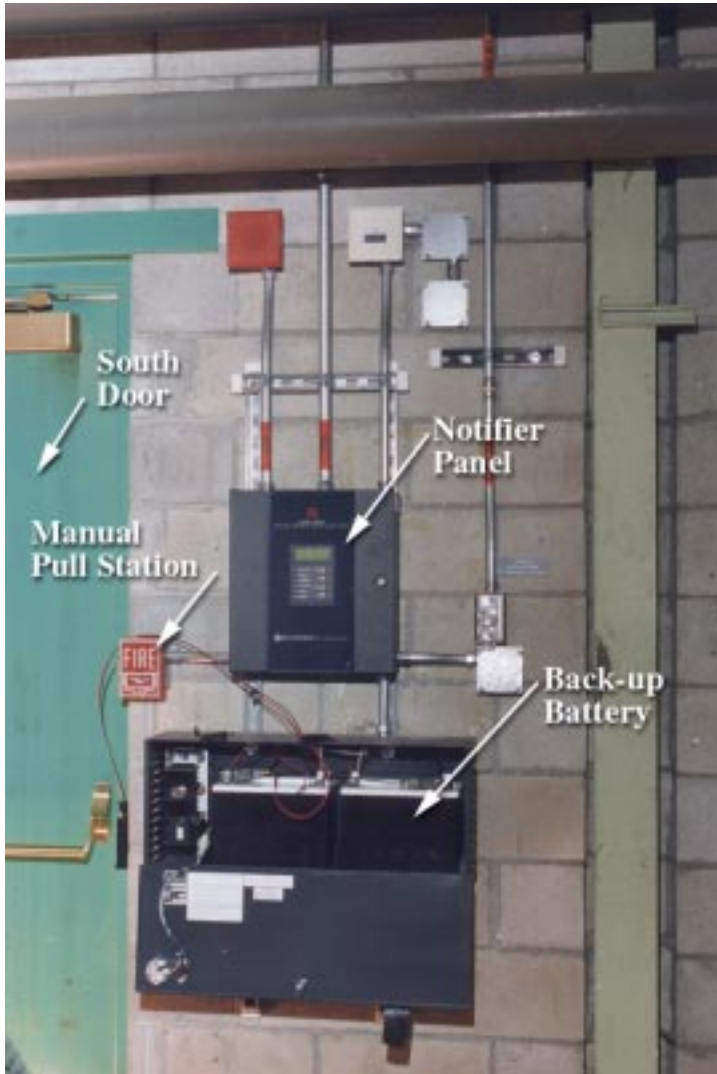
**Exhibit 3-1. Notifier Fire Alarm Panel**

*The fire alarm system controls the evacuation alarms and the carbon dioxide discharge system.*

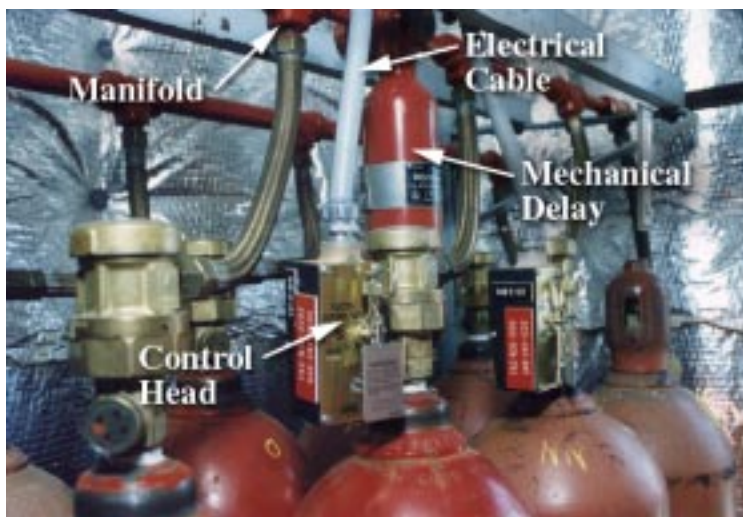
**Exhibit 3-3. Control Head and Mechanical Delay Mechanism**

*A valid activation of the system produces an alarm and allows enough time for workers to evacuate before carbon dioxide is discharged.*

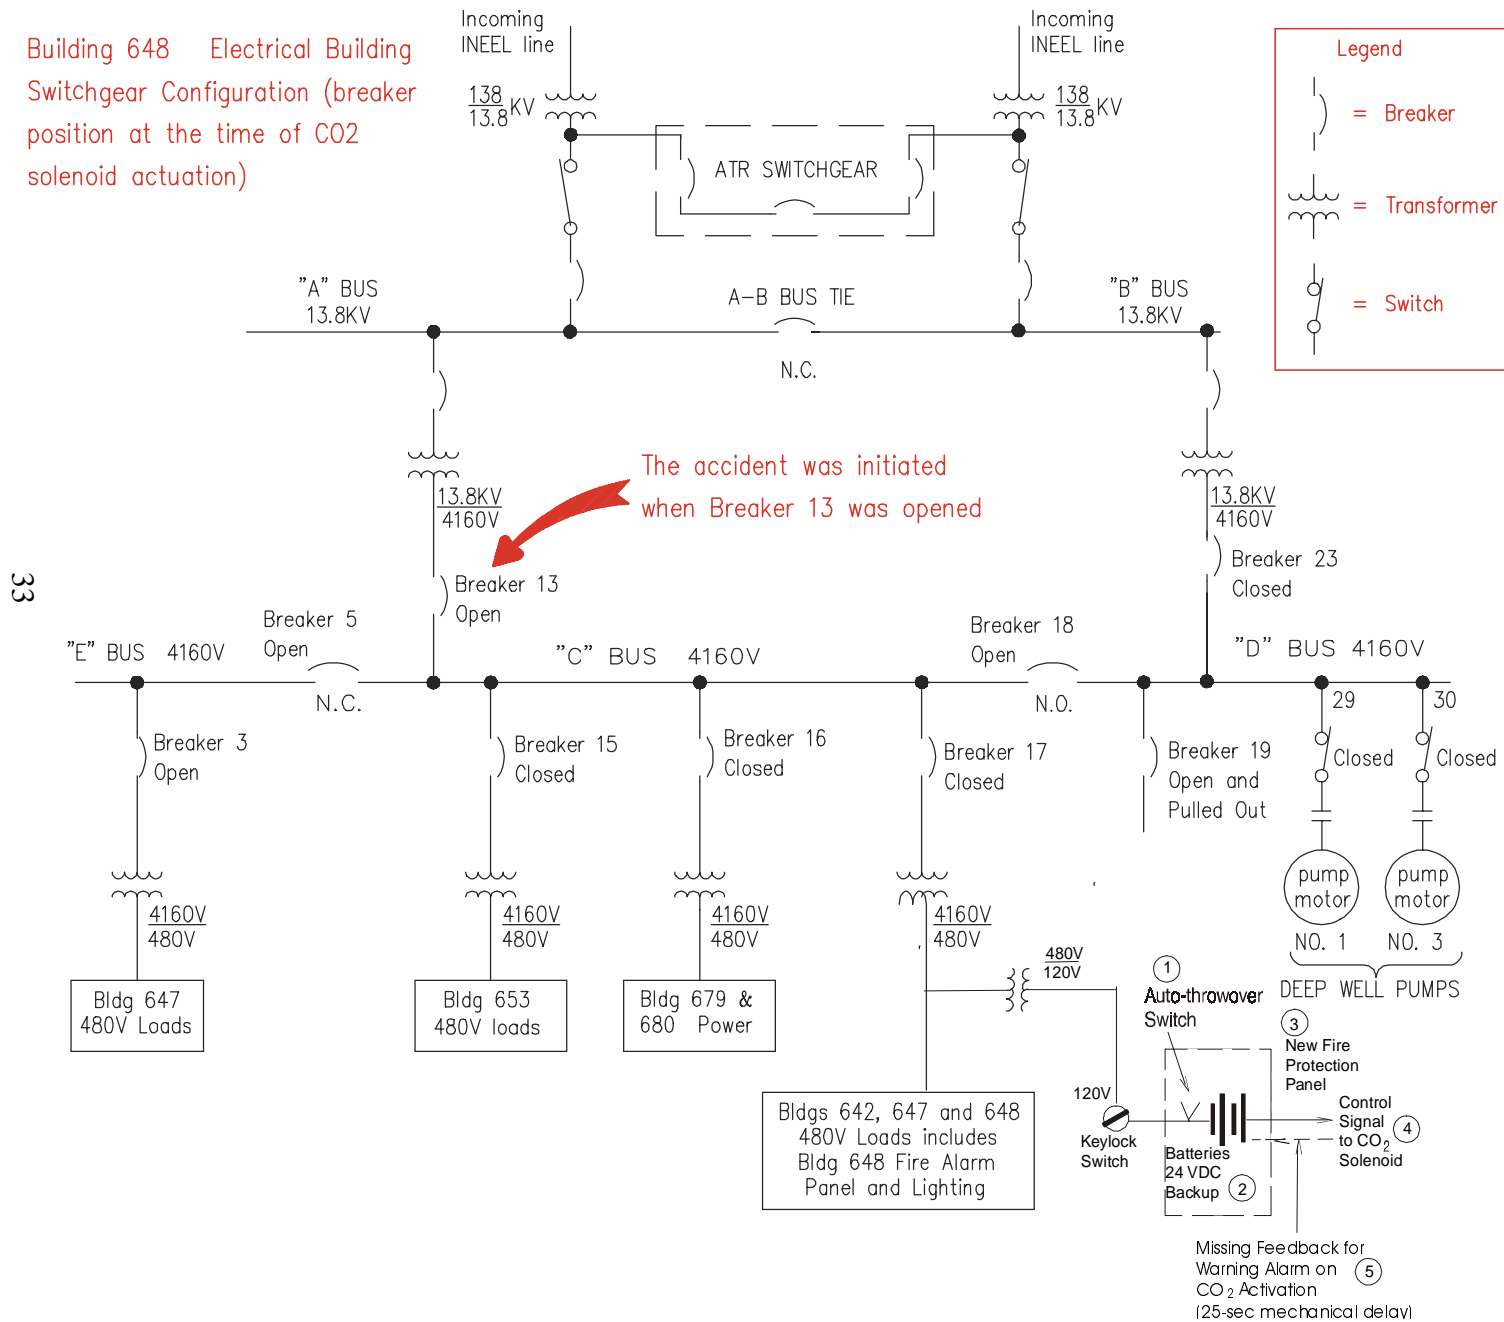
**Figure 3-1. Simplified Schematic of Switchgear**

Electrical power is provided to Building 648 by three sources: commercial power, diesel power, and batteries. Commercial power is provided from the main INEEL substation by two parallel 138,000 volt lines to the TRA substation, then from the TRA substation to Building 648 on two parallel 13,800 volt lines, and transformed to 4160 volts and fed on two parallel lines to the Building 648 switchgear. These parallel lines feed the 4160 volt bus through Circuit Breakers No. 13 and 23, with Breaker No. 18, which is normally opened, acting to tie together the 4160 bus sections. Breaker No. 13 feeds power to facilities through Breakers No. 15, 16, and 17. Breaker No. 23 feeds power to TRA deep well pumps. The diesel power supply to the Building 648 switchgear is not relevant to the accident. The battery power supply provides direct current (DC) voltage primarily used for switchgear control power at 125 volts DC. A simplified schematic of the relevant switchgear is shown in Figure 3-1.

Fire protection systems in Building 648, as well as building lighting systems, are fed electrical power from 4160 volt switchgear Breaker No. 17, that feeds a 480 volt switchgear Breaker No. 11C, and a 480 volt distribution panel (648-E-25). The fire protection system is fed from this distribution panel, through Lighting Panel K, to a 240 volt transformer, sub-panel KA circuit Breaker No. 5 which supplies 110 volt alternative current (AC) service to the Notifier AFP-200 panel. The fire alarm panel was provided with 60 hours of dedicated emergency battery backup power.

installation deviations were significant with respect to the accidental CO<sub>2</sub> discharge. The auxiliary power supply is suspect because opening Breaker No. 13 appears to have been the cause of the CO<sub>2</sub> discharge, presumably as a consequence of a voltage surge or spike. The fact that this power supply is unregulated and unfiltered may make it easier for a transient input to that supply to get through to the panel and trip the releasing circuits. The shielding on the addressable circuits is suspect because it is intended to dissipate transient signals before they can affect system operation.

On August 14, 1998, the circumstances of the CO<sub>2</sub> discharge were successfully re-created by the work package's first attempt at disconnecting the circuit breakers. Opening of 4160 volt Circuit Breaker No. 13 caused the alarm system to shut down momentarily and energized both control heads (CO<sub>2</sub>-releasing solenoids). Consistent with the evening of July 28, 1998, audible alarms were silent and the fire alarm system history did not record either an alarm or the actuation of the releasing circuits.

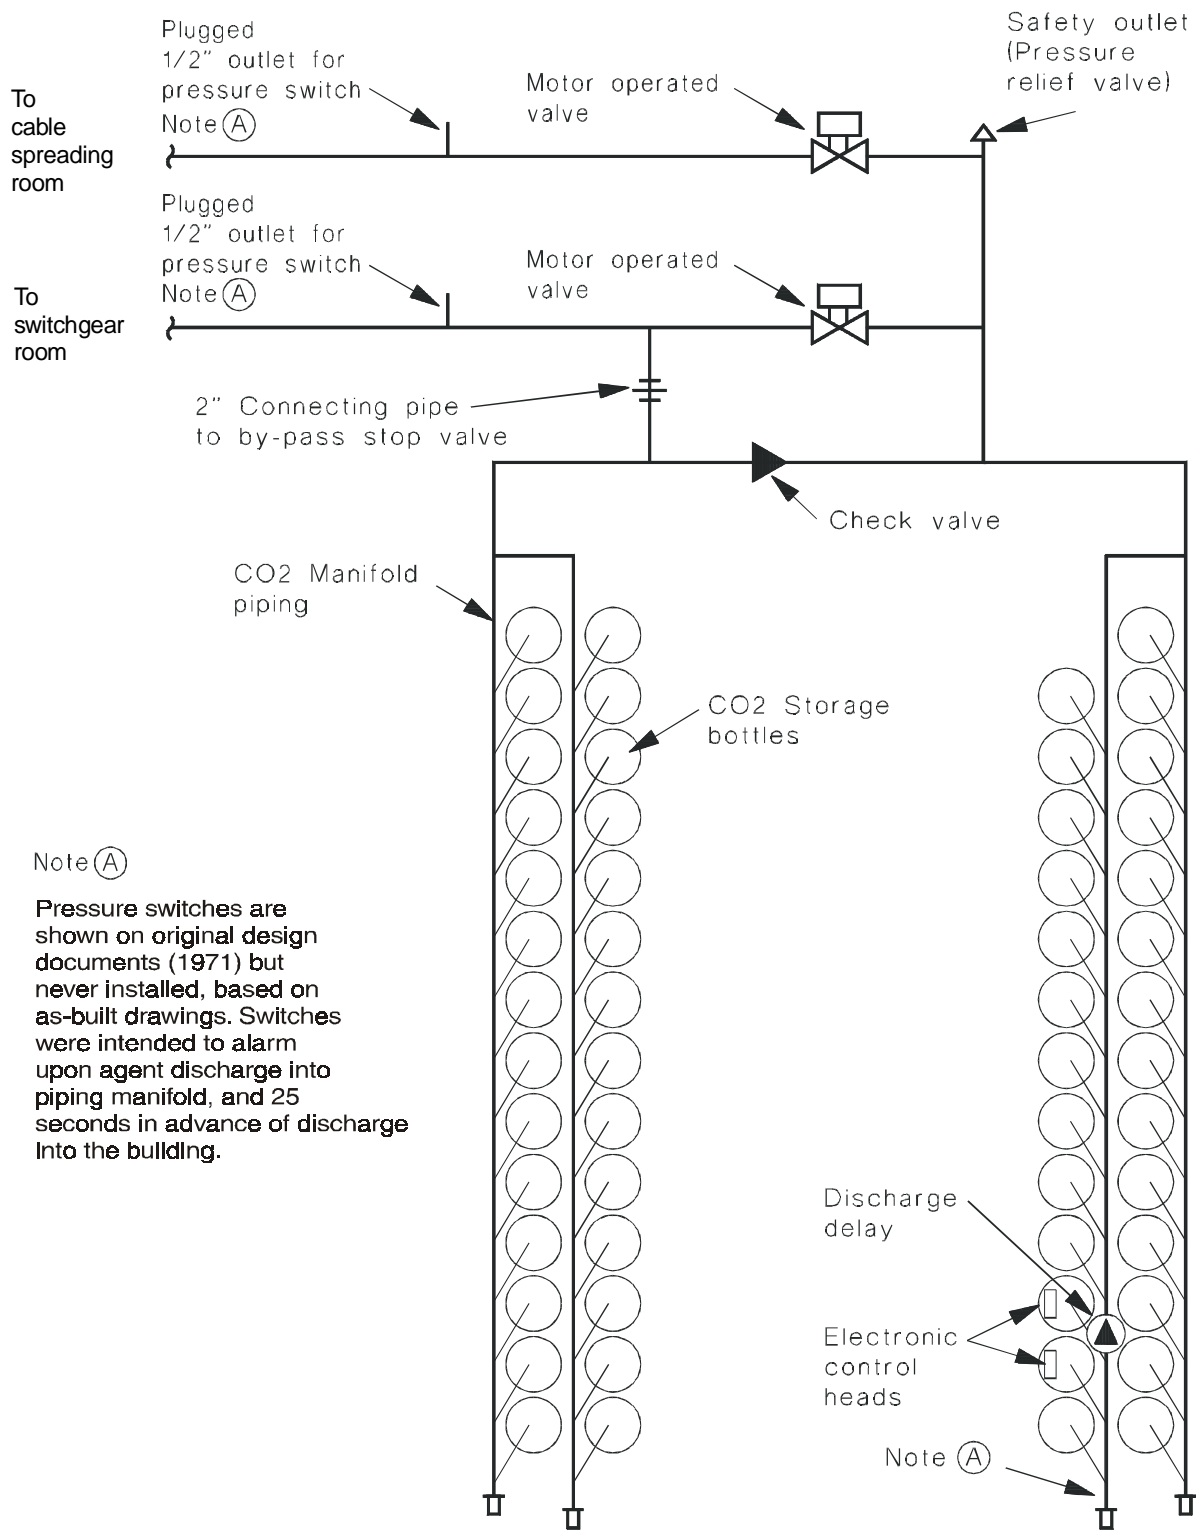
**Figure 3-2. Carbon Dioxide System Arrangement Pre Line Item Upgrade**

Review of existing drawings indicated that the CO<sub>2</sub> system was originally installed in 1971 as a two-zone system. One zone covered the main floor, and the second zone covered the basement.

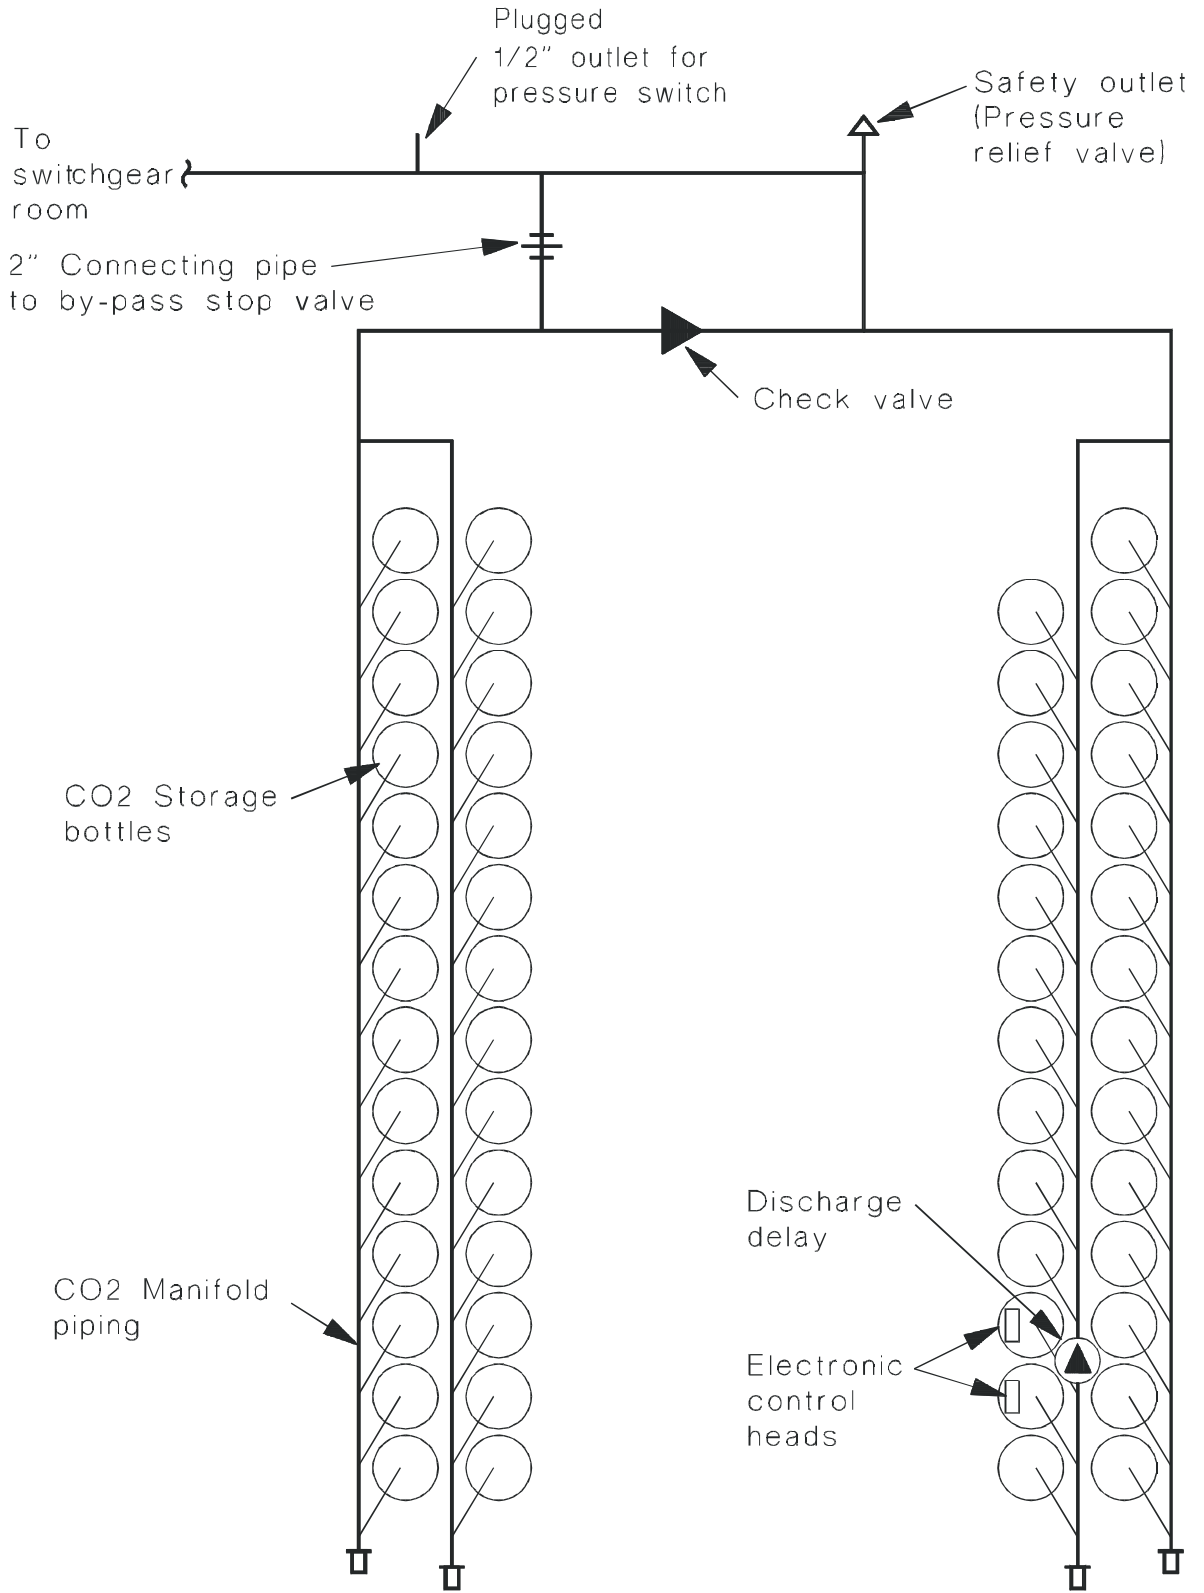
**Figure 3-3. Carbon Dioxide System Arrangement Post Line Item Project**

*The failure to install a carbon dioxide system discharge monitoring circuit prevented a 25-second pre-discharge warning alarm and safe escape.*

*Deviations in the fire alarm system installation could have made it easier for a transient electrical input to trigger the unexpected discharge.*

**Configuration Management.** The CO<sub>2</sub> system was not properly designed, because it did not monitor discharge of the suppression system it controlled. This monitoring could have been accomplished by installing a pressure switch on the CO<sub>2</sub> manifold (upstream of the mechanical delay) arranged to activate the evacuation signals upon initial pressurization of the manifold. While this deficiency did not cause the discharge, it was important to the outcome because it allowed the CO<sub>2</sub> system to operate without warning. Had the CO<sub>2</sub> system been monitored as required, the evacuation signals would have provided 25 to 55 seconds warning before CO<sub>2</sub> was discharged into the building. This would presumably have been sufficient time to allow the building occupants to escape without injury.
