**Type A Accident
Investigation Board Report
of the July 28, 1998
Fatality and Multiple Injuries
Resulting From Release of
Carbon Dioxide
at
Building 648, Test Reactor Area
Idaho National Engineering and Environmental Laboratory
Chapters 4,5,6,7**

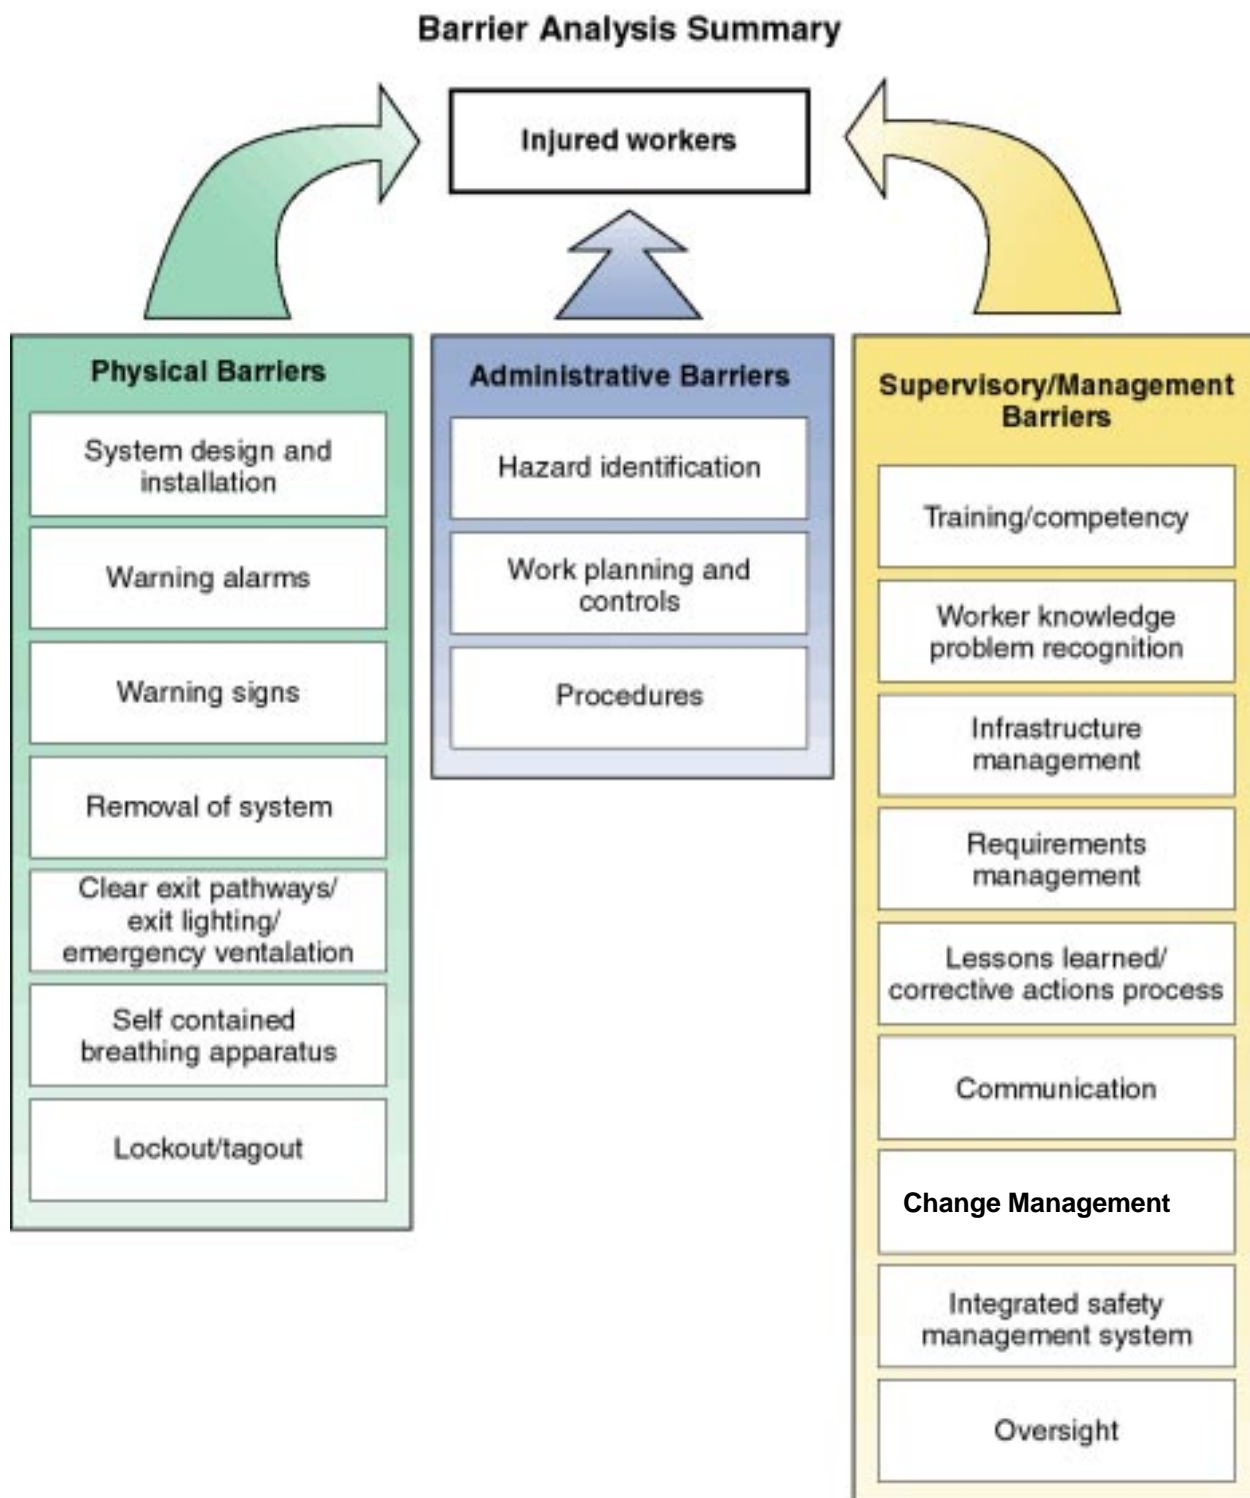
Figure 4-3. Barrier Analysis Summary

Figure 4-4 provides a more detailed assessment of some of the key physical barriers and selected barriers related to immediate emergency response and rescue. It shows how the proper functioning of the barrier could have prevented the accident entirely or reduced its consequences considerably, and the expected consequences if the barrier had functioned as intended. Finally, the figure describes the barrier failure mode, which identifies how action and/or inaction resulted in the barrier not functioning as intended.

As seen on Figure 4-4, the lockout/tagout barrier had the capability to completely prevent the accidental CO₂ discharge and thus to eliminate the possibility of injuries and fatalities. The other physical barriers (e.g., CO₂ header pressure sensors and alarm feedback circuit, in conjunction with the 25-second mechanical discharge) would not have prevented the discharge but would have provided a pre-discharge alarm and time to escape the building if they had functioned properly, thus reducing the likelihood of injuries and fatalities. However, these systems were either not installed or failed.

A variety of barriers related to emergency preparedness could have facilitated emergency escape and immediate search and rescue, thus reducing the risk to rescuers and possibly avoiding serious injuries. However, as discussed previously, weaknesses were evident in many of these barriers, so accident mitigation was not totally effective, and the accident's consequences were not minimized.
