CX Posting No.: DOE-ID-INL-24-108

## SECTION A. Project Title: EBR-I Post Season Maintenance 2024

Scope of Work: EBR-I 2024 Post-Season Maintenance

During a walkdown of EBR-I on 14 October 2024 to determine post-season maintenance needs, the following work was identified as necessary to maintain or improve conditions for the public following the Summer 2024 season. All work is being done under Maintenance Work Request (MWR) 2024-7842.

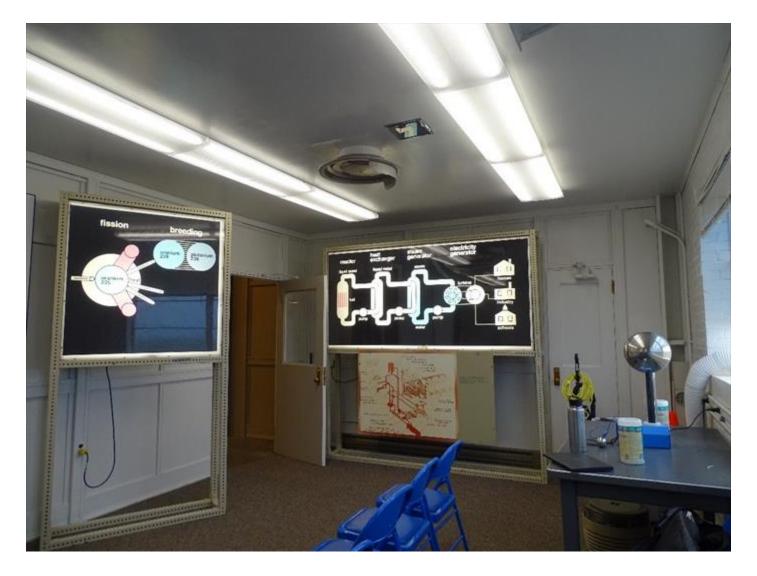
- Rewire plug to the four lightbulbs: Tours reports that the wires to the plug have frayed and wires are exposed. Replace plug component and rewire as necessary. This is not an original component of the building.
- Adjust door closer on the north door of the mezzanine classroom: Tours reports that the door will no longer stay open. Adjust tension on the door closer to enable this functionality. (Figure 1)

Figure 1. South door in classroom.

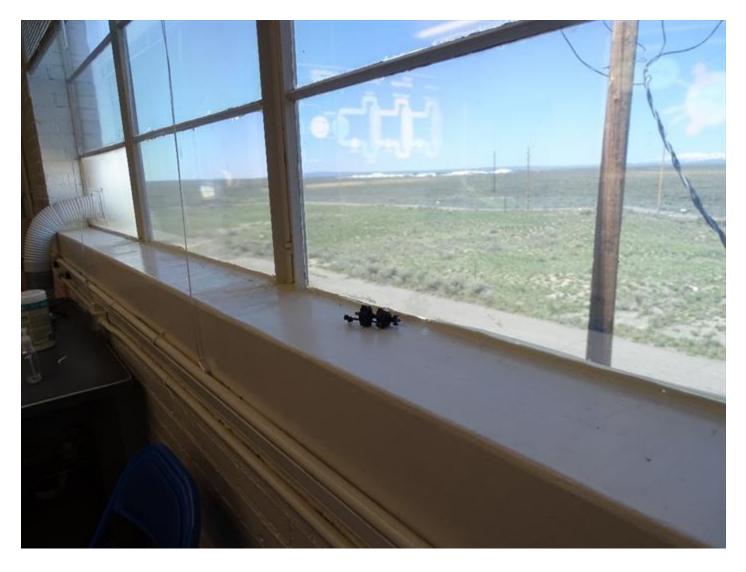
• UV Film on Mezzanine Windows: The UV film on the windows located on the mezzanine level appears to have reached the end of its useful life and is beginning to crack, peel, and flake. Remove the current film, being cautious not to damage the panes or disturb the glazing. (Note: original glazing compound may contain asbestos.) Replace UV film with similar product. New film should offer

adequate UV protection while being minimally visible and should be easily removable. Final product choice will be confirmed with CRMO before installation. (Figure 2)

Figure 2. Windows in classroom with failing UV film.

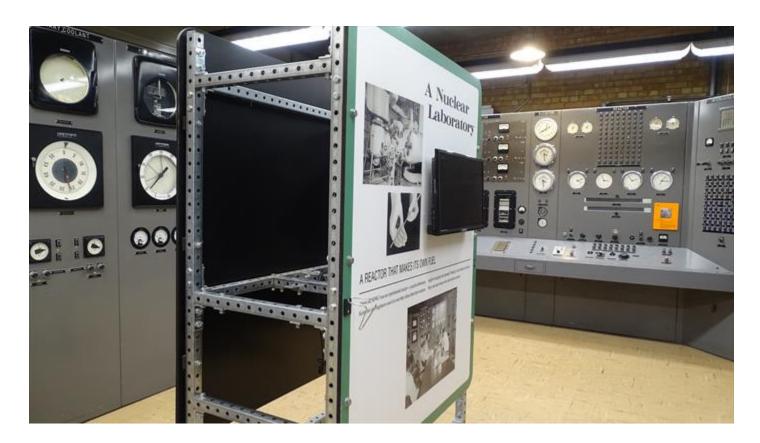
• Reinstall logbook stand in Control Room: Display case formerly used for the Zinn Journal was removed to allow Archives to retrieve the journal. Reinstall the display case in the metal frame without plexiglass cover to allow guest access to a reproduction journal. (Figure 3)

Figure 3. Frame for logbook display in Control Room.

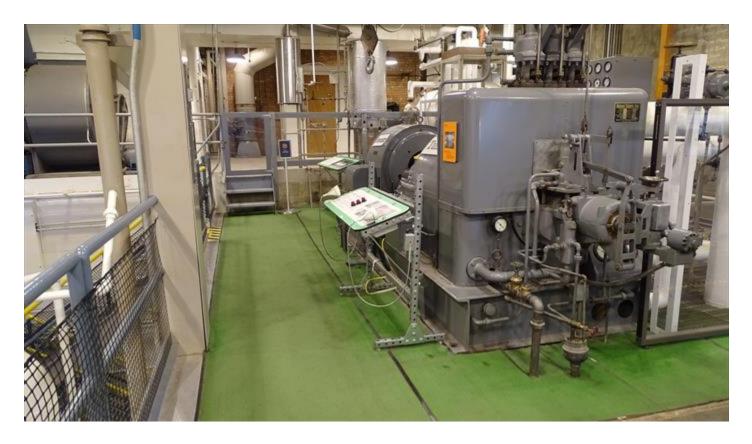
• Turbine Deck carpeting: The green carpeting around the turbine and the generator prevents life safety events as it encloses metal grate flooring, but is not historically accurate. Replace green carpet with a low-profile or low-shag flooring material that matches or is close in color to the surrounding concrete floor and does not require permanent installation. Confirm final product choice with CRMO before installation. (Figure 4)

Figure 4. Green carpet in Turbine Area.

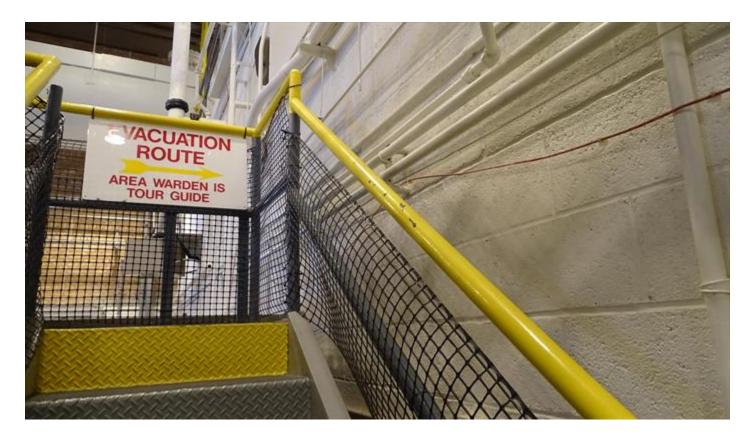
• Handrails: Handrails on the stairs between the main floor and the mezzanine are showing signs of wear. Clean by the gentlest means possible. If wear extends beyond built up dirt, repainting may be necessary. Contact CRMO to confirm paint match. (Figure 5)

Figure 5. Stair in northwest corner of low bay, showing paint loss.

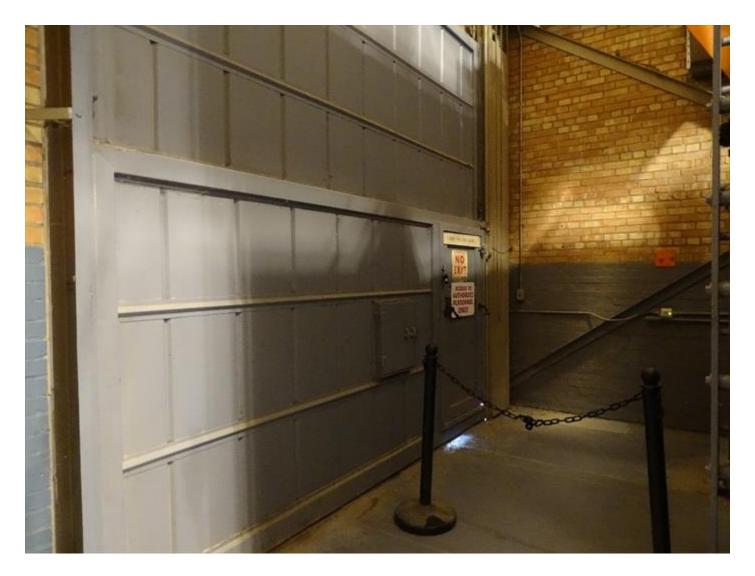
- Hot Cell Display Contents: Several non-historic display items were placed in the hot cell at an unknown time. Several of these, namely flasks filled with colored liquids, are showing signs of deterioration. Remove non-historic contents. Coordination with RadCon and WGS will be necessary to open the hot cell and dispose of contents appropriately.
- South Door Weatherstripping: The weatherstripping on the bottom of the south overhead door (by the hot cell) has deteriorated to the point that light is visible beneath the door. Water staining in the area indicates that water intrusion has also occurred in this location in the past. Replace weatherstripping with a product that will prevent water and wildlife intrusion and is minimally invasive. (Figure 6)

Figure 6. North door of Hot Cell Area.

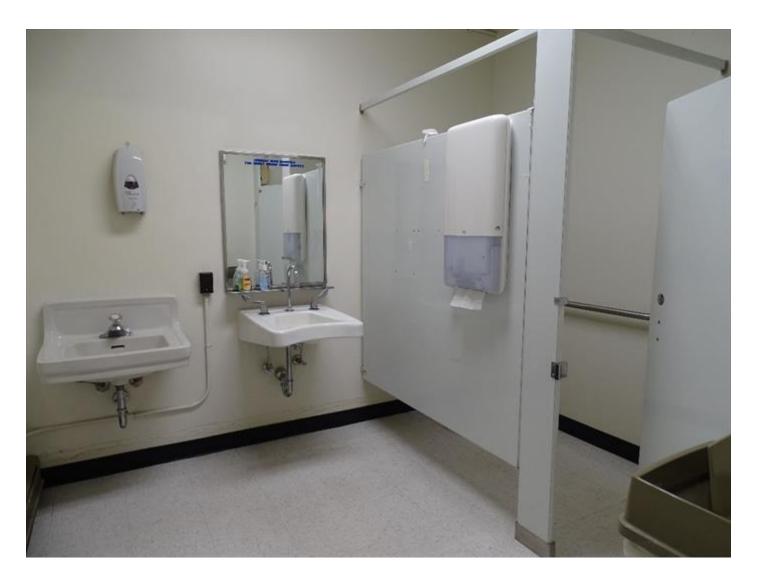
• Annex Women's Restroom: Door to the stall in the restroom sticks on opening/closing and the receiver is misaligned with the slider. Repair as practical. These doors are not original to the building, but were installed in 1980. (Figure 6)

Figure 7. Annex Women's Restroom.

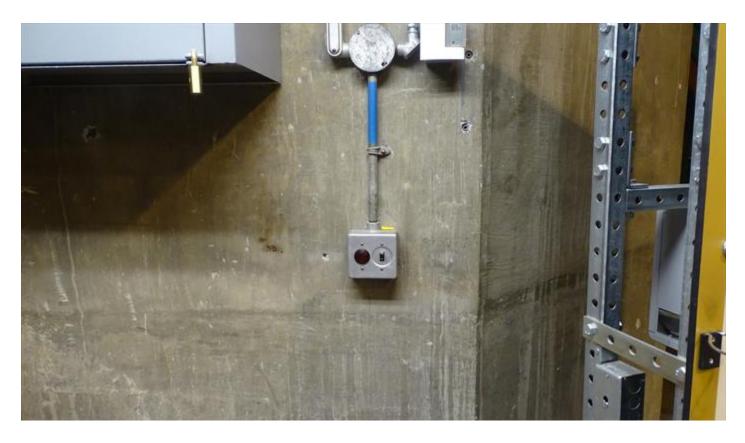
• Light Switch Indicators: Several of the original light switches on the main floor have indicators that illuminate when in the "on" position. The indicators are comprised of a red lens and a small bulb behind. Several of these bulbs have burned out over time. Remove faceplates, being careful not to damage the red lens. Replace the bulbs behind. Reinstall face plates. (Figure 4)

Figure 8. Light switch with burned out indicator.

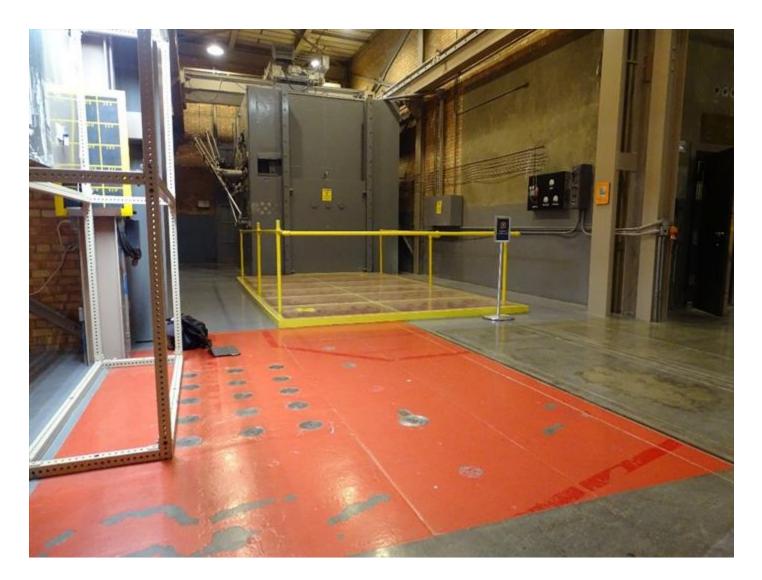
• Repair Paint over Washroom: The red paint on the reactor floor that indicates the area of the Washroom beneath had deteriorated to the point several large areas are missing. Repair paint with matching color. Confirm color choice with CRMO prior to work. Before work begins, assess for possible lead paint and fixed contamination. (Figure 9)

Figure 9. Area over Wash Room showing paint loss.

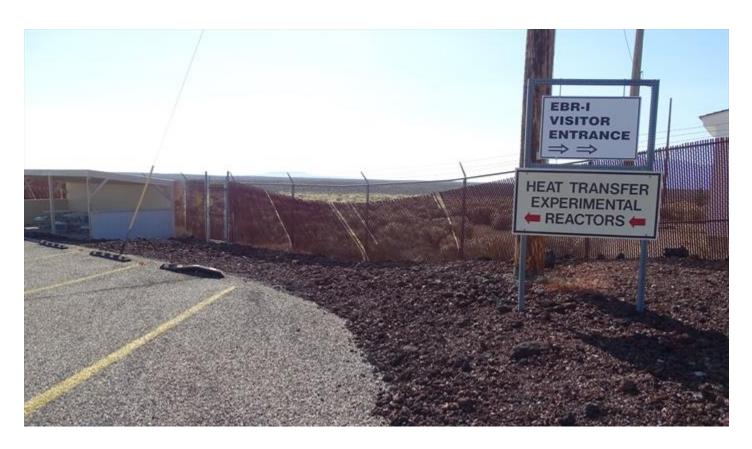
• Repair Fencing: the fencing panels have come detached at several locations along the parking lot. Reaffix panels and repair as necessary. (Figure 10)

Figure 10. Current condition of fencing.
