1.7 Core and Thermal Shield Deformation

1.7.1 Preliminary Observation Underneath Core

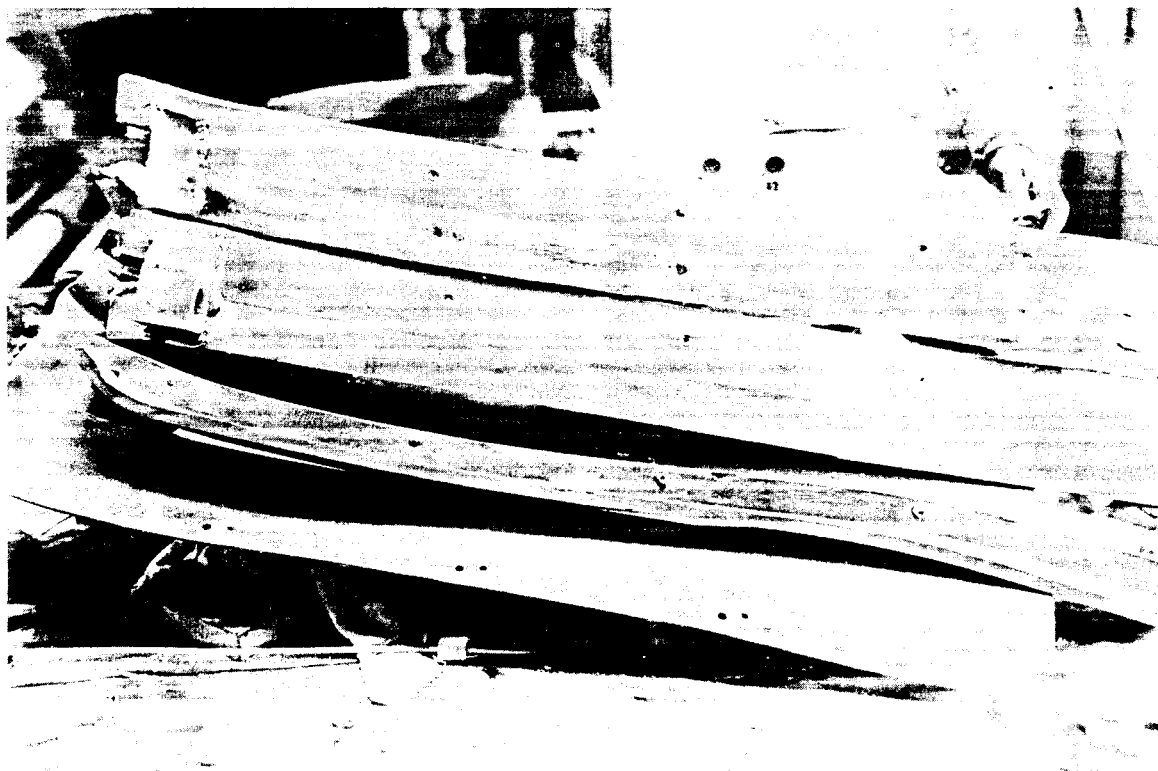
Figure III-43, Core, Tee-Stanchions

Observation inside the core (Figure II-52) shows vividly the results of the radial forces collapsing all the cruciform shrouds and binding a major number of the peripheral fuel elements between the shrouds and the thermal shield. Shrouds Nos. 1, 2 and 9 were removed from the core structure and revealed the damage to the lattice support structure which included the shearing of the bolt stud threaded to the core support bracket. A cross shaped stanchion was bent outward and the shrouds disengaged from the stanchion by the rivets which were sheared. Figure III-43 shows three tee-shaped stanchions, two with the lattice support pads sheared off and one still in place. All rivets on all stanchions, as shown in the figure, have been sheared.

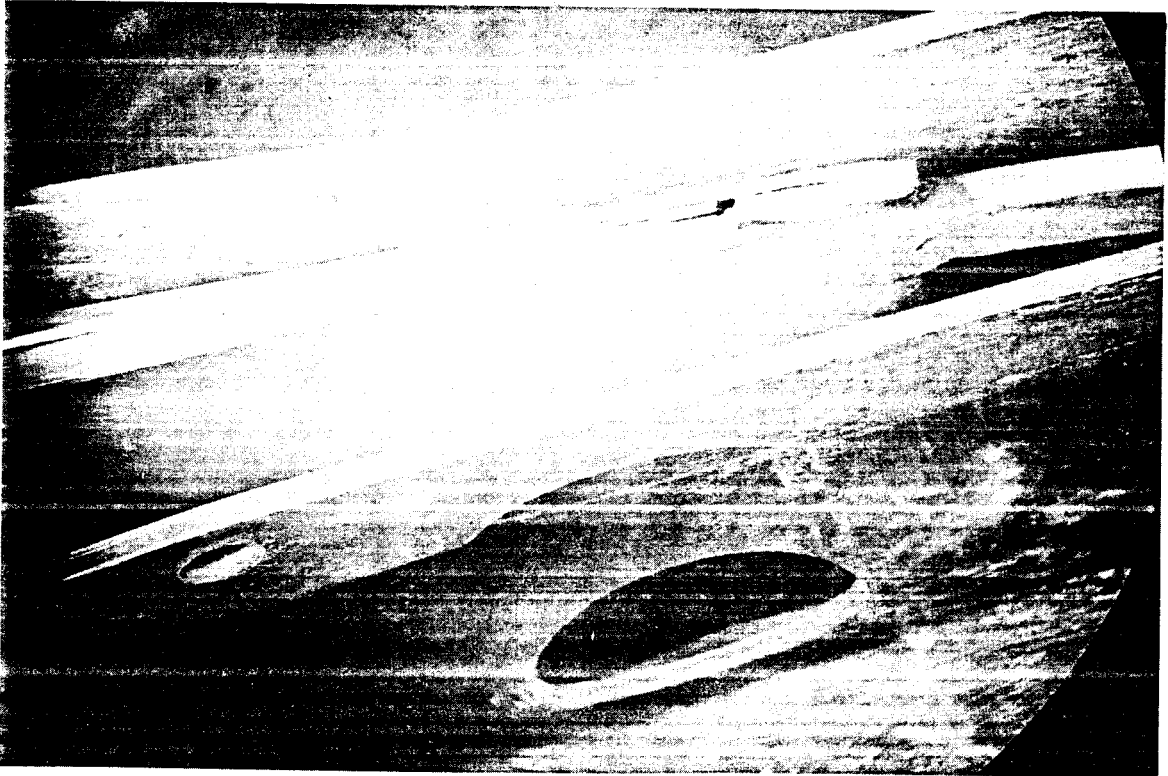
Shroud No. 6: No fuel cartridges were attached to this shroud assembly. Figures III-53 and 54 show the separation of the cadmium blade edges. The welds at the upper end of the shroud appear to be partially fractured. One cadmium blade was 2-1/2 inches up from the bottom of the shroud, and the other two blades were 5 inches above the bottom of the shroud. One of the cadmium blades had the lifting fixture blown off. The tee-shroud was not collapsed but was deformed and all the rivets were sheared.

Figure III-54, Cadmium Blade, Assembly #6.

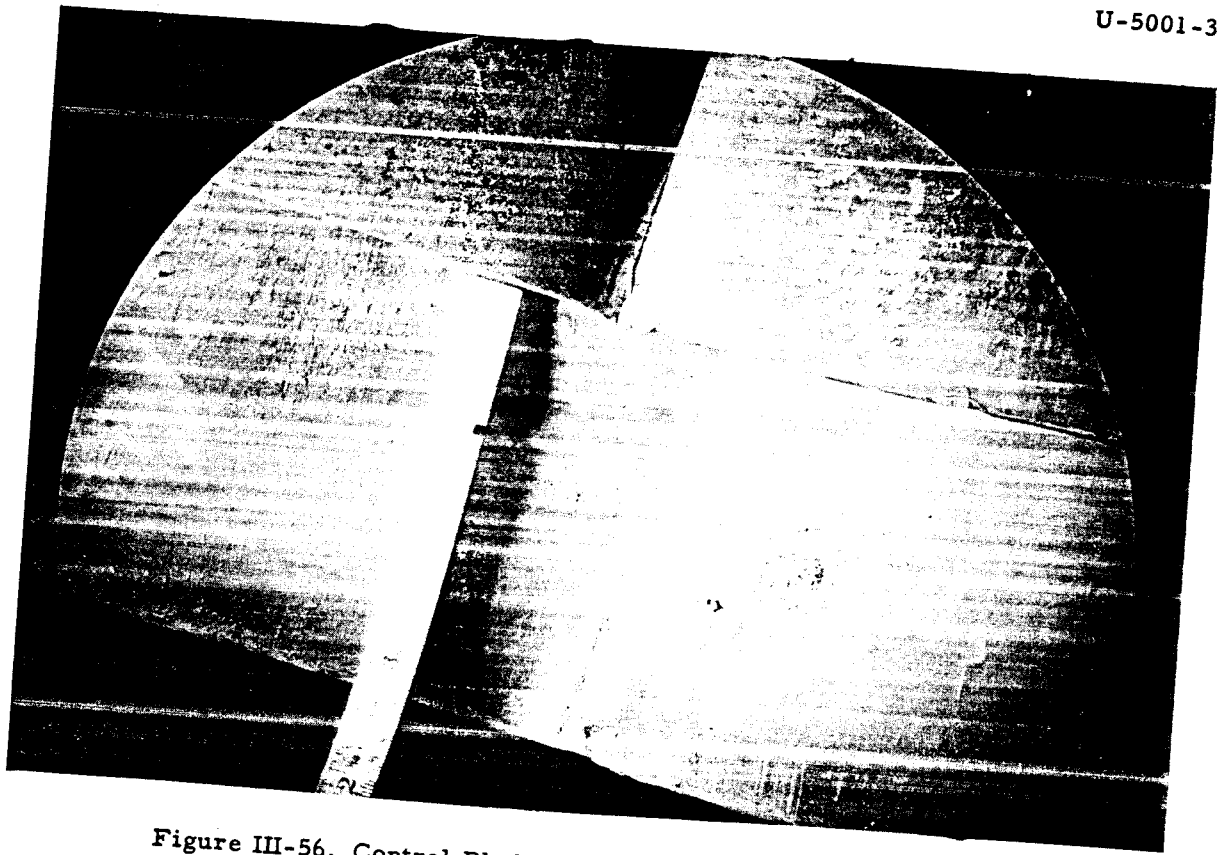
Figure III-56, Control Blade No. 7 extending 3-3/8 inches below bottom of its shroud.

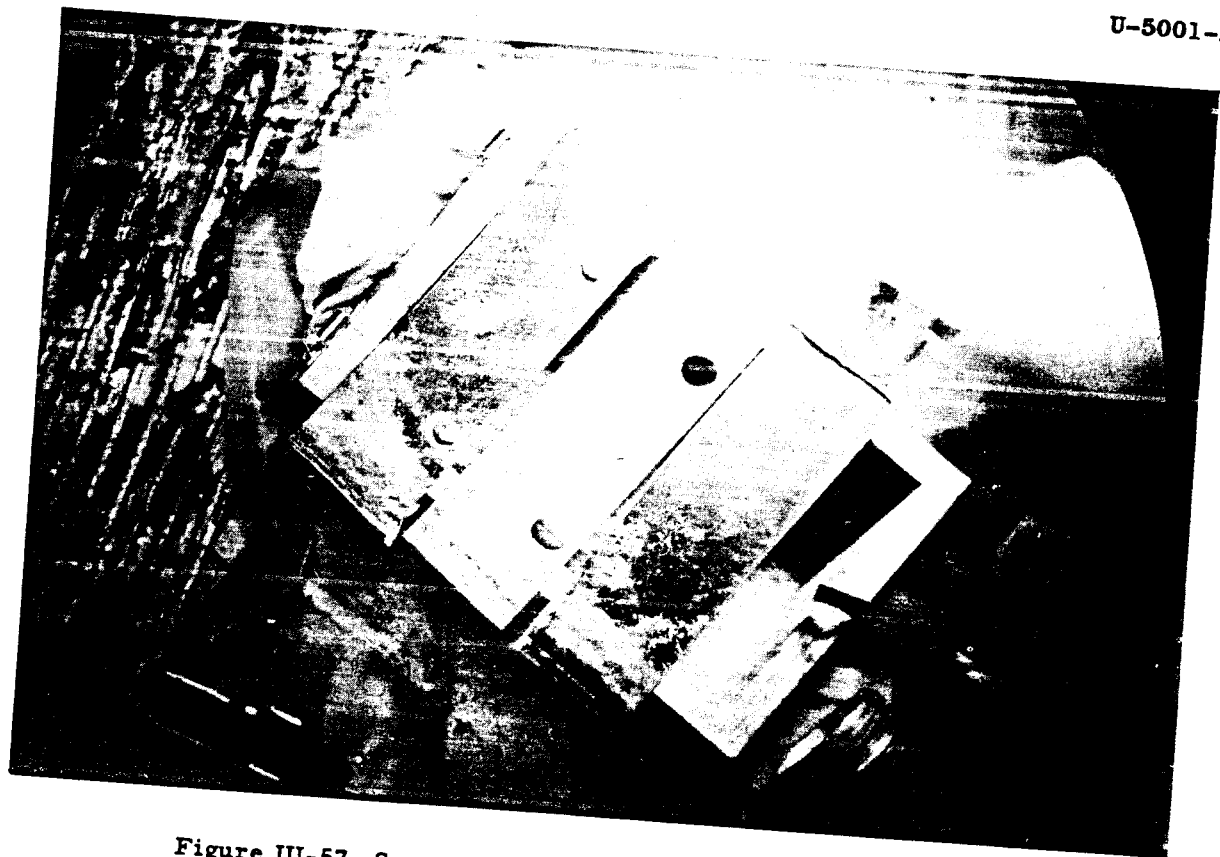
Figure III-57, Sample section from control blade #9.

Sectioning and sampling for radiochemical and metallurgical analyses were completed on the control rod cruciform. Four 2 inch wide strips were sectioned from three of the blades. One was left intact. These four strips from each blade were sectioned corresponding to $1/4$, $1/2$, $3/4$ and maximum flux. Macroscopic observation indicated the cadmium metal and its alloy clad were in good condition (Fig. III-57).

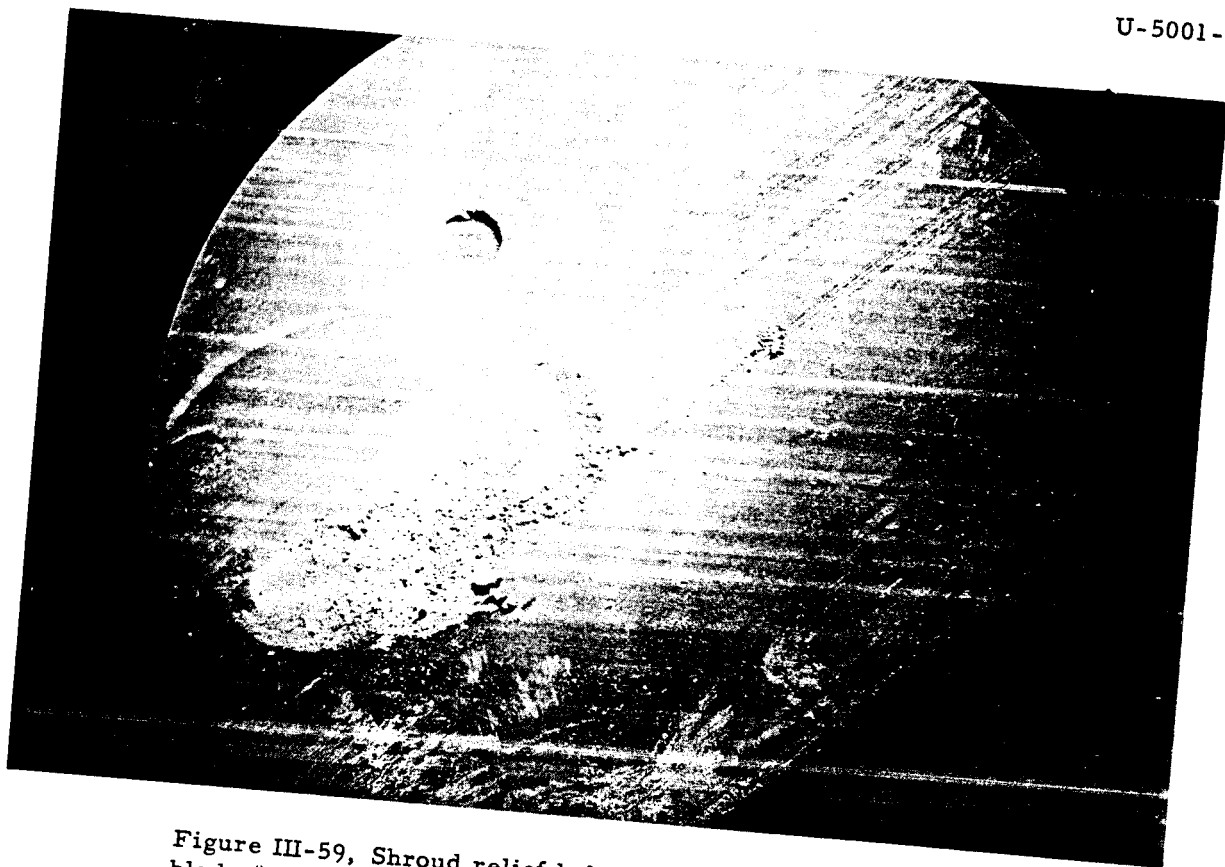
Figure III-59, Shroud relief hole imprint on control blade #9 and metal spatter.

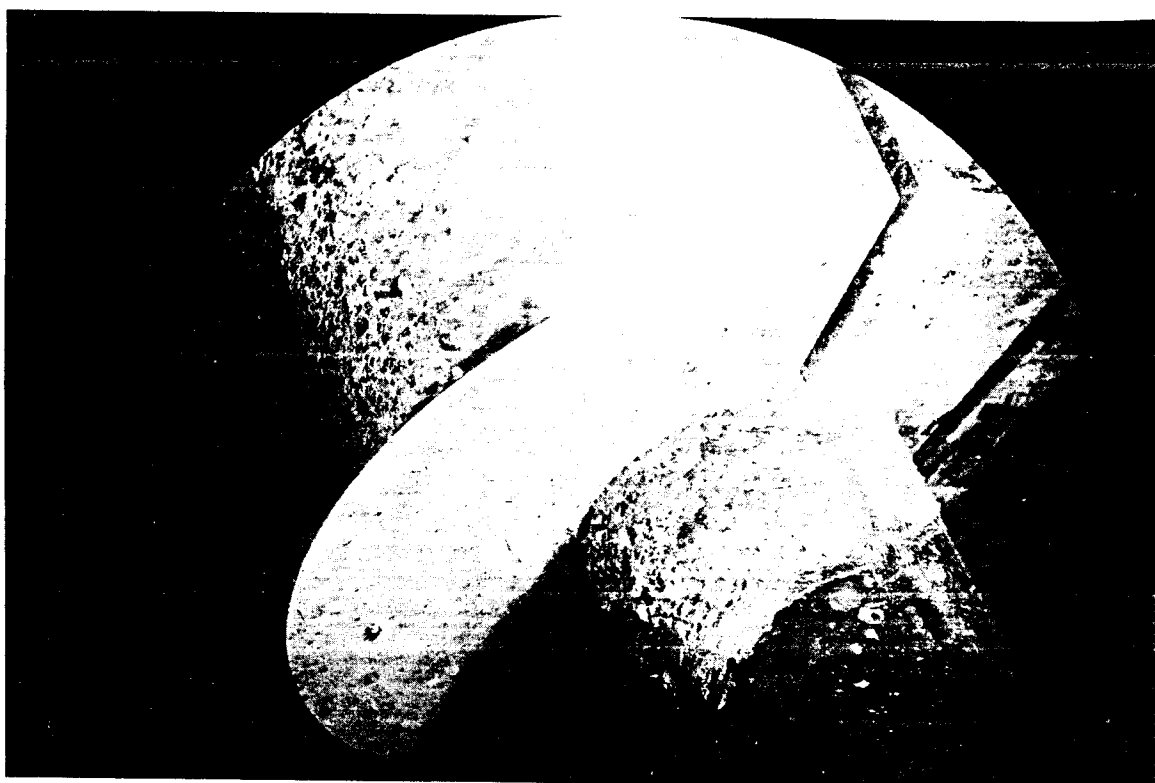
The type of deposits found within the pressure vessel can be seen in Section II, Figure II-33. Figures III-63 and 64 are photographs of the deposits on shield plug #5 and shield plug #4, respectively.

Figure III-64, Deposits on Dummy Rod Assembly #4

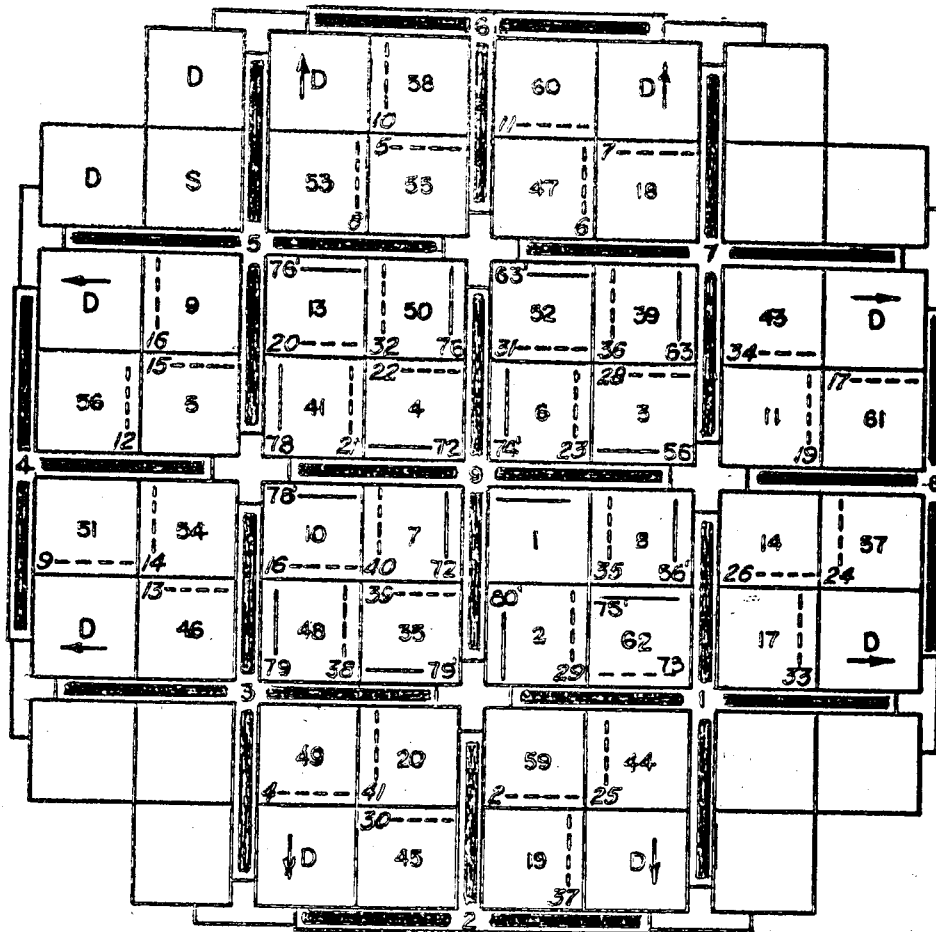
Figure III-65

The SL-1 core had been loaded with 39 full and 16 half strips of burnable boron-aluminum, as shown in Figure III-65. During the pre-incident

SL-1 LOADING FOR 40 ELEMENT CORE

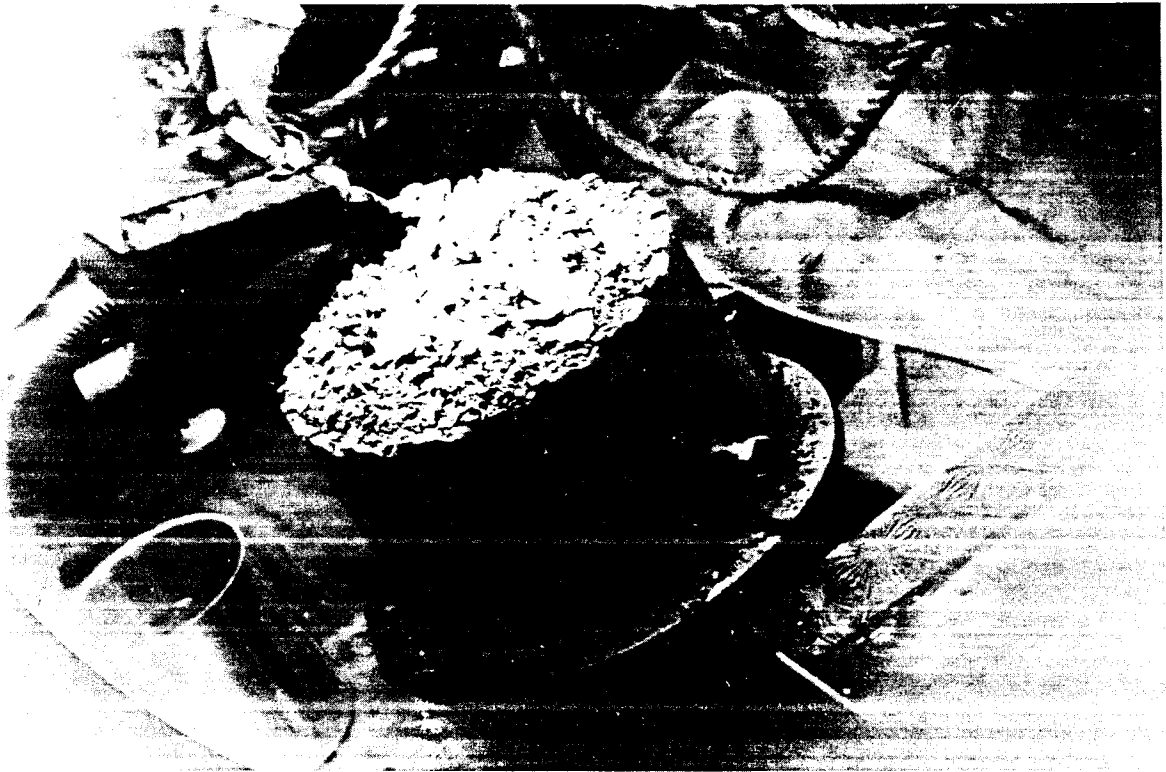
Figure III-68 Cutter Loaded with Debris from Bottom of Pressure Vessel

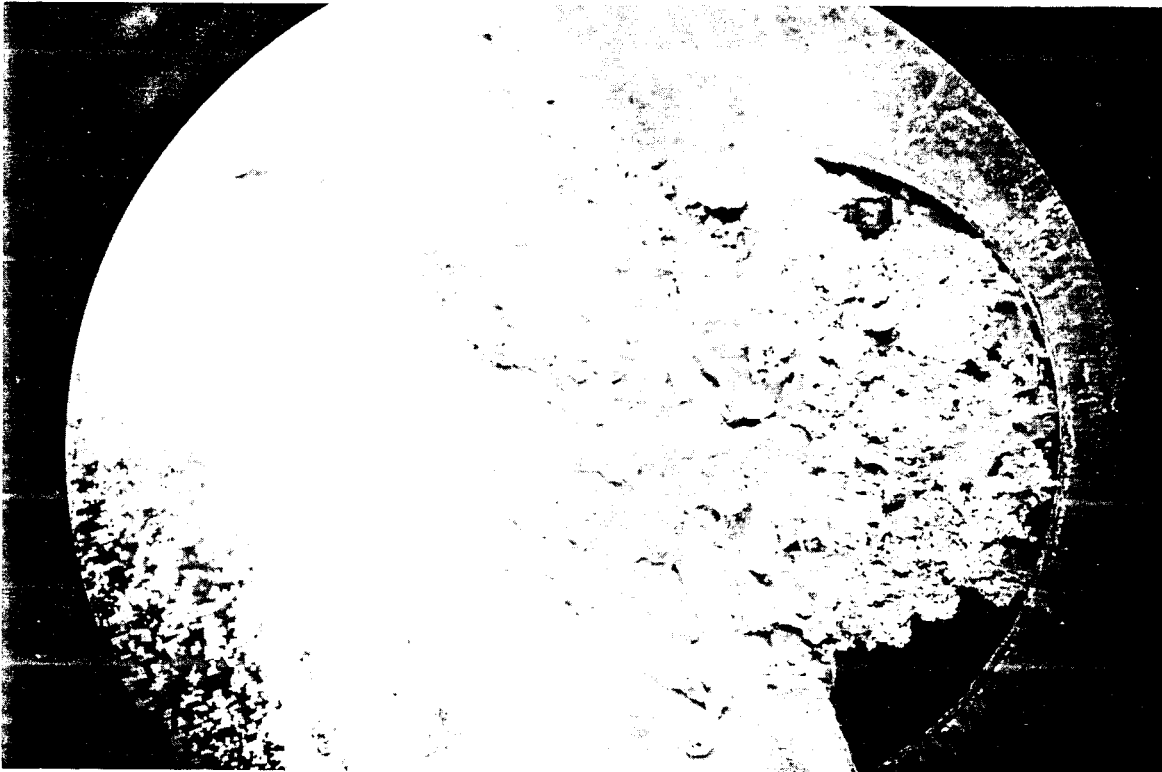
Figure III-73 Fuel Material Spatter from Element #3

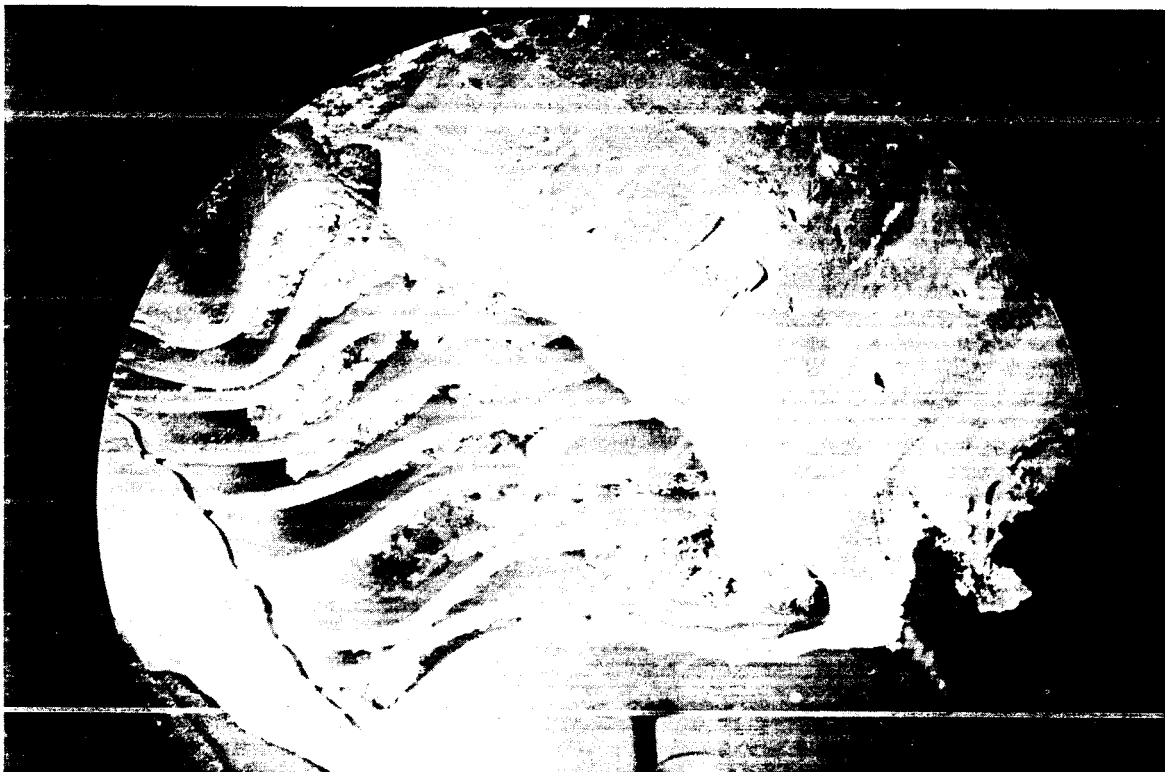
Figure III-74 Extraneous Material in Fuel Element #52

Figure III-74 shows the lower end of fuel element #52 with the spaces between plate filled with some molten material, sponge-like material and unmelted pieces.

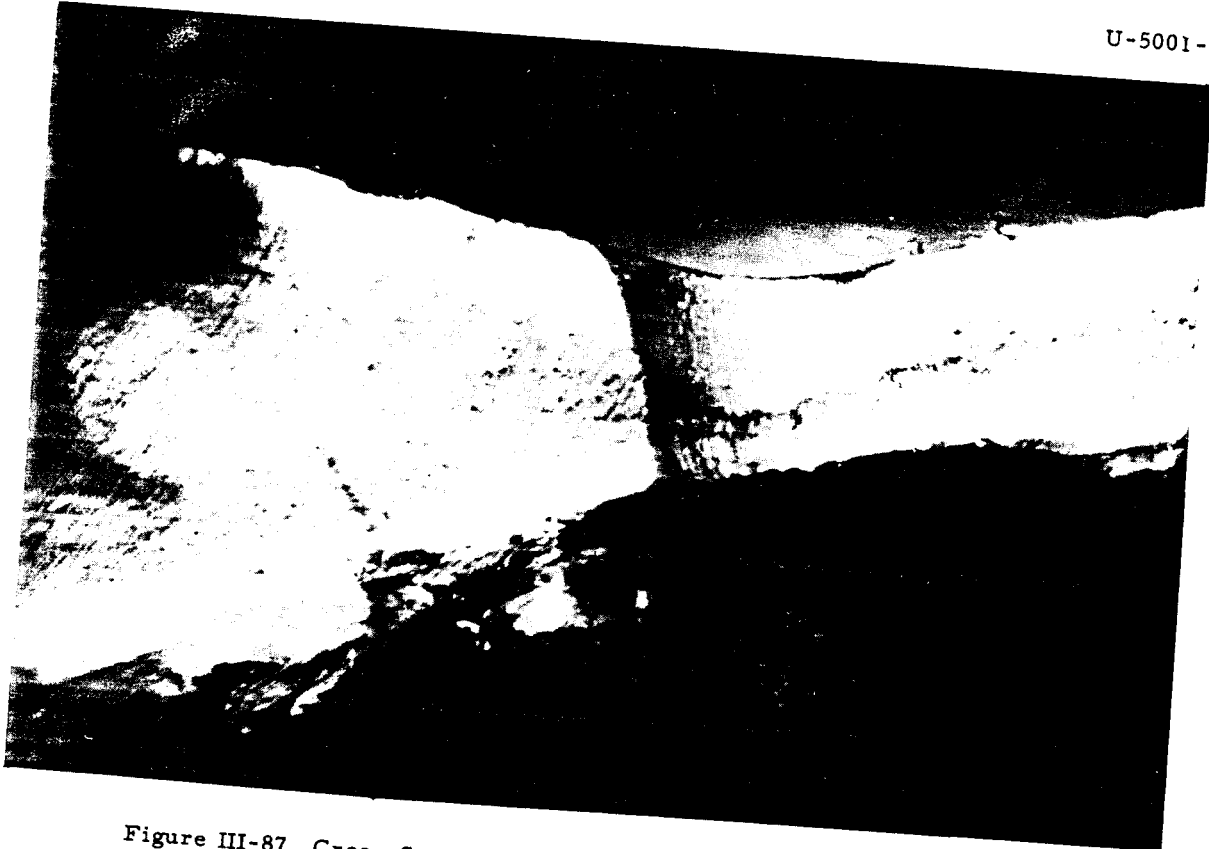
Figure III-87, Cross-Sectional View of Fuel Plate Swelling from Fuel Element #6
