SUBJECT: Contract No. DE-AC07-05ID14517 - Response to DOE-ID Request for Beryllium Exposure Assessment and Monitoring Data

Summary Report:
Beryllium Exposure Characterization, TRA-670 and TRA-662.

Prepared by:
BEA Industrial Hygiene Program Office
February 1, 2010

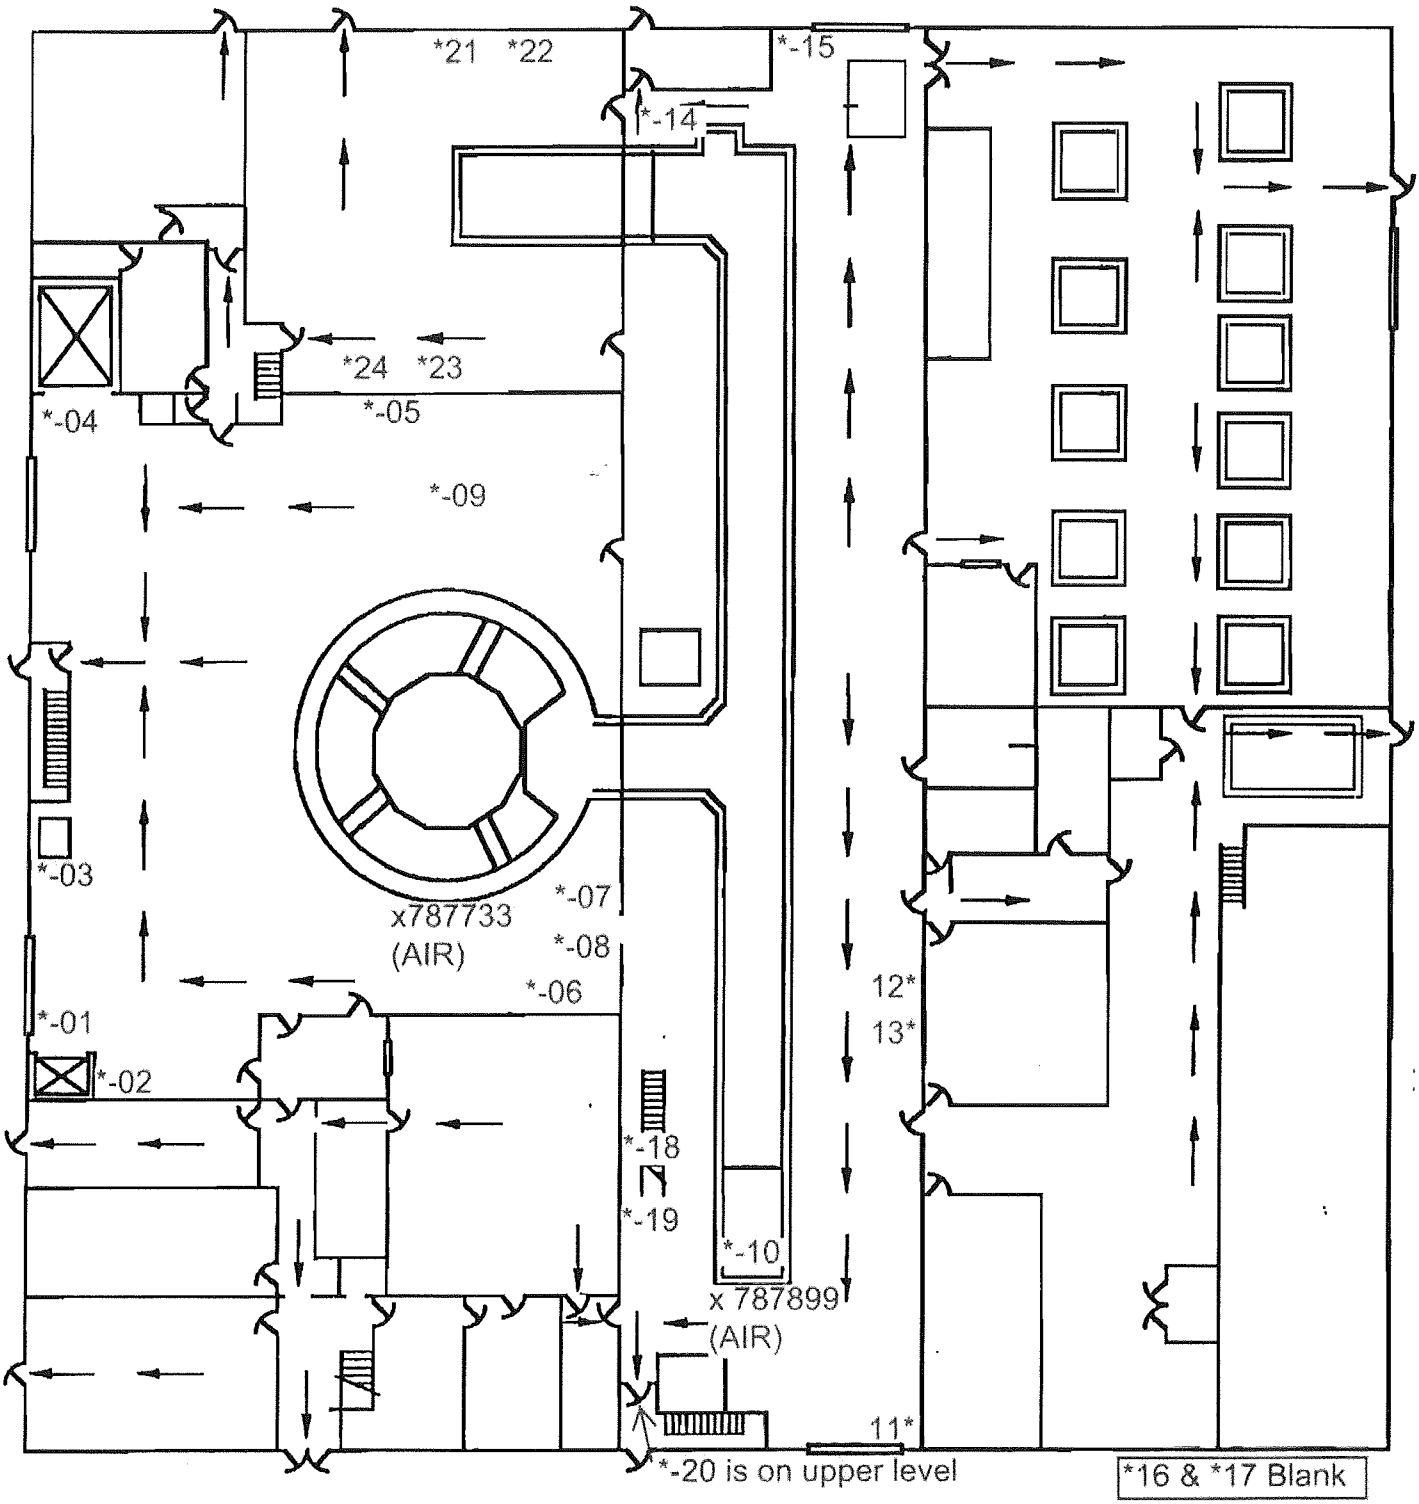
Building 670, Beryllium Sample Locations, 01/14/2010

LOCATION	ACTIVITY	AGENT	SAMPLE TYPE	MEASURED RESULTS	DATE
TRA-670, Top of Electrical Box by elevator	Sampling of building surfaces for Be Contamination.	Be	Wipe	0.029 ug/100cm^2	1/14/2010
TRA-670, Top of beam by south tool storage area	Sampling of building surfaces for Be Contamination.	Be	Wipe	<0.023 ug/100cm^2	1/14/2010
TRA-670, Top of drain pipe (roof) SW corner	Sampling of building surfaces for Be Contamination.	Be	Wipe	<0.023 ug/100cm^2	1/14/2010
TRA-670, Leak rate control box, West wall	Sampling of building surfaces for Be Contamination.	Be	Wipe	<0.023 ug/100cm^2	1/14/2010
TRA-670, NE corner under overhead ladder to crane	Sampling of building surfaces for Be Contamination.	Be	Wipe	<0.023 ug/100cm^2	1/14/2010
TRA-670, Top of Ram analog read out	Sampling of building surfaces for Be Contamination.	Be	Wipe	<0.023 ug/100cm^2	1/14/2010
TRA-670, Top of electrical junction box below phone	Sampling of building surfaces for Be Contamination.	Be	Wipe	<0.023 ug/100cm^2	1/14/2010

TRA-670, Flat surface above blue air hose reel	Sampling of building surfaces for Be Contamination.	Be	Wipe	<0.023 ug/100cm^2	1/14/2010
TRA-670, East parapet wall top	Sampling of building surfaces for Be Contamination.	Be	Wipe	<0.023 ug/100cm^2	1/14/2010
TRA-670, Cinder block wall by east rollup door (top)	Sampling of building surfaces for Be Contamination.	Be	Wipe	0.028 ug/100cm^2	1/14/2010
TRA-670, Top of roll up window	Sampling of building surfaces for Be Contamination.	Be	Wipe	<0.023 ug/100cm^2	1/14/2010
TRA-670, Diagonal support beam	Sampling of building surfaces for Be Contamination.	Be	Wipe	<0.023 ug/100cm^2	1/14/2010
TRA-670, Floor by canal	Sampling of building surfaces for Be Contamination.	Be	Wipe	<0.023 ug/100cm^2	1/14/2010
TRA-670, West wall, cinderblock West rollup door drainpipe	Sampling of building surfaces for Be Contamination.	Be	Wipe	<0.023 ug/100cm^2	1/14/2010
TRA-670, Horizontal beam	Sampling of building surfaces for Be	Be	Wipe	<0.023 ug/100cm^2	1/14/2010

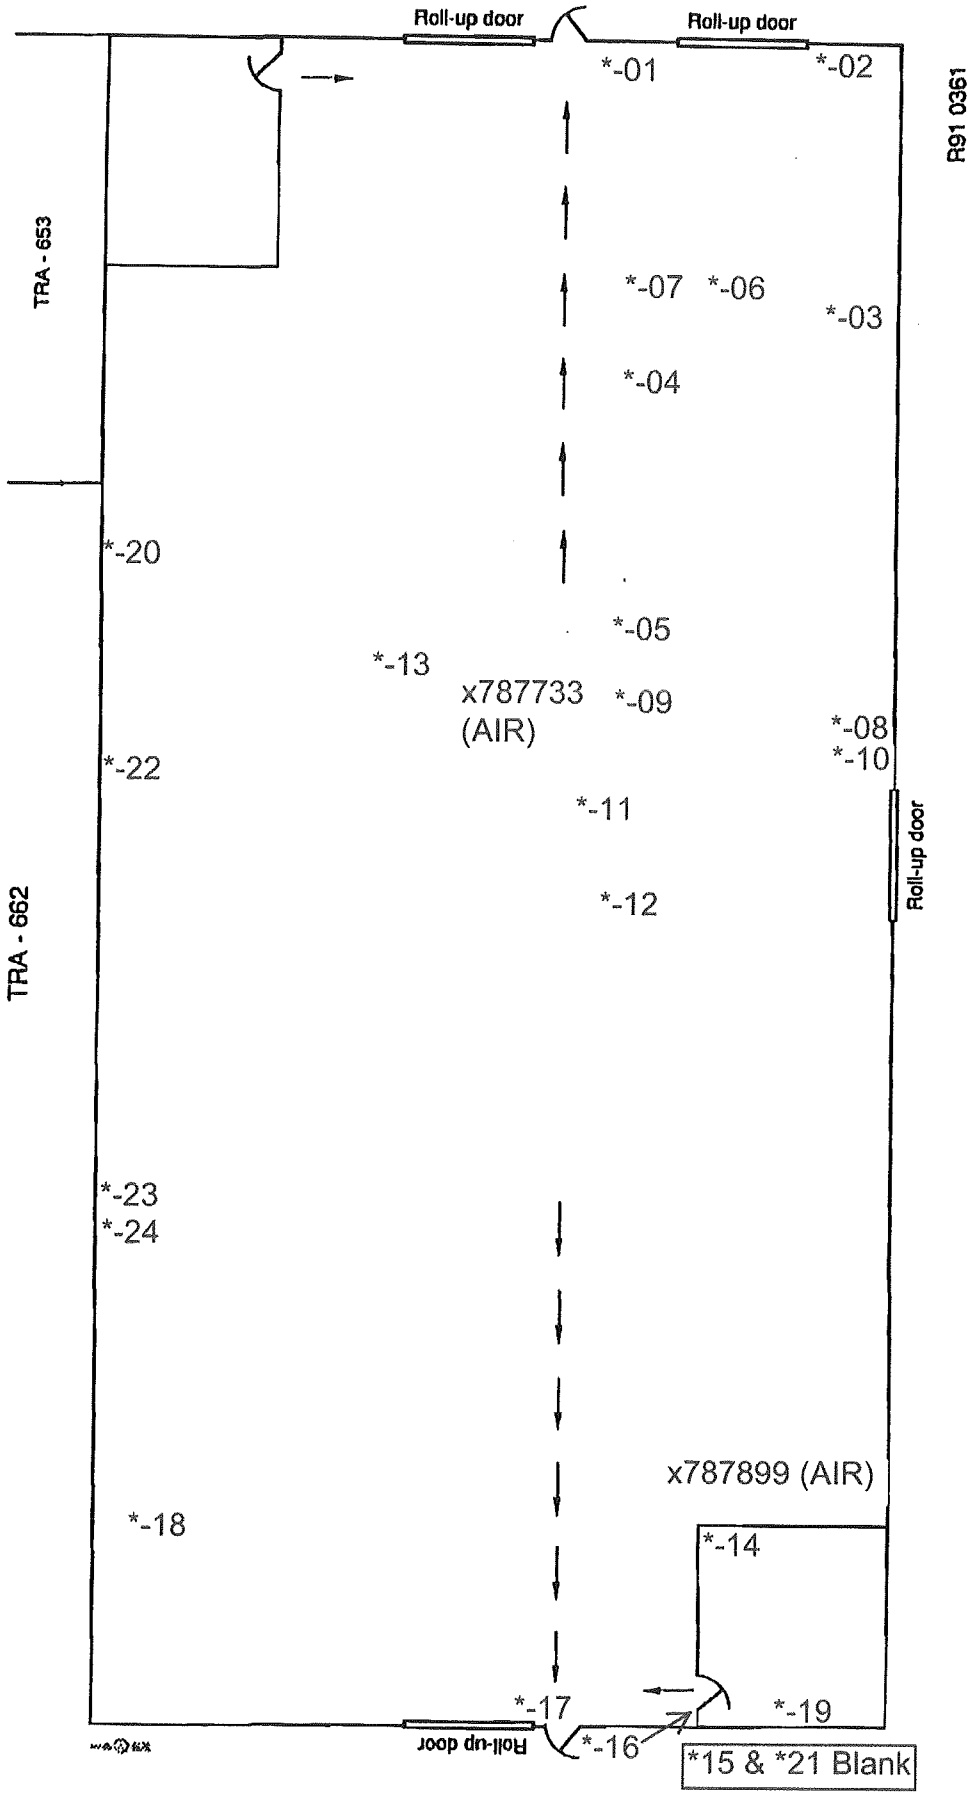
Building 662, Beryllium Sample Locations, 01/13/2010

LOCATION	ACTIVITY	AGENT	SAMPLE TYPE	MEASURED RESULTS	DATE
TRA-662, Eyeglass holder, top	Sampling of building surfaces for Be Contamination.	Be	Wipe	<0.023 ug/100cm^2	1/13/2010
TRA-662, Electrical Box, (South East roll-up door)	Sampling of building surfaces for Be Contamination.	Be	Wipe	<0.023 ug/100cm^2	1/13/2010
TRA-662, Blue air hose reel, South Wall	Sampling of building surfaces for Be Contamination.	Be	Wipe	0.034 ug/100cm^2	1/13/2010
TRA-662, South side of crane	Sampling of building surfaces for Be Contamination.	Be	Wipe	<0.023 ug/100cm^2	1/13/2010
TRA-662, Top of the King, B7L	Sampling of building surfaces for Be Contamination.	Be	Wipe	<0.023 ug/100cm^2	1/13/2010
TRA-662, Back of Shear – SHR-MA-151	Sampling of building surfaces for Be Contamination.	Be	Wipe	0.025 ug/100cm^2	1/13/2010
TRA-662, Floor by large shear	Sampling of building surfaces for Be Contamination.	Be	Wipe	<0.023 ug/100cm^2	1/13/2010

TRA-662, Electrical Box by rollup door	Sampling of building surfaces for Be Contamination.	Be	Wipe	0.067 ug/100cm^2	1/13/2010
TRA-662, Old shelf in bathroom	Sampling of building surfaces for Be Contamination.	Be	Wipe	<0.023 ug/100cm^2	1/13/2010
TRA-662, Ducting grill in resin storage	Sampling of building surfaces for Be Contamination.	Be	Wipe	<0.023 ug/100cm^2	1/13/2010
TRA-662, Top of electrical panel	Sampling of building surfaces for Be Contamination.	Be	Wipe	<0.023 ug/100cm^2	1/13/2010
TRA-662, Floor by steam lines	Sampling of building surfaces for Be Contamination.	Be	Wipe	0.039 ug/100cm^2	1/13/2010
TRA-662, Top of transformer	Sampling of building surfaces for Be Contamination.	Be	Wipe	0.025 ug/100cm^2	1/13/2010
TRA-662, Top of electrical panel	Sampling of building surfaces for Be Contamination.	Be	Wipe	<0.023 ug/100cm^2	1/13/2010
TRA-670, Top of fire riser flange SE corner	Sampling of building surfaces for Be Contamination.	Be	Wipe	<0.023 ug/100cm^2	1/14/2010
