SL-1 ACCIDENT

ATOMIC ENERGY COMMISSION INVESTIGATION BOARD REPORT

JOINT COMMITTEE ON ATOMIC ENERGY
CONGRESS OF THE UNITED STATES

JUNE 1961

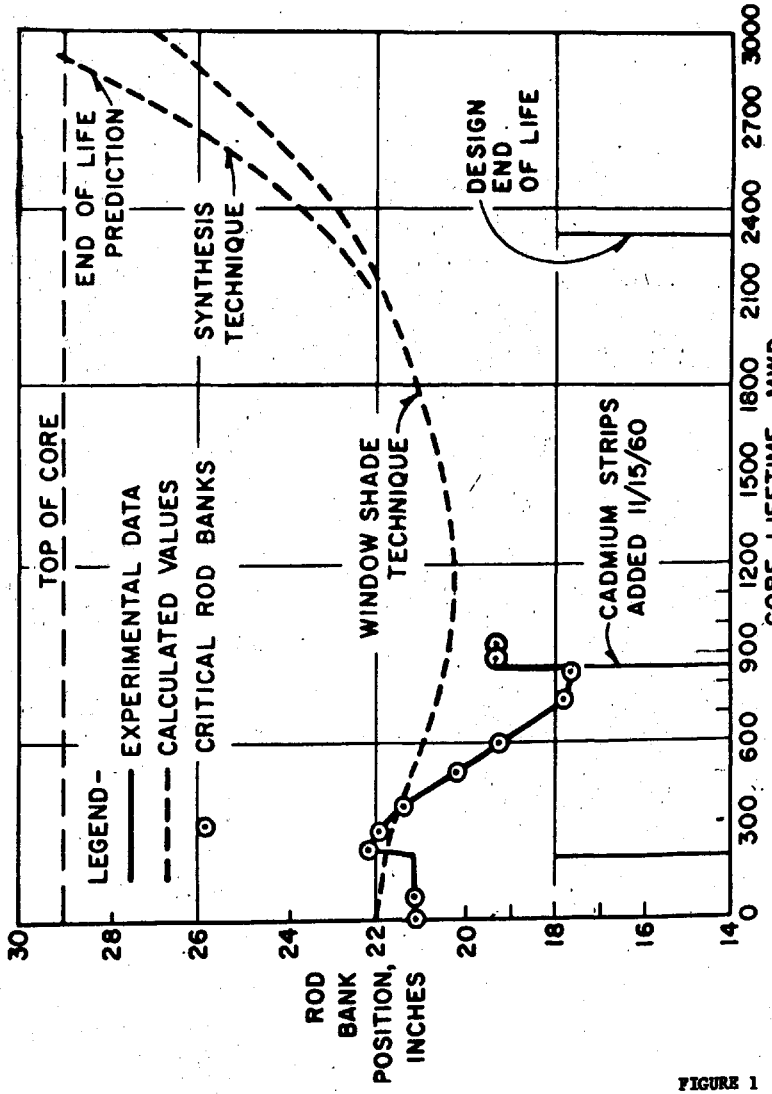
FIGURE 1

CRITICAL ROD BANK POSITION
WITH EQUILIBRIUM XENON CONCENTRATION AT 2.56 MW

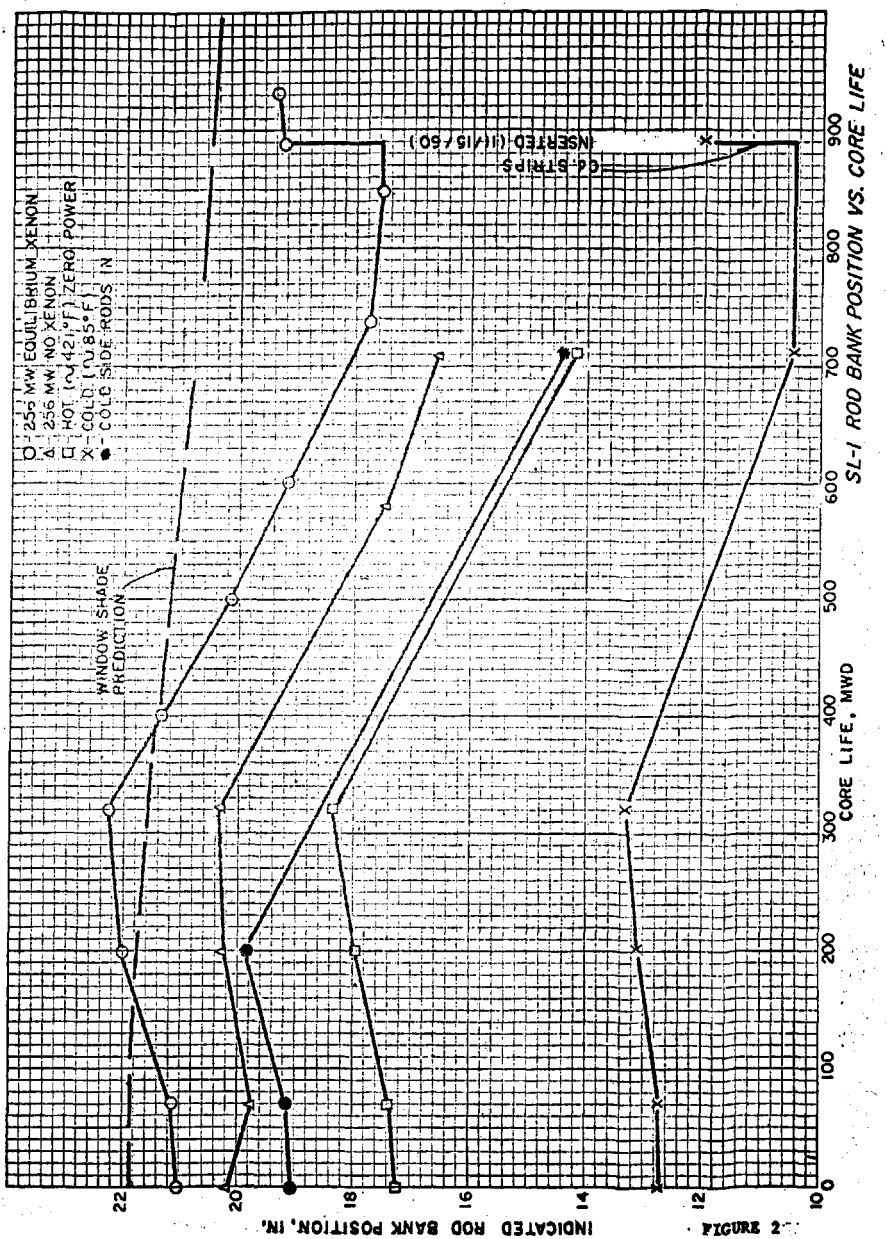
FIGURE 2

Of greater safety significance (as opposed to interest in the core lifetime only), the greater rate of reactivity gain, and, in fact, the larger amount of reactivity gain, reduced the capability of the control rods to render the core subcritical (decreased the reactivity shut-down margin). Figure 2 indicates, as a function of core exposure, the banked rod position for different operating conditions. From these data, and from estimates of the worth of the control rods, estimates of the shut-down margin were made.

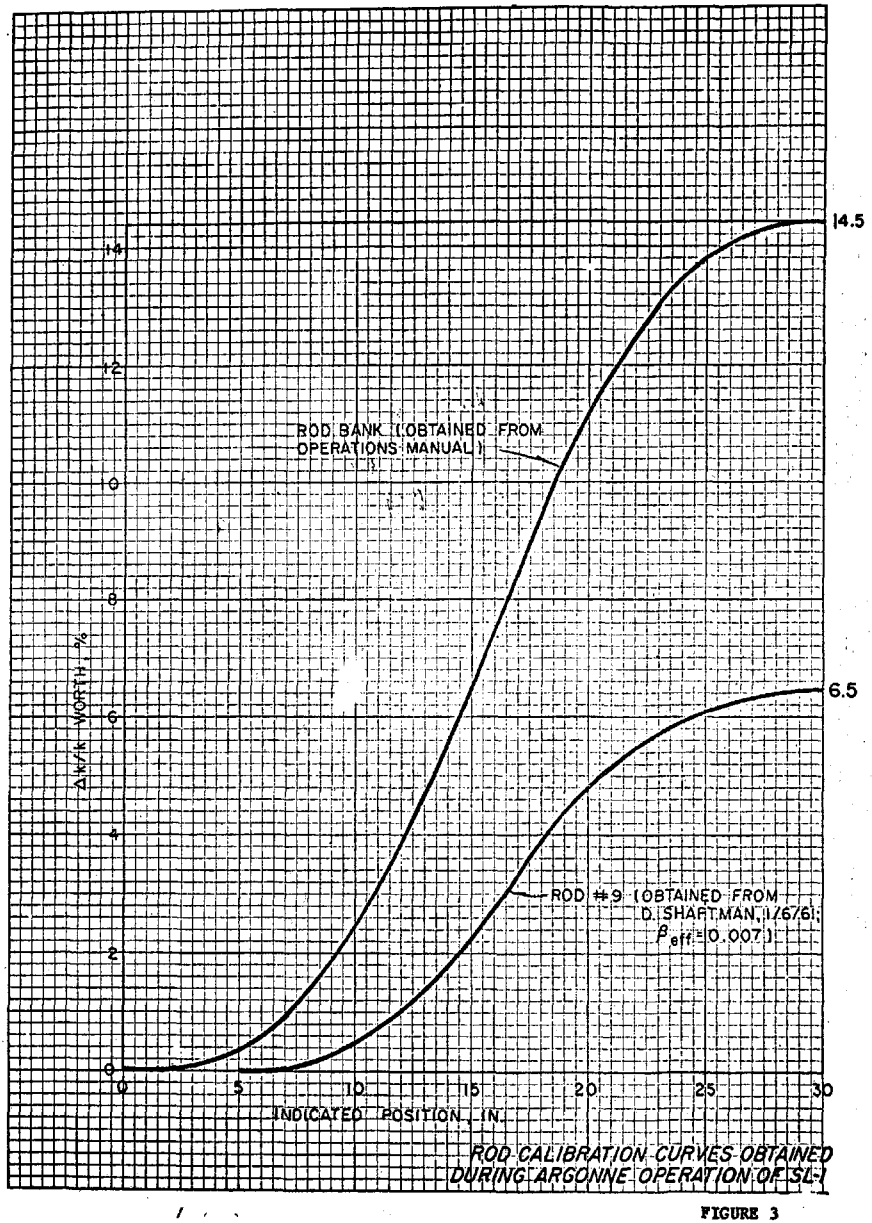
FIGURE 3

ROD CALIBRATION CURVES OBTAINED DURING ARGONNE OPERATION OF SL-1

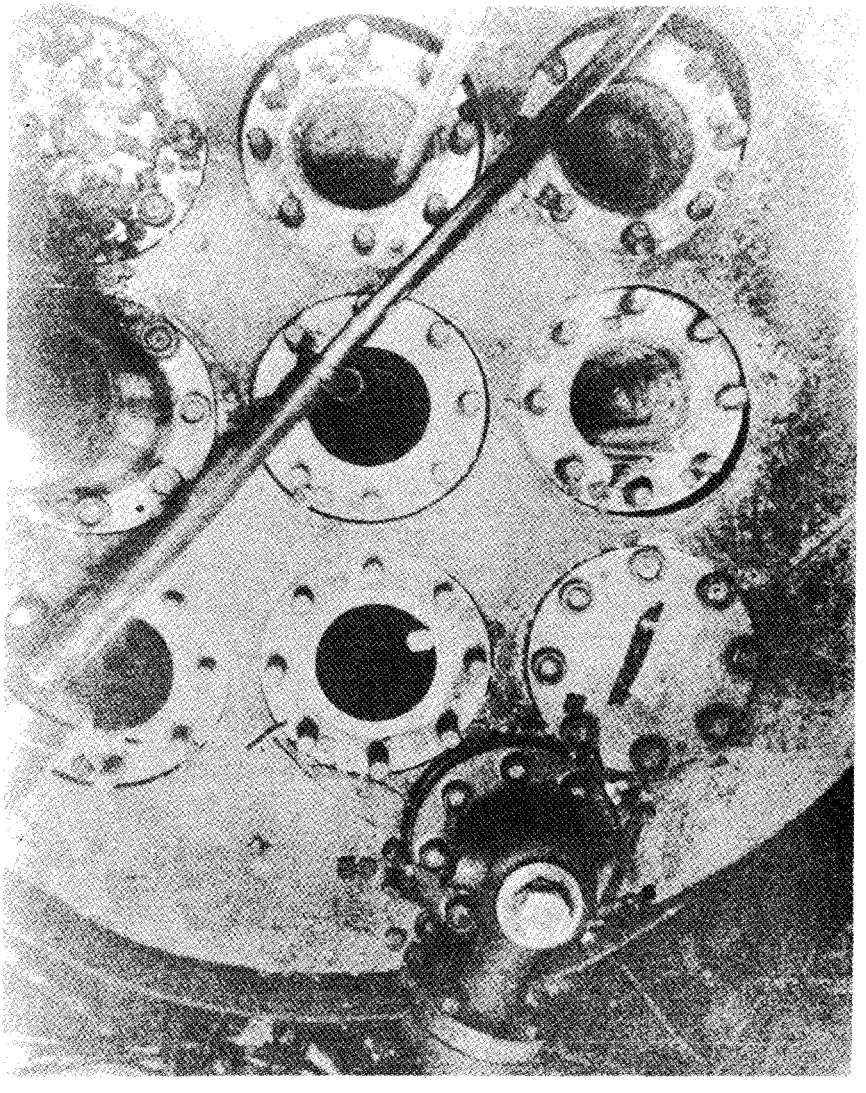
FIGURE 4

There appears to have been only minor physical damage to the reactor building. A buckling of reactor room ceiling directly above the reactor (the fan room floor) has been observed. Two of the shield plugs were driven upward out of the nozzles in the head of the reactor vessel and penetrated and stuck in the reactor room ceiling. One of these plugs was removed during subsequent operations. A peeling back of a portion of this ceiling indicates the possibility that some additional parts of the reactor system, for example, a shield plug, may have been projected into the fan room area.
