INEEL/EXT-99-00669

June 1999

Identification of the Specific Mechanism by which the CO₂ System in Building TRA-648 Accidentally Discharged

Idaho National Engineering and Environmental Laboratory

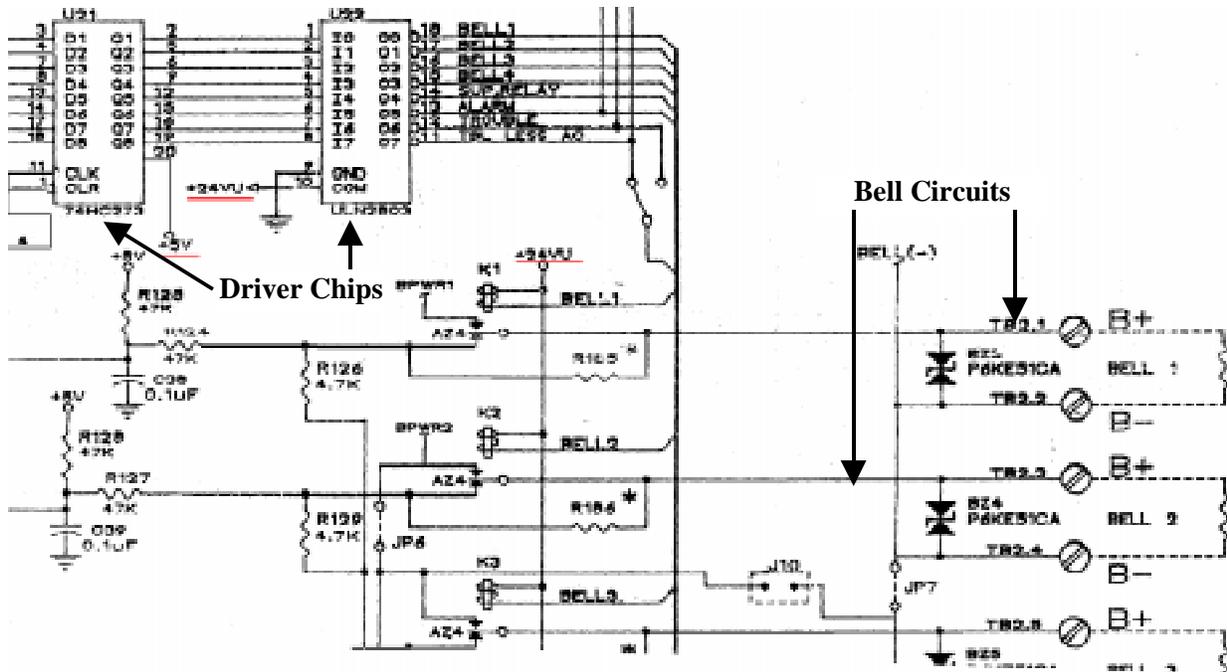
2.2.1.1 Output (bell) Circuit Analysis. The Kidde control heads for the CO₂ system at TRA-648 were connected to Bell Circuit 2 and Bell Circuit 3. Each of these bell circuits is functionally identical (see Figure 2-1). During the remainder of the circuit analysis, Bell Circuit 2 will be referenced.

Figure 2-1. Bell circuit and driver chips.

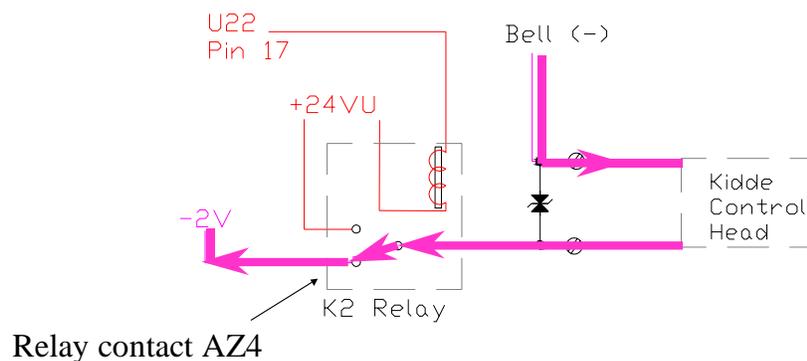
Under normal conditions (120 volts AC power supplied to the panel, no alarm condition), a small supervisory current flows from the terminals on the output circuits to the device (Kidde control heads for the CO₂ at TRA-648) connected to the output circuit terminals. Figure 2-2 shows that relay K2 is deenergized and contact AZ4 is connected to a source of supervisory voltage (~ -2 V). The fire panel monitors the continuity of the wiring connection between the terminals and the CO₂ system actuator by this current flow. An open circuit between the terminals and the actuator will prevent flow of the supervisory current and cause a “trouble” or “supervisory” alarm at the control panel.

Figure 2-2. Bell Circuit 2 in normal supervisory condition—no alarm. Relay K2 is deenergized.

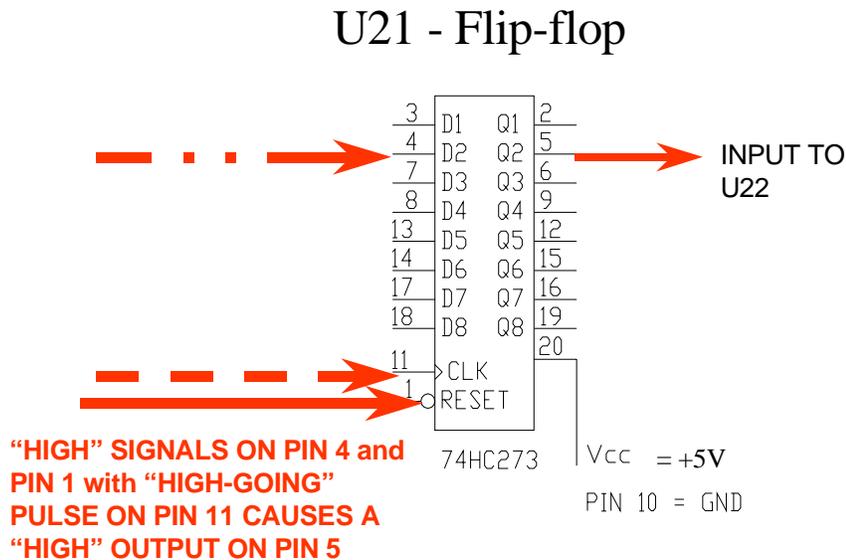
To activate a bell circuit, a high signal must exist on an input data pin of U21, simultaneously with a high signal on Pin 1 of U21, and simultaneously with a high-going pulse on Pin 11 of U21. With these three high pulses present, the voltage on the related output pin of U21 will go high and stay high until chip U21 is reset. In other words, the circuit latches. The high output signal from U21 is applied to the connected input pin of U22 causing the related transistor in U22 to operate. Key points of the U21 flip-flop include:

- Specified operating voltage +2 to +6 volts direct current (DC)
- High output signal occurs when (1) high signal on reset pin, (2) high signal on data pin (3) high-going signal on clock pin occur simultaneously
- High output signal latches until chip is reset.

Figure 2-3. Operation of U21 flip-flop circuit

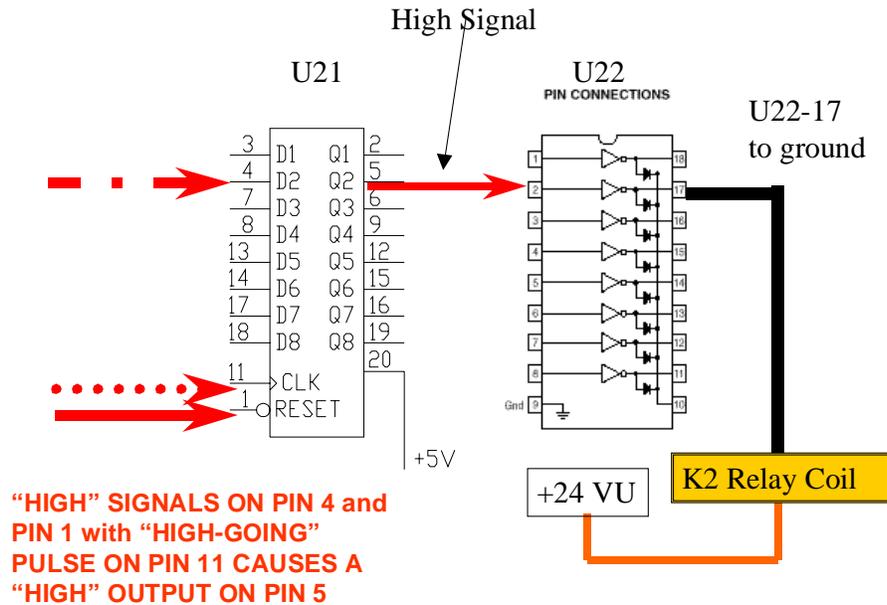
Figure 2-4 shows U21 and U22 activating Bell Circuit 2. High signals at U21 provide the input signal to U22. The U22 output lead is connected to ground. Current flows through the relay coil and the relay operates.

Figure 2-4. U21 and U22 activate Bell Circuit 2.

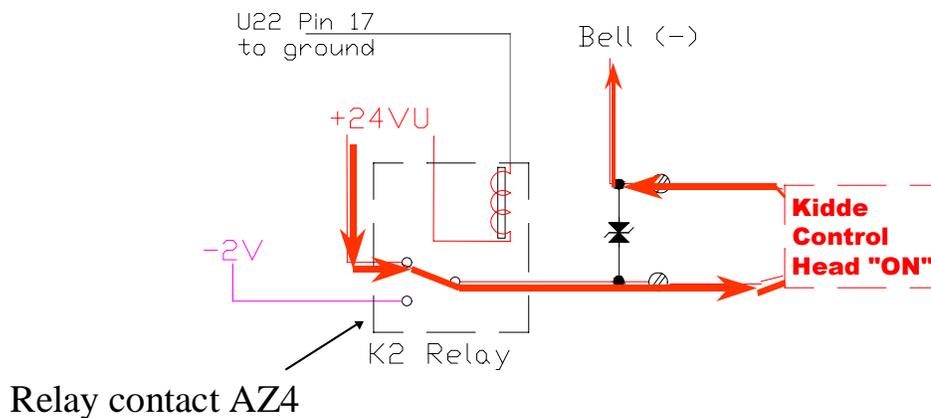
Figure 2-5 shows Bell Circuit 2 activated. When the Darlington transistor in U22 operates, Pin 17 pulls one side of the K2 relay coil to ground while the other side of the relay coil is connected to +24 volts (+24 VU). The coil is energized and the AZ4 relay contact is transferred. Terminal TB2.3 is now connected to +24 VU and the solenoid coil in the Kidde control head on Bell Circuit 2 is energized.

Figure 2-5. Relay K2 is energized activating Bell Circuit 2.

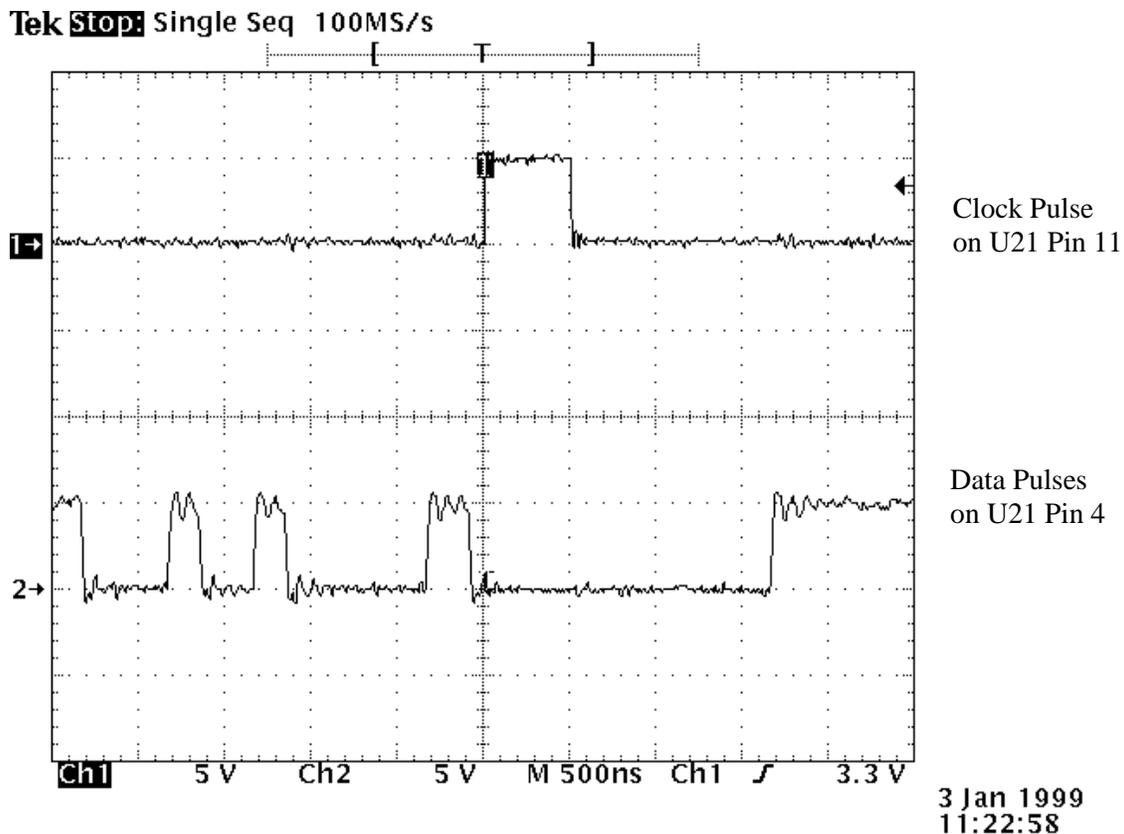
2.2.2.1 Normal Standby Operation. Figure 2-6 is a recording of pulses from the clock pin (Pin 11) of U21 and a data pin (Pin 4) of U21. These pulses are typical of those recorded when the AFP-200 panel is in normal, standby operation with no alarm. The high-going clock pulses occur every 250 milliseconds but do not occur simultaneously with the data pulses.⁸

Figure 2-6. Oscilloscope recording of typical pulses in a normal (no alarm) condition.

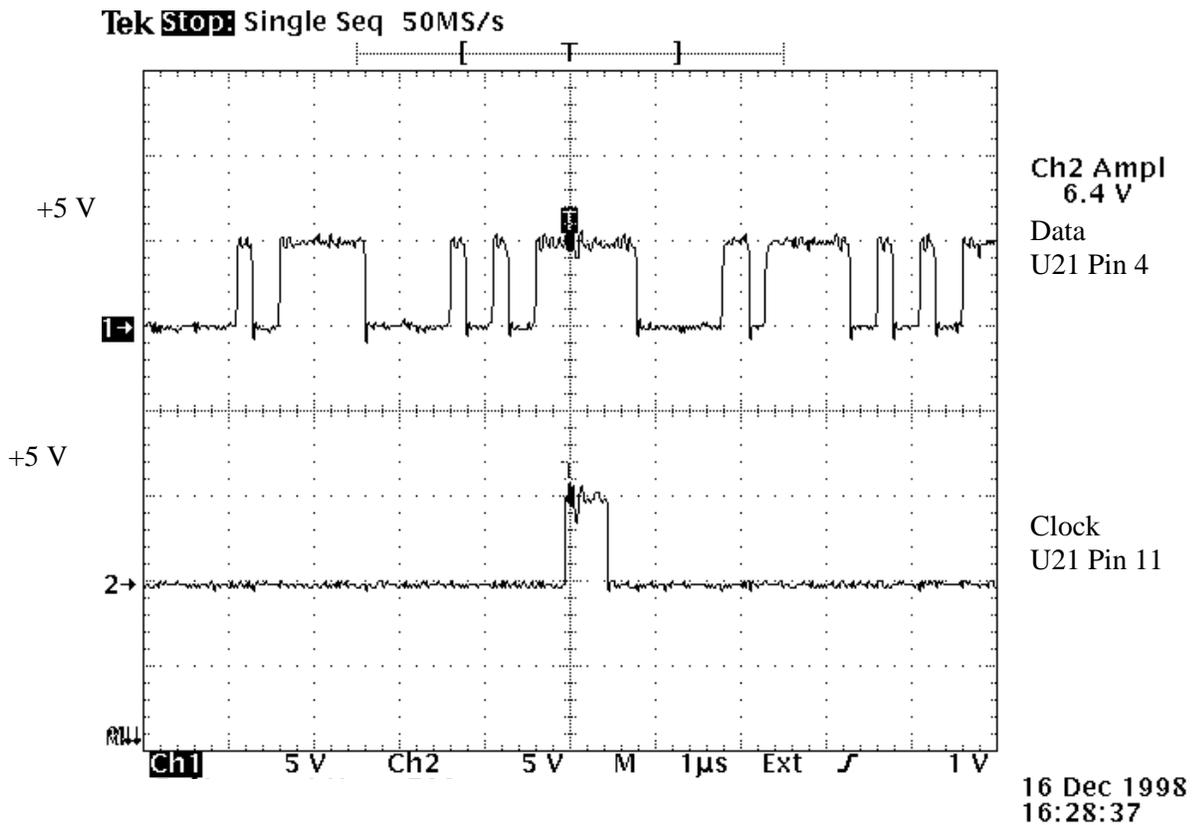
Figure 2-7 is a recording of pulses on the clock pin (Pin 11) of U21 (lower trace) and a data pin (Pin 4) of U21 (upper trace). These pulses are typical of those recorded as a manual station or detection device activates a bell circuit. Note that the high-going clock pulse occurs simultaneously with a data pulse. Also note that the peak voltage on the pulses is approximately 5 volts. The reset pin of U21 (Pin 1) is also high and a high signal on the associated output, Pin 5, of U21 results. The transistor connected to Pin 17 of U22 operates, energizing Relay K2 to energize Bell Circuit 2. These pulses were recorded when the bell circuit was activated by operation of a manual station connected to the TRA-648 fire alarm control panel.

Figure 2-7. Oscilloscope recording of pulses during activation of Kidde electric release heads initiated by operation of a manual station.

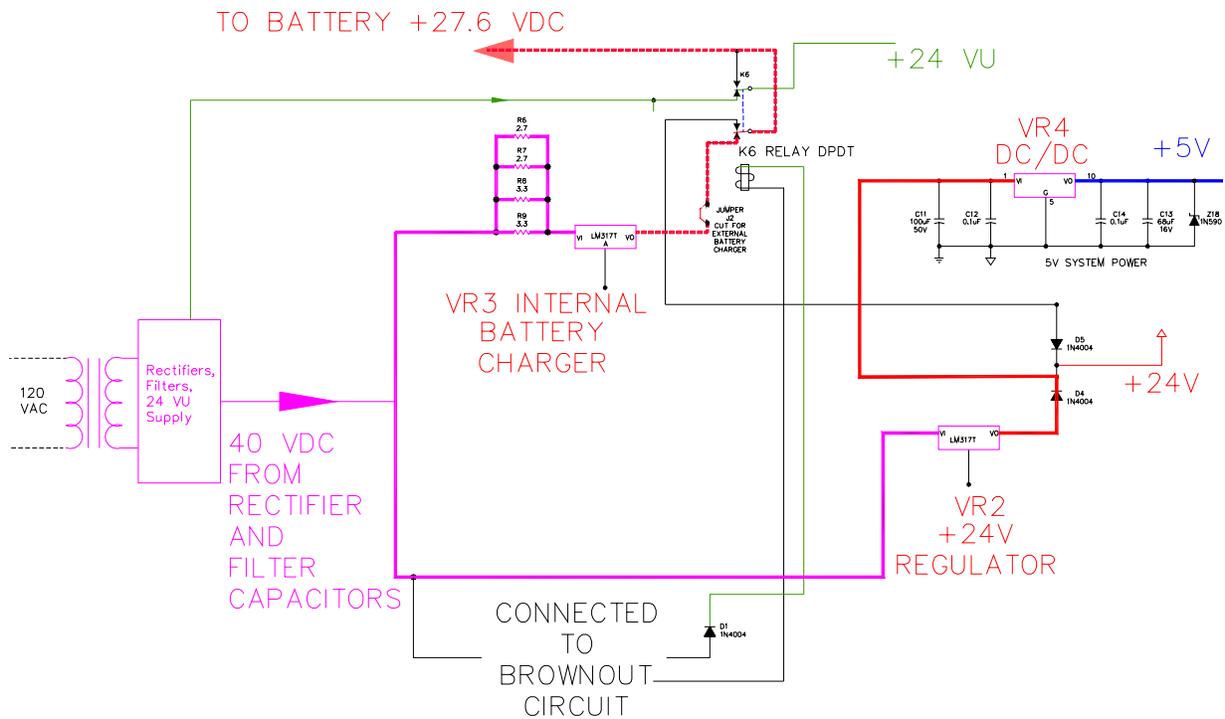
2.2.3.2 AFP-200 Power Supply Circuit. If the required capacity of the standby batteries for the AFP-200 fire alarm system does not exceed 20 amp hours, the internal battery charger in the AFP-200 panel may be used. This arrangement is depicted in Figure 2-12. The components essential to the current discussion are included.¹⁴ This figure shows the power supply condition with 120 volts AC power connected to the AFP-200 panel.

Figure 2-12. Simplified diagram of internal power supply section of AFP-200 panel.

A power transformer reduces the 120 volts AC voltage, and sets of rectifiers convert the low voltage AC to DC. Some of the DC is filtered and supplied to the input side of voltage regulators VR2 and VR3. In Figure 2-12, this voltage is labeled “40 VDC FROM RECTIFIER AND FILTER CAPACITORS.”

Voltage Regulator VR3 regulates the nominal 40 volts DC to approximately 27.6 volts DC and provides charging current to the standby batteries. This charging current is depicted by the line labeled “TO BATTERY” in Figures 2-12 and 2-13.

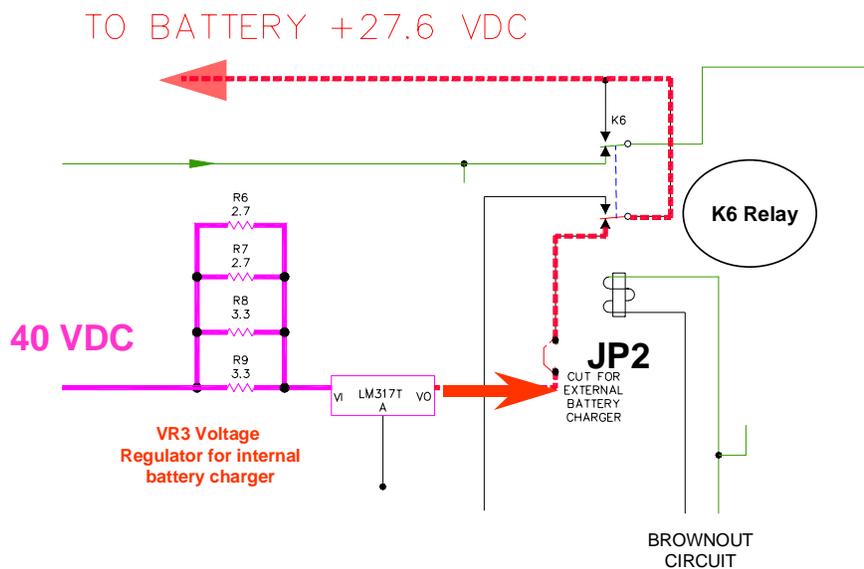
Internal Battery Charger with 120 VAC “ON”

Figure 2-13 is an enlarged view of the internal battery charger circuit showing the battery transfer relay K6 in an energized condition (sufficient AC power connected).

Figure 2-13. Enlarged view of the internal battery charger circuit.

2.2.3.3 Brownout Circuit. When nominal 120 volts AC is supplied to the control panel, the brownout circuit keeps relay K6 energized. This condition is shown in Figure 2-13. If AC line voltage falls to an unacceptably low level (approximately 100 volts or 85% of the nominal rated voltage), a brownout circuit acts to de-energize relay K6 and permit its contacts to transfer. When K6 is deenergized, the relay contacts connect the standby battery to the internal power supply circuits in the AFP-200 panel.
