FINAL REPORT
OF
SL-1 RECOVERY OPERATION

SL-1 Project
Idaho Test Station
General Electric Company
July 27, 1962

ABSTRACT

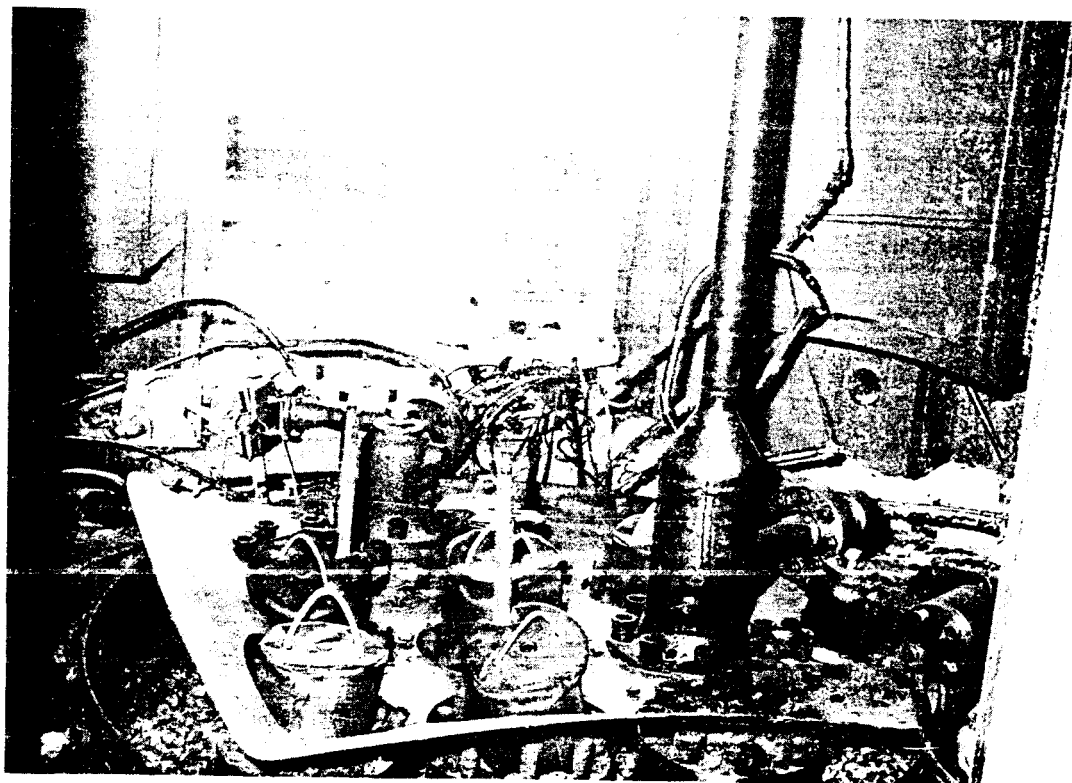
Figure II-1 Reactor vessel head after placement of shield bags

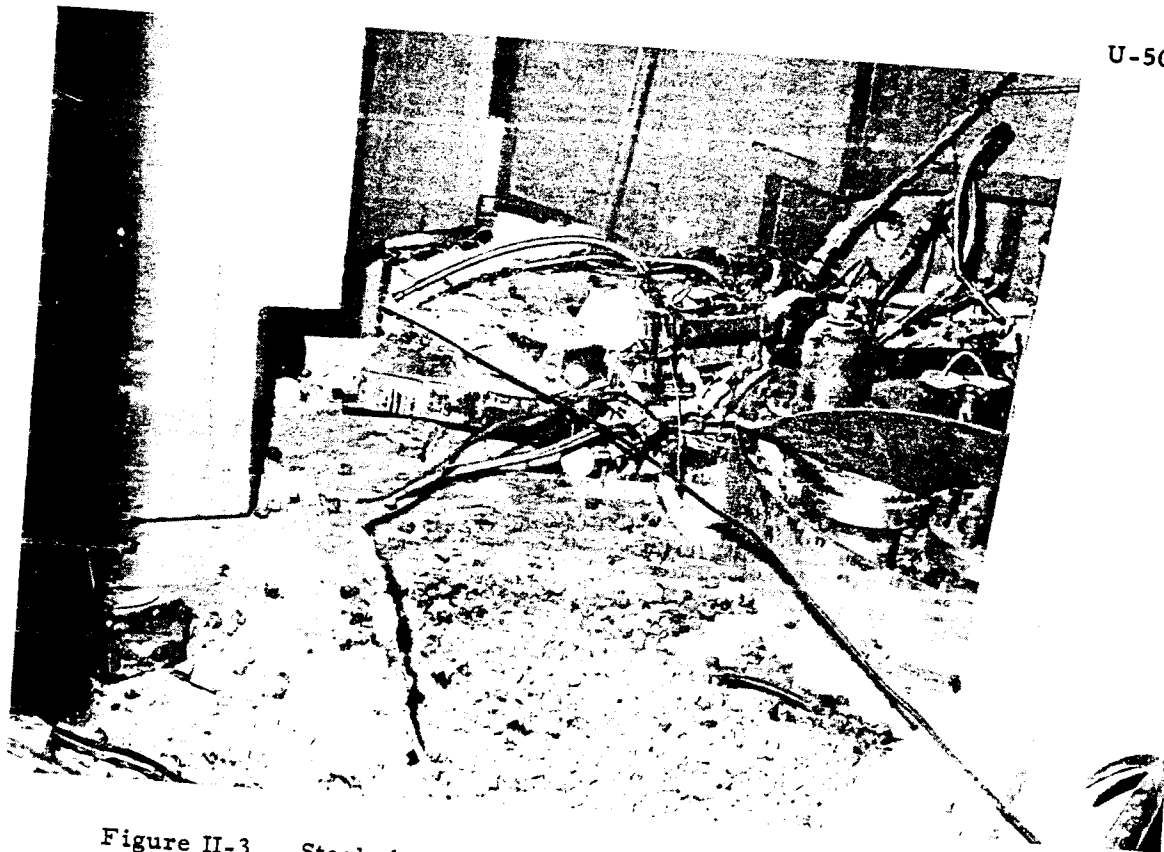
Figure II-3 Steel plate and cooling lines displaced by accident

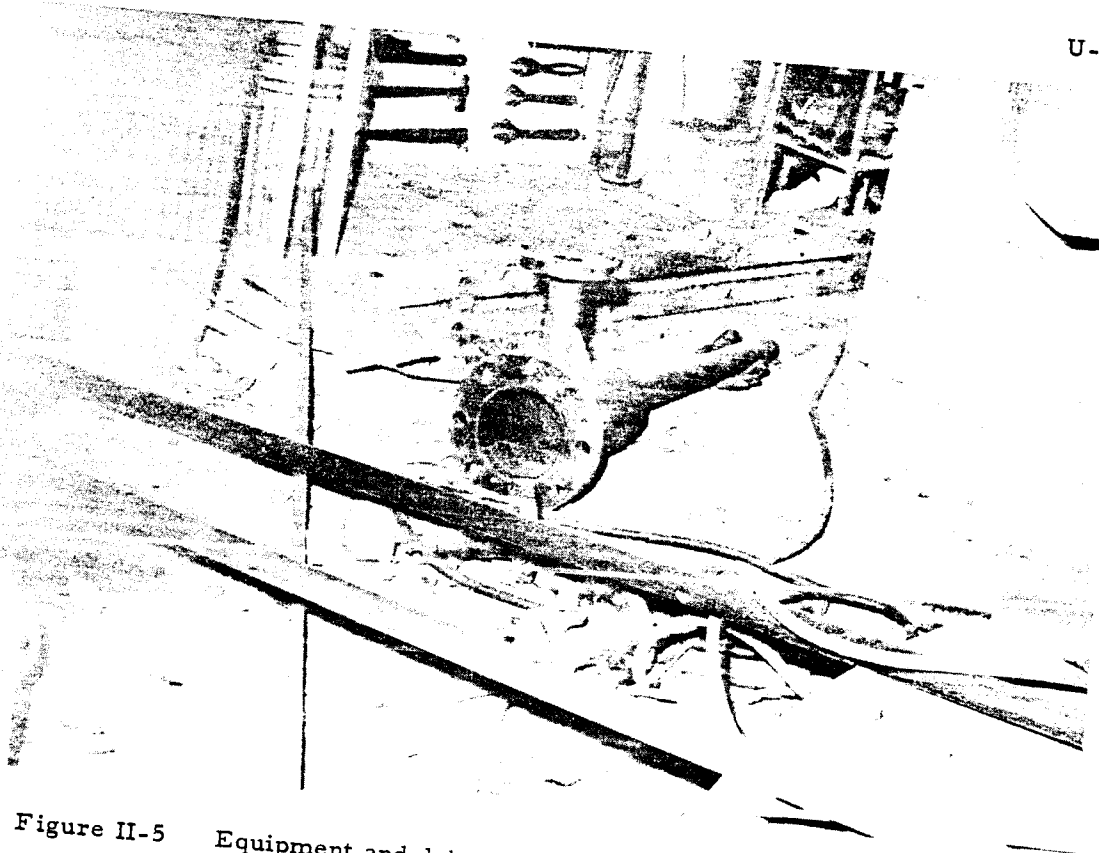
Figure II-5 Equipment and debris on floor of operating room

The most noteworthy feature about the curve is the large reduction in exposure rate obtained by the first few cleaning entries when compared to the normal decay curve above. The big items were thrown out of the building and the smaller pieces of equipment picked up during the first three entries, which resulted in a reduction of a factor of about three in the dose rate. Entries 4 through 11 were of the same general nature except that some vacuuming was done. These first 11 rough cleanings resulted in a total reduction of a factor of about 8.5. This large reduction points up the extreme value of the initial rough overall cleanup of the operating room. Also, it becomes evident that it would have been very helpful had the operating room been kept free of extraneous tools, fixtures, and equipment during normal operation and maintenance.

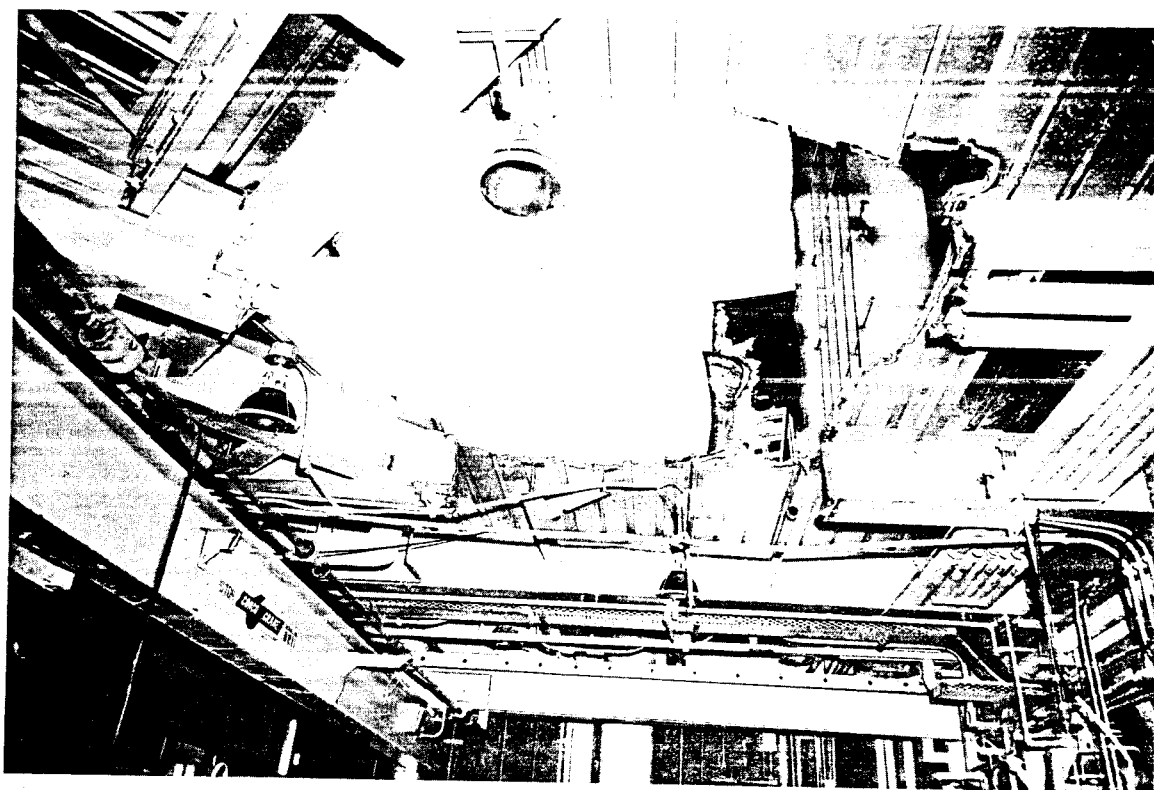
Secondly, the valley in the isodose curve between the reactor and the cargo doors indicates that the major portion of the downward streaming radiation was coming from the fan room floor rather than from the ceiling of the operating room. If most of the contamination had been deposited on the ceiling it would have been deposited on the crane also and the collimator would have seen no valley. Also, the radiation levels would have been lower on the side of the bridge crane away from the reactor because that portion of the ceiling would have been protected by the bridge crane from contamination.

Figure II-20 Operating Room Ceiling

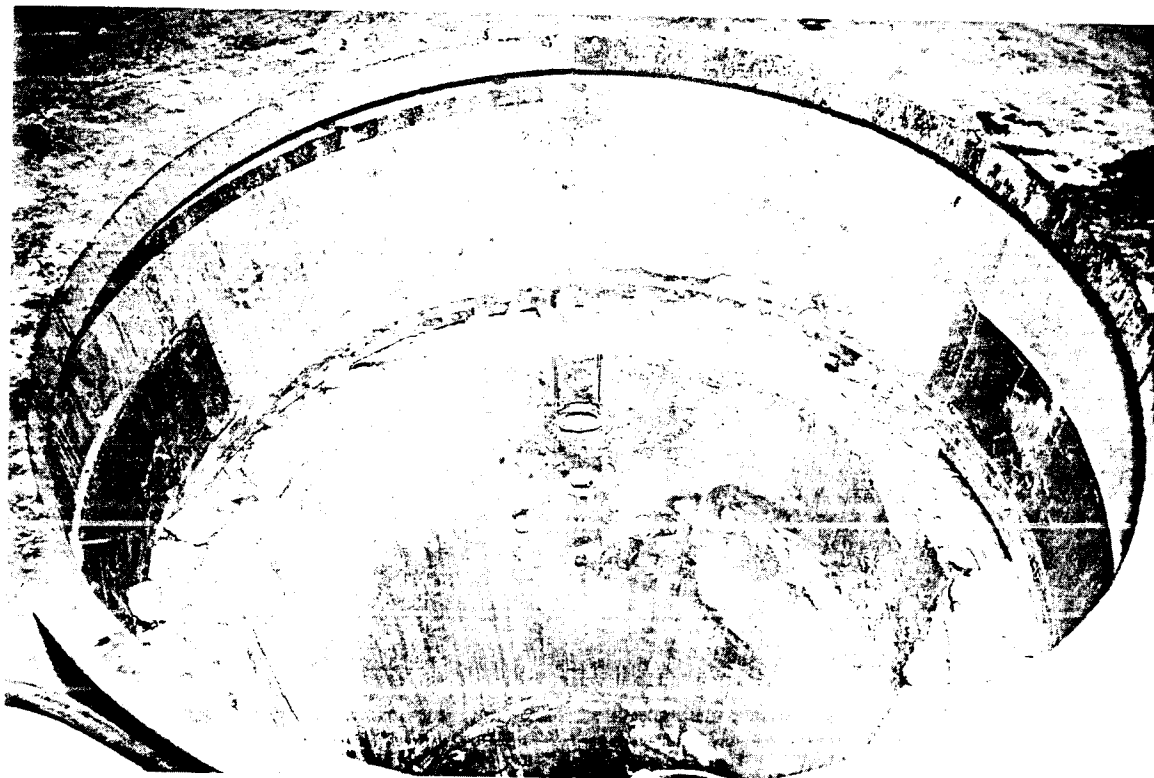
Figure II-25 Inside of Support Cylinder

Of interest was the condition of the vessel support and containment structure. Figure II-25 is a photograph looking into the support vessel. The upper surface is the operating floor, and the change in diameter about 2 feet below this is the upper edge of the insulation cover plate and the support vessel. The lower surface of the pressure vessel flange rested on this surface. The cylinder seen extending below this is the inner surface of the insulation cover plate. Protruding through this surface may be seen the sheared off ends of the five pipe entrances. The debris seen on the support vessel flange is predominantly insulation which became lodged there at the time of the incident and during the lifting operations. Figure II-26 is a photograph looking into the bottom of the support and containment vessel. As was anticipated essentially all the insulation had fallen into the bottom of the vessel. The metal straps seen in this photograph were placed around the insulation blocks to secure them to the pressure vessel. Cracks and warpage to the insulation cover may be seen in this photograph.

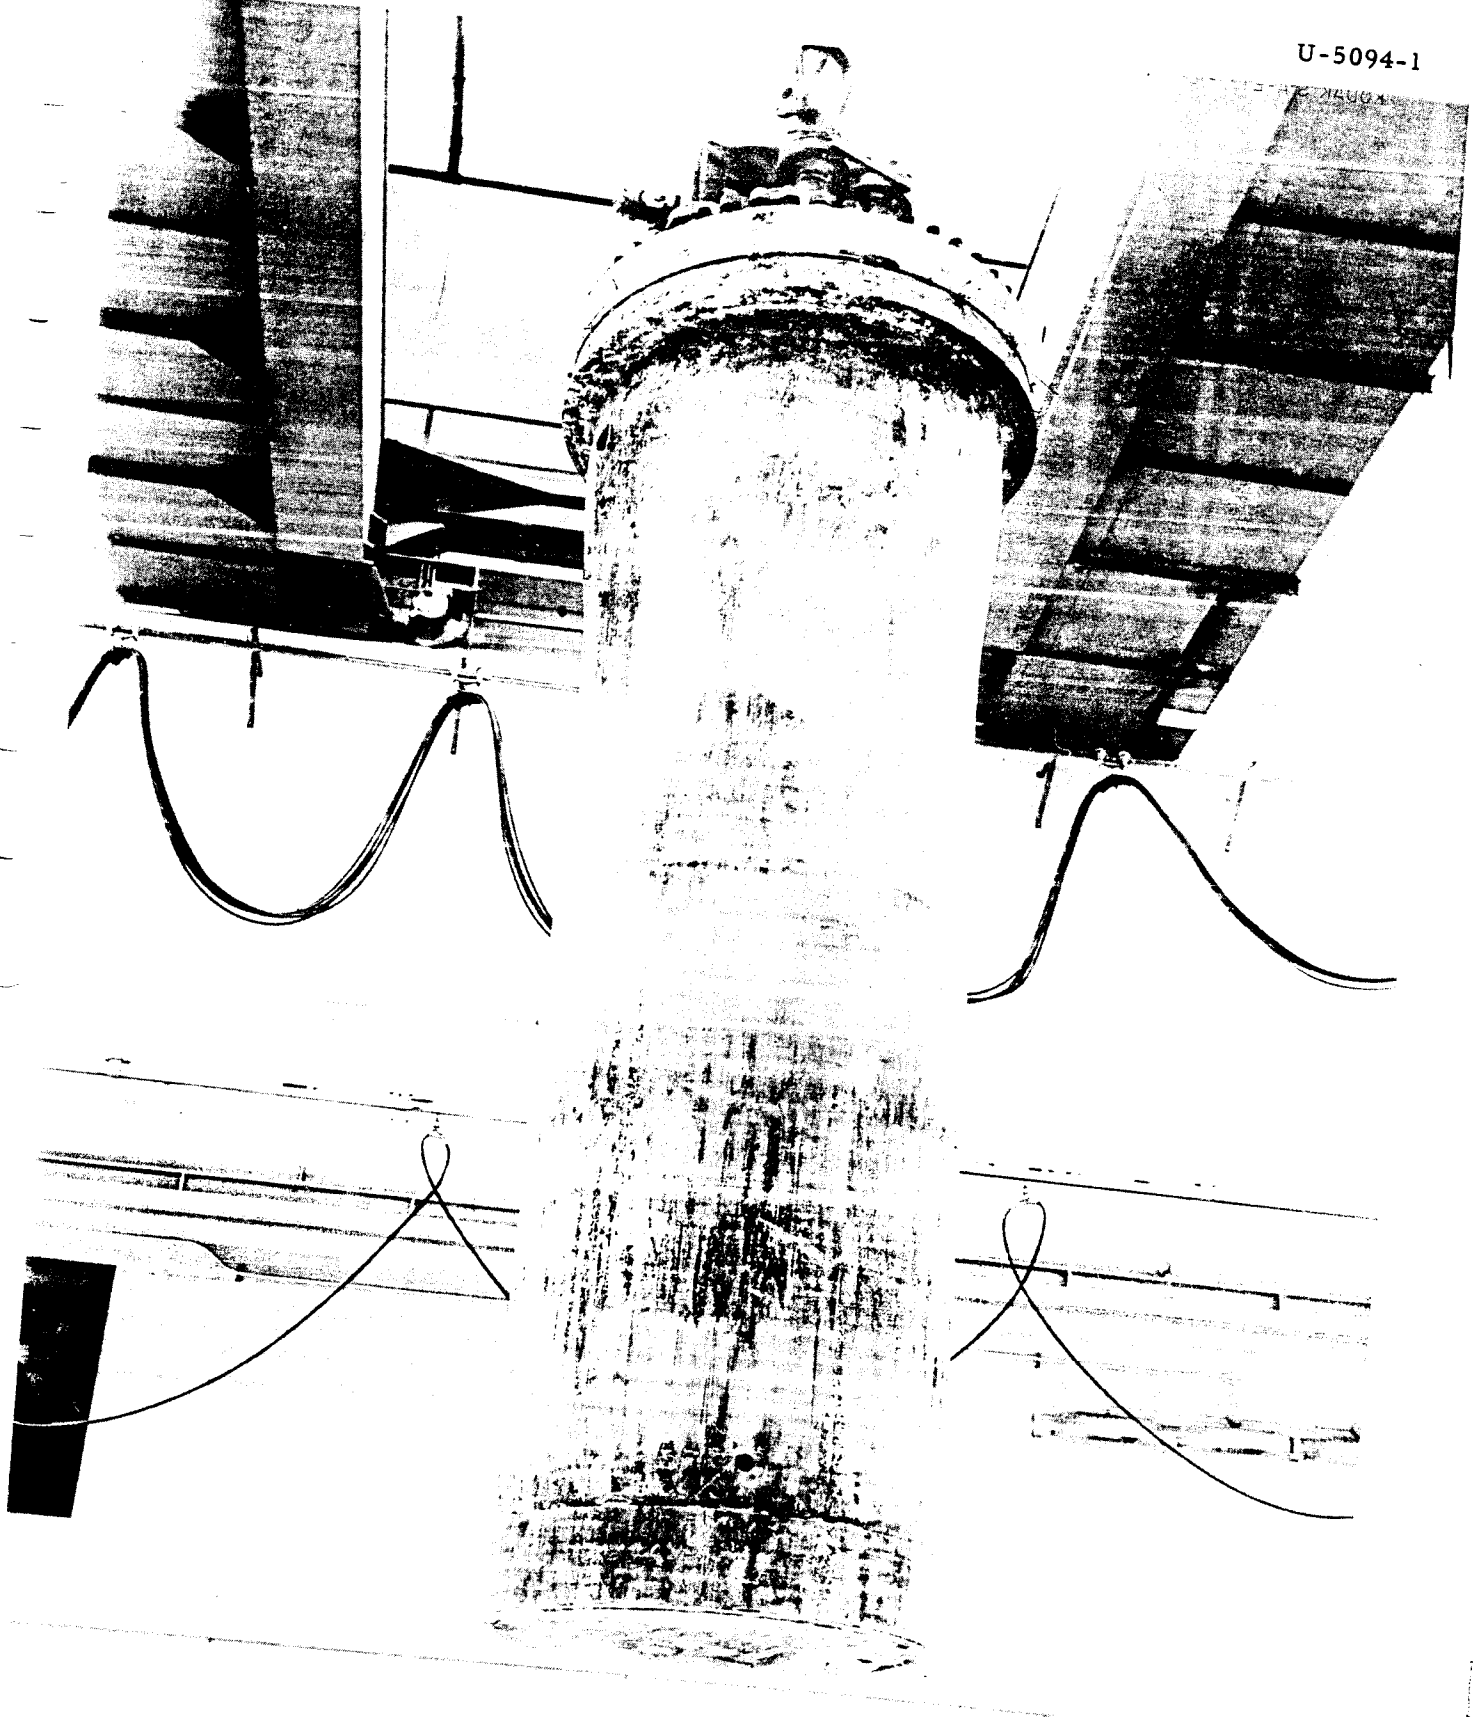
The rubberized contamination cover was stripped off the pressure vessel and the pressure vessel examined. The #7 control extension rack had shifted to a position approximately 5 inches lower in its nozzle during transit. This extension and rack had been completely separated from its control blade during the incident and had shifted slightly during lifting or transit. All major components stayed in place during transit, as far as could be determined.

Figure II-30

SL-1 Pressure Vessel

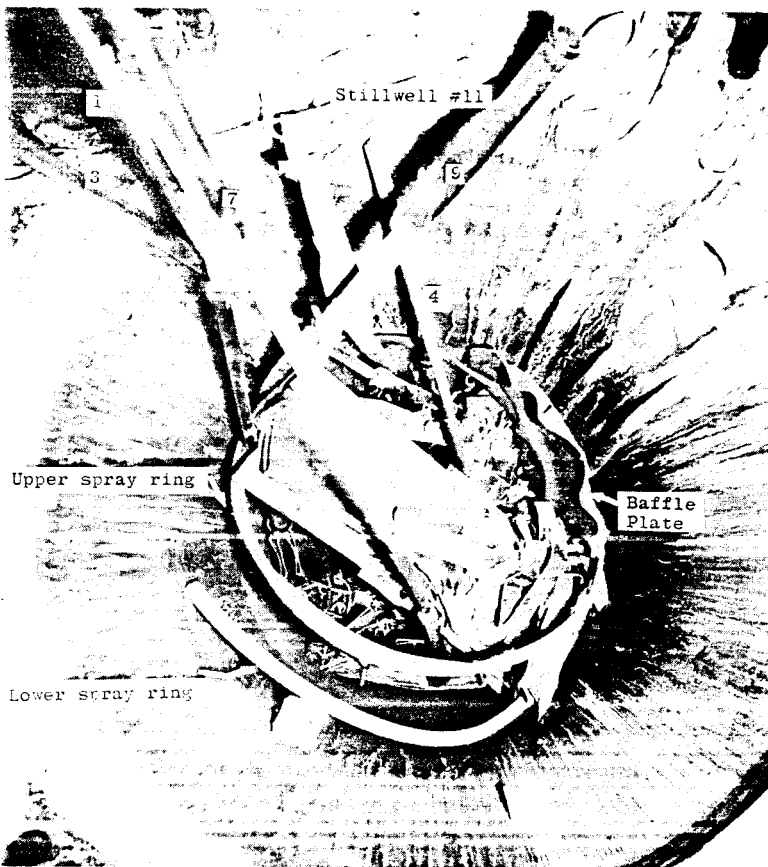
Figure II-33

SL-1 Core

The core condition when the pressure vessel head was removed is clearly shown in Figure II-33. The #9 control rod shroud, the spray rings, steam baffle, etc. can be clearly seen. The #1 and #3 control rod extensions and racks were still attached to the poison blades. All loose inert pieces and fueled pieces more than six inches above the remaining core volume were removed to make ready for a critical experiment. An inventory of all pieces removed was kept and checked off against photographs of the core. These operations were performed with a long armed manipulator while observing the work in a mirror. Photographs were taken at each significant stage of the dissection using a remotely operated 4 x 5 press camera and electronic flash held over the core with a manipulator. On several occasions two photographs would be made in such positions as to form a stereo pair. This assisted greatly in understanding the conditions inside the core.

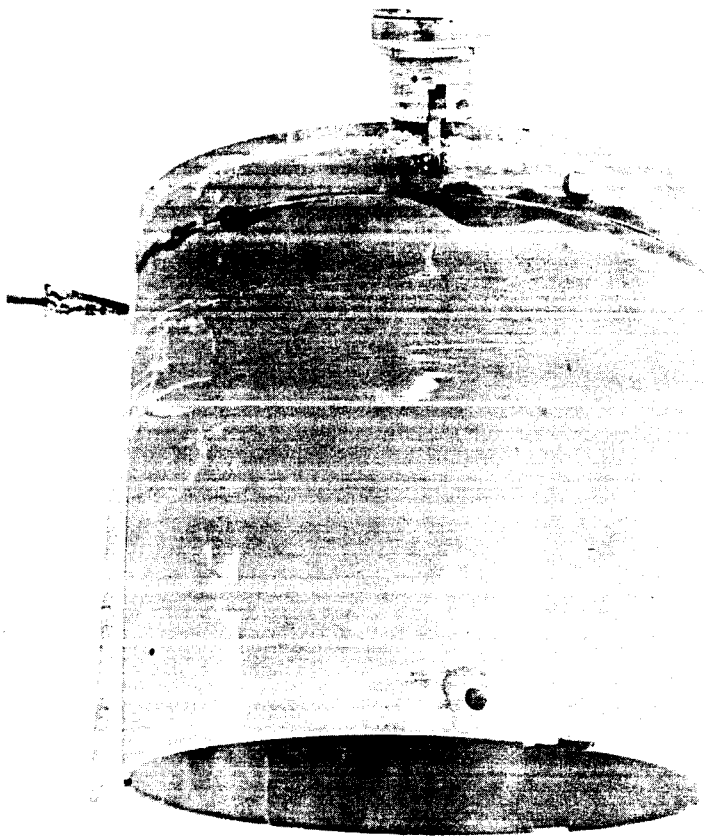
Figure II-53 Thermal Shield

The core support structure was removed. The thermal shield, Figure II-53, was lifted out with the manipulator and examined. The mid-point of the cylinder had increased its diameter by about 1/2 inch. There are eight support structure brackets attached to the inside of the thermal shield. Two of these have guide pins, three have broken hold-down studs and three have intact hold-down studs.

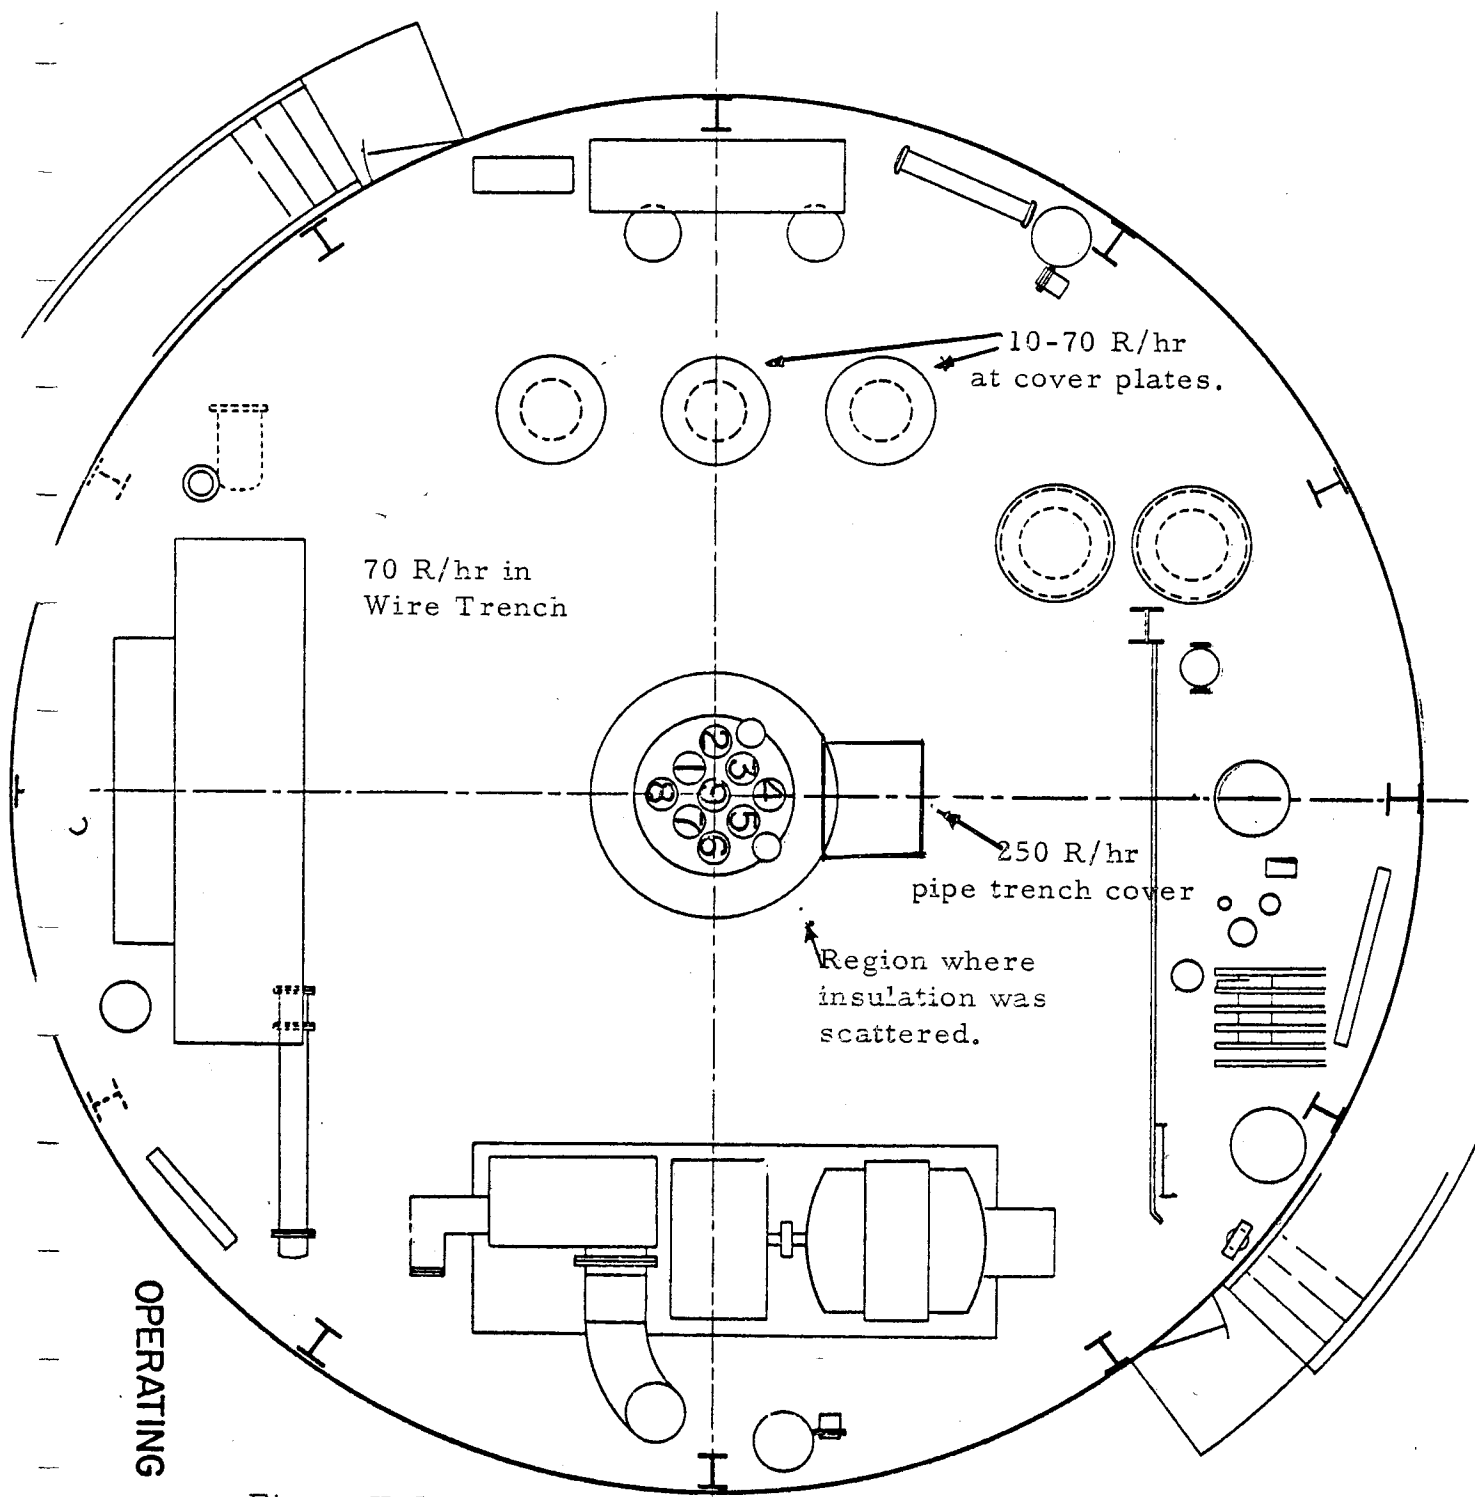
Figure II-59

70 R/hr in
Wire Trench

10-70 R/hr
at cover plates.

Radiation Hot Spots, 9-29-61.
Average waist high
Level \approx 4 R/hr

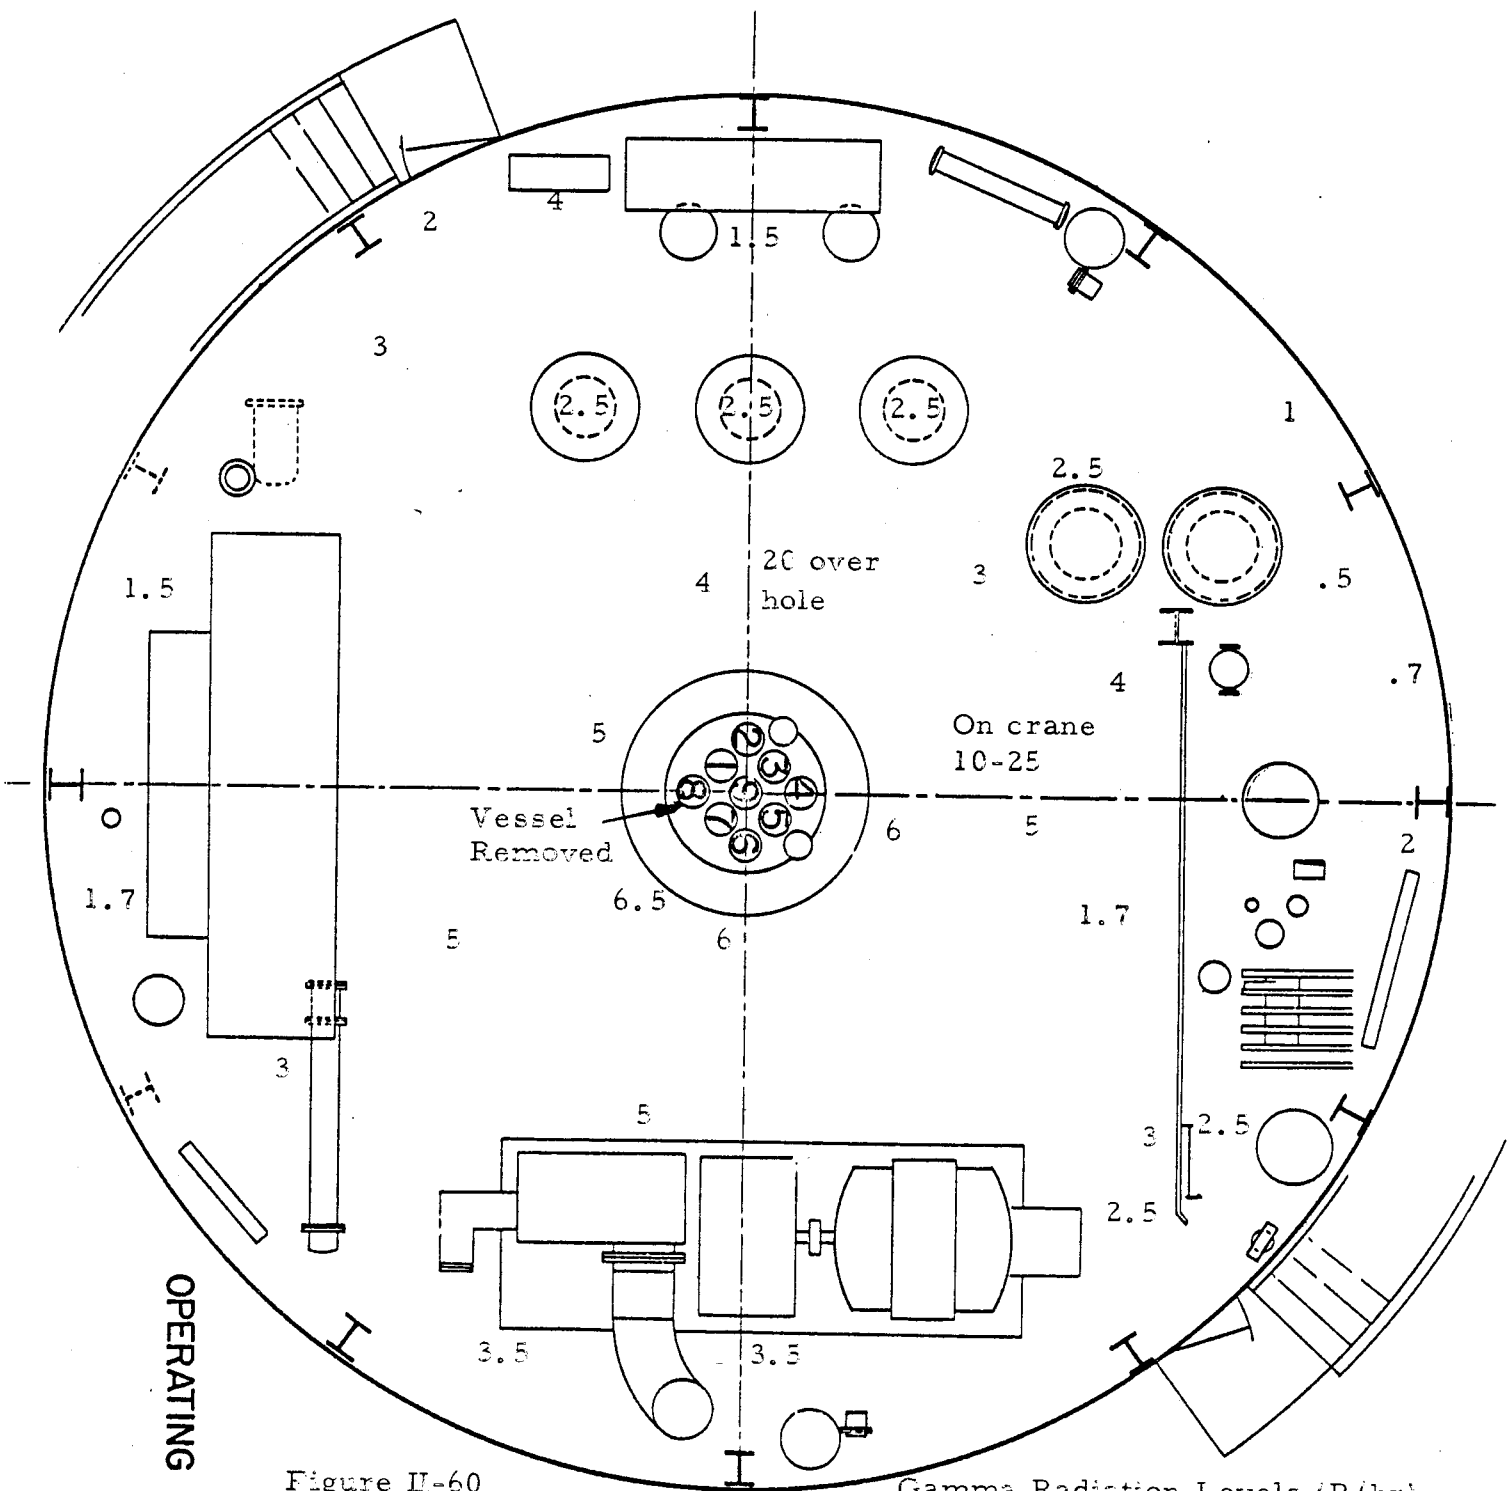
Figure II-60

Gamma Radiation Levels (R/hr)
 12-1-61
 Readings at 4' above floor.

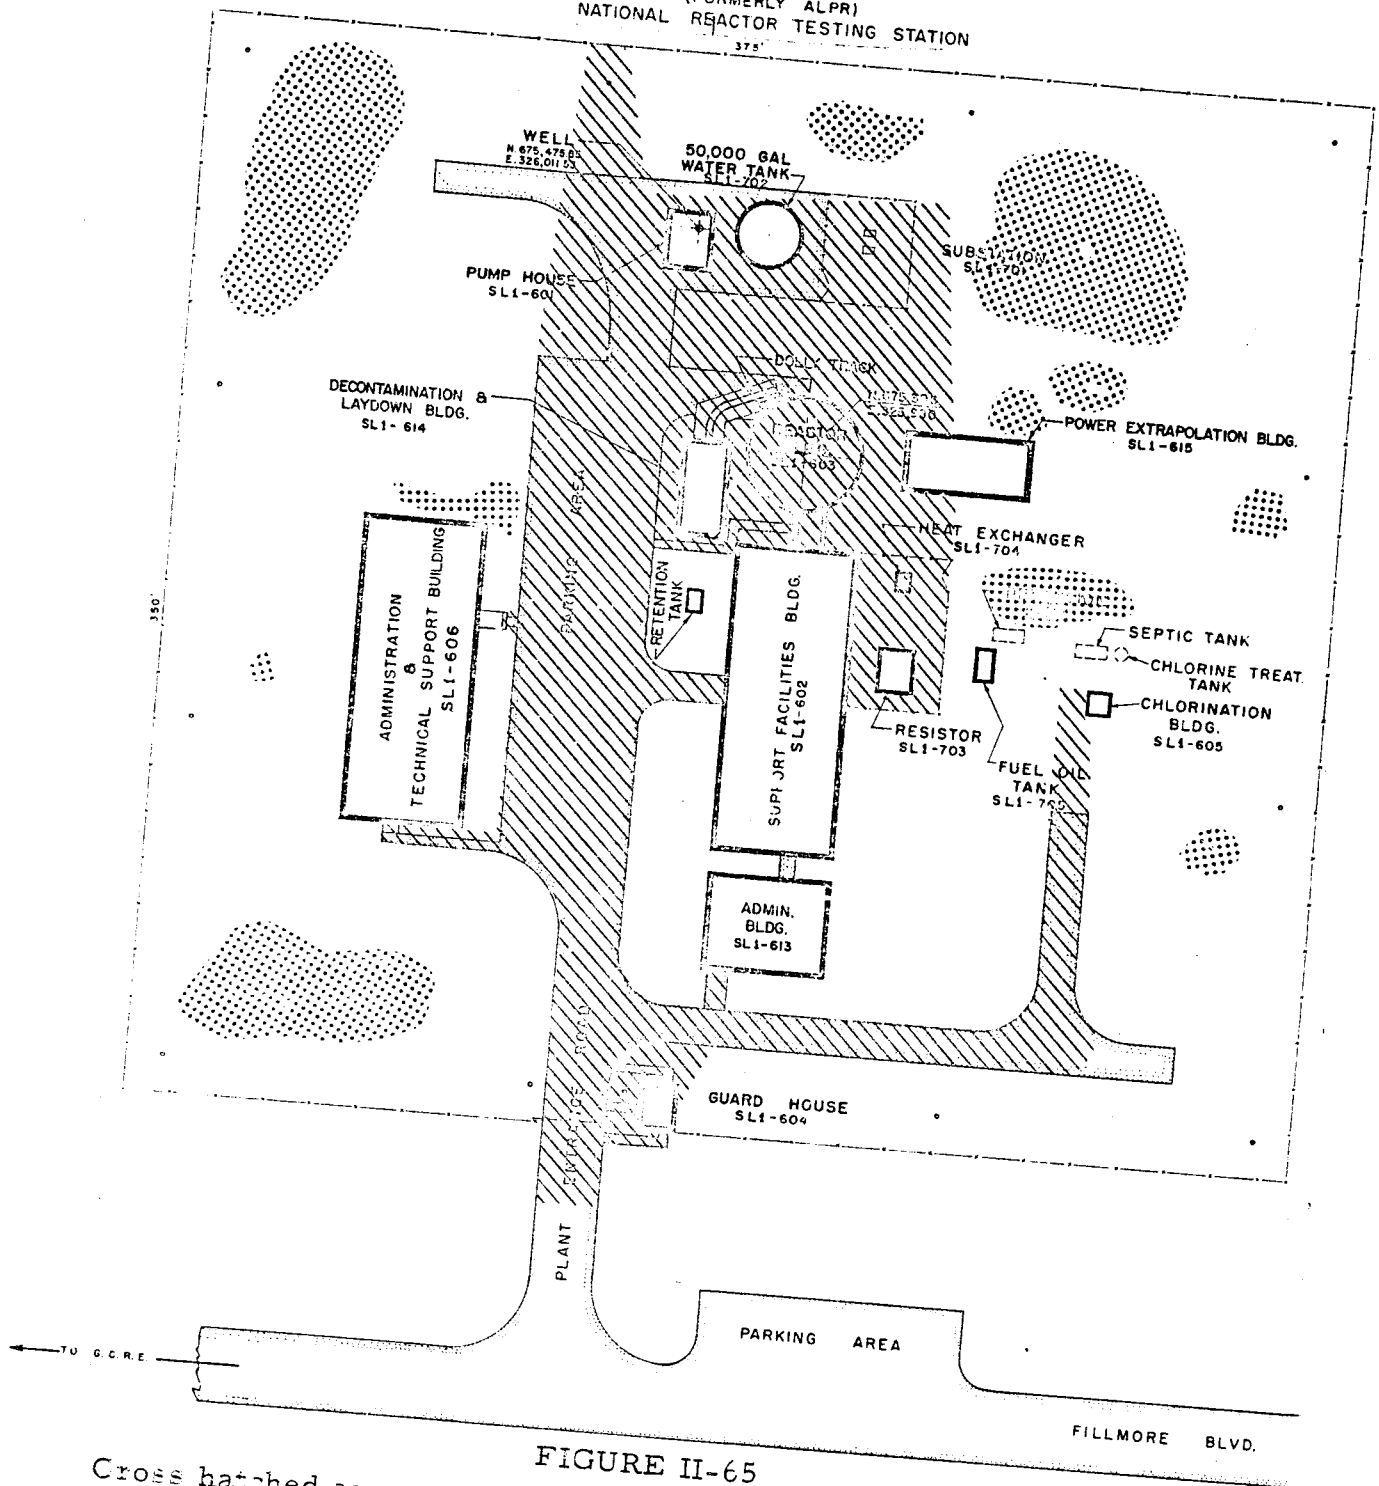
FIGURE II-65

Cross hatched area: Clean dirt replaced (< 1 mrad/hr, at contact, G.M.)
 Dotted Area: 3" to 6" dirt removed; Radioactive particles still remain.
 5 mrad/hr to 5 rad/hr at 3" above ground.
 All Other Areas: 1 mrad/hr to 30 mrad/hr at 3" above ground.

Ground not disturbed, contamination due to deposition from passing cloud

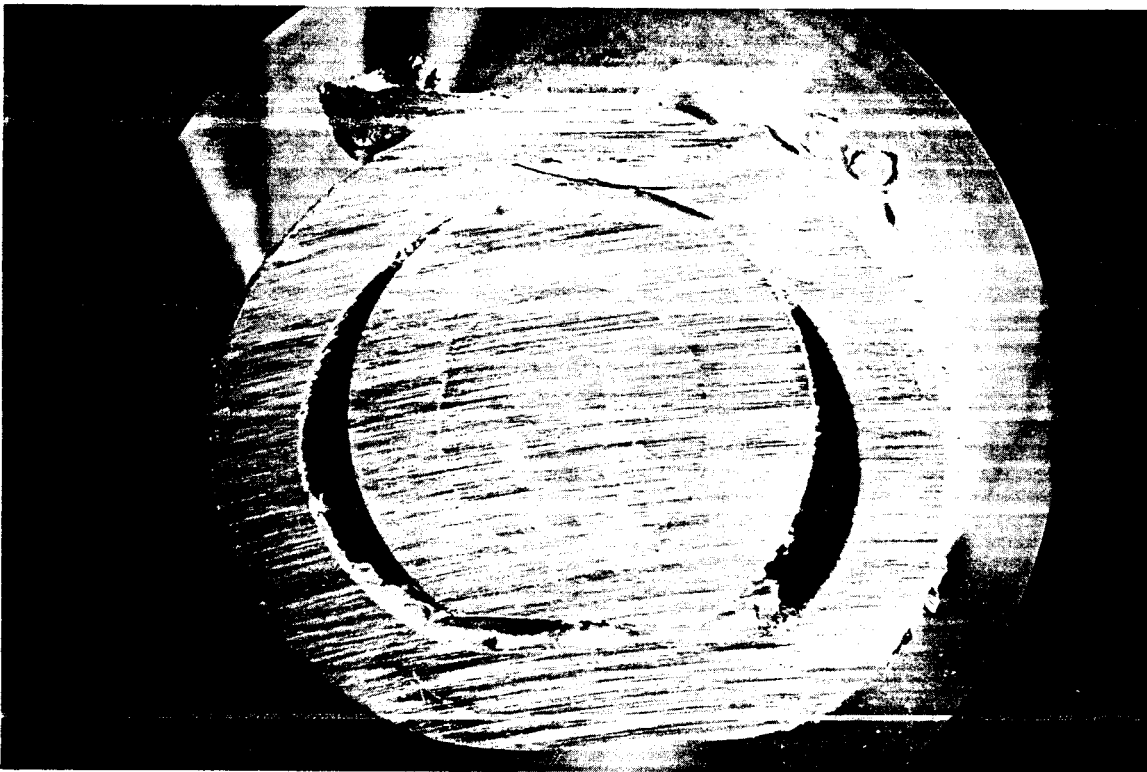
region as a 4-3/4" long section. The cut closest to the seized section revealed the pinched guide tube on the extension rod, seen in Figure III-5.

Fig. III-5, Shield Plug #9, cross section of seized extension rod by collapsed guide tube.

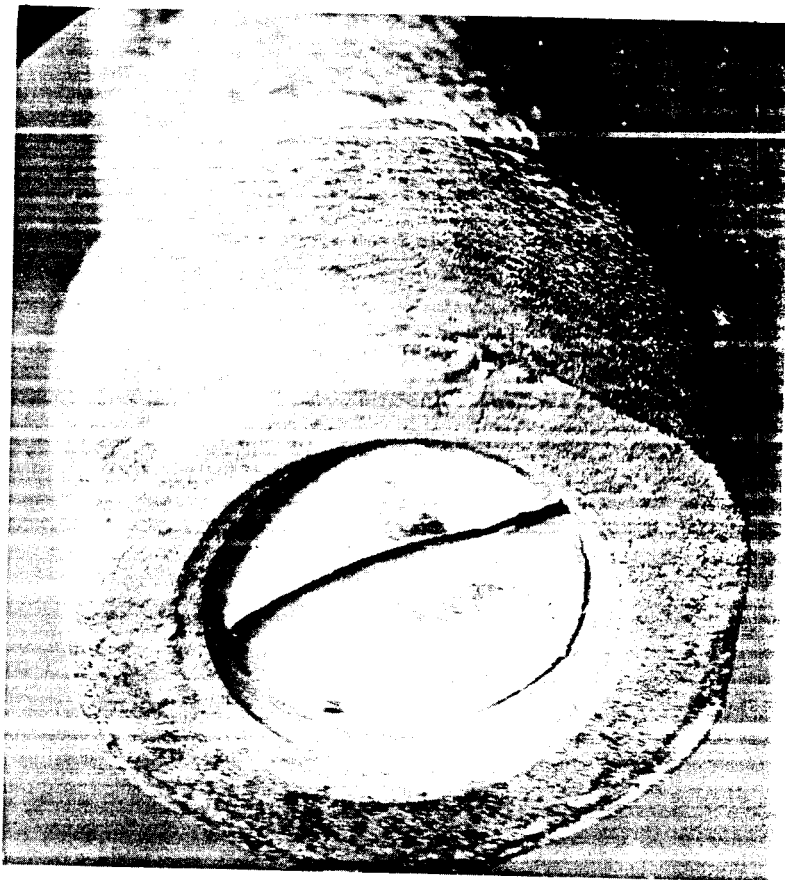
U-5081

Fig. III-12, Handling tool with broken end of #9 gear rack stud retained in tool which was found embedded in fan room floor.

Stud section found in control-rod handling tool

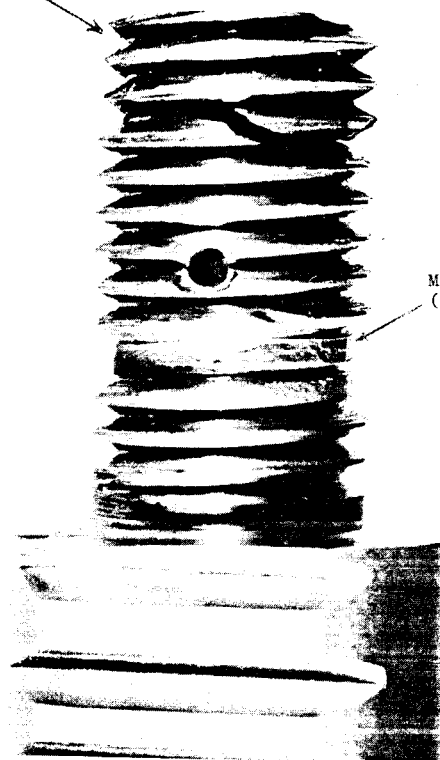
Missing thread (pre-incident)

Rack of central control-rod

Fig. III-13, Matching of broken stud of central control rod rack.

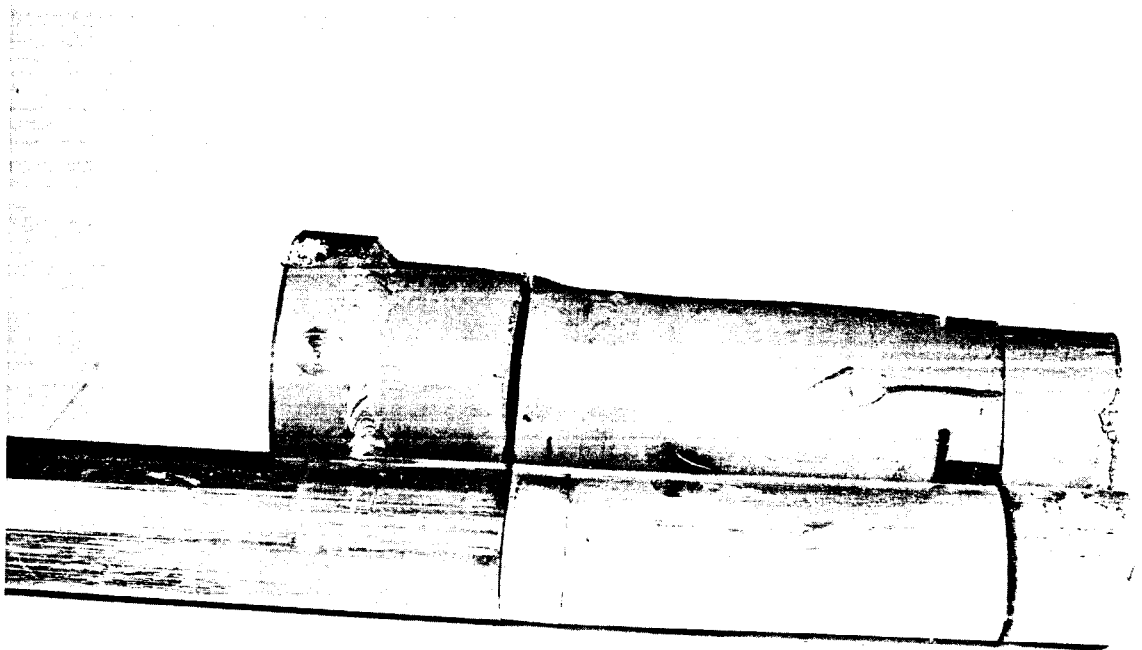
Slide marks are evident on the extension rod as it was found sticking out of the guide tube. It is apparent that there are longitudinal marks in the black chromous acid deposit. These are shown in detail in Figure III-15. Though it was originally thought that these marks were produced by the manipulator hands, Figure III-15 shows that the marks extend well beyond the end of the housing, up inside where the manipulator hands could not have reached. Therefore, it is evident that this slide mark (as well as two similar marks spaced approximately at 120° around the rod) was not made by the manipulator hands. There are other less well defined markings on the extension rod, markings which did not extend up inside the guide tube and which do not extend down the rod a uniform distance. These marks can be attributed to the manipulator hands.

Fig. III-15, Shield Plug #9, relative position of extension rod and sectioned guide tube showing sliding marks.

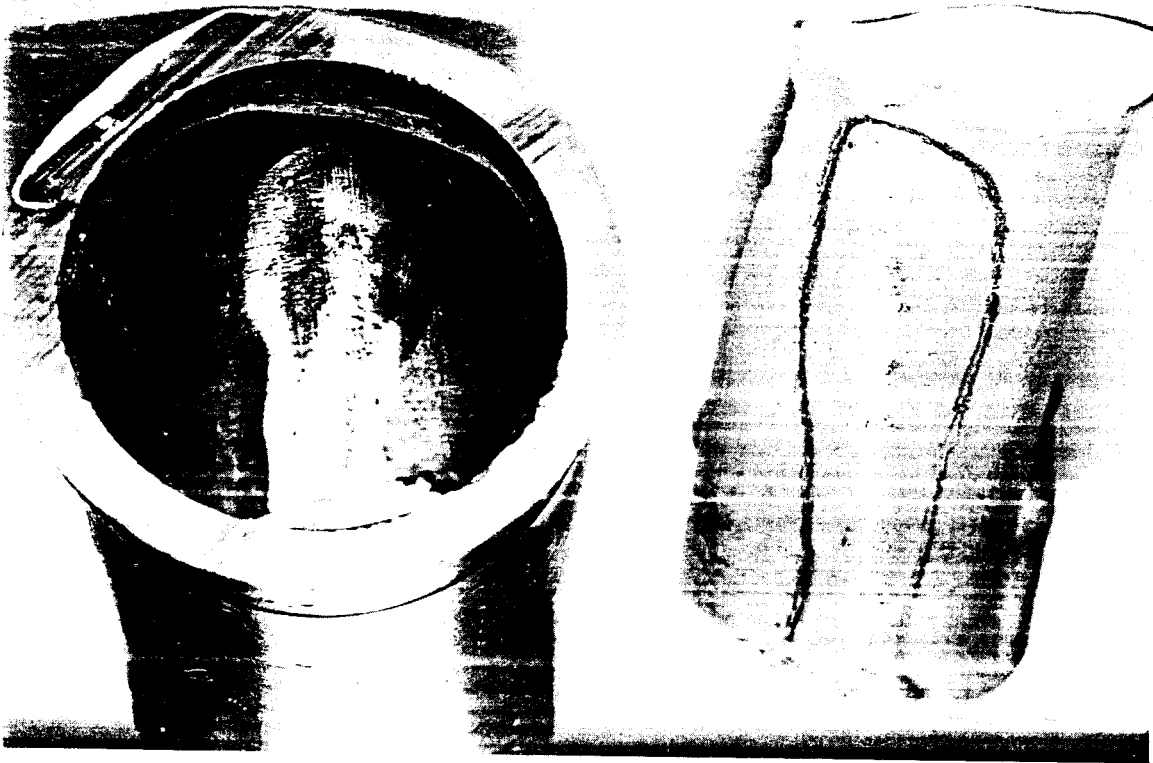
Fig. III-16, Shield Plug #9, seized region of the guide tube with plaster cast. Pencil line on plaster cast outlines impression area.

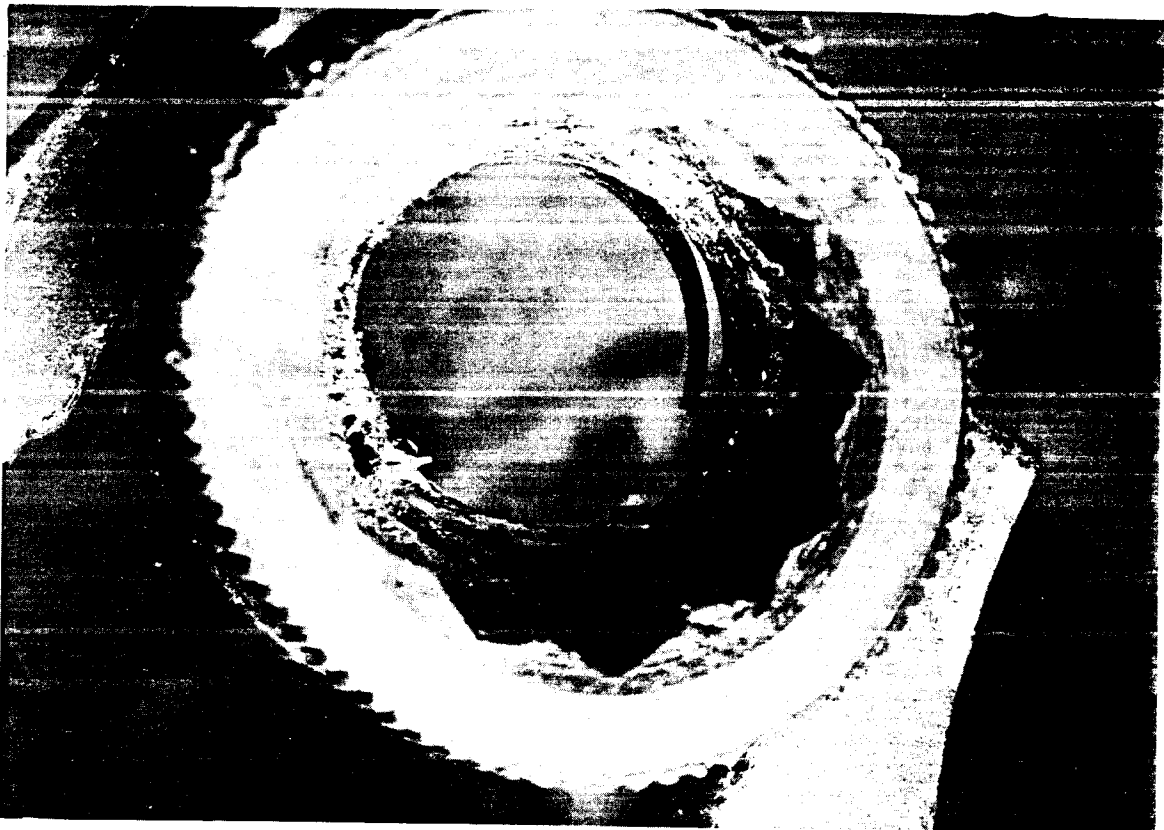
Figure III-27, Nut from Instrumented Flange #8, Showing Sheared Stud Threads Retained in Nut.
