FINAL REPORT
OF
SL-1 RECOVERY OPERATION

SL-1 Project
Idaho Test Station
General Electric Company
July 27, 1962

ABSTRACT

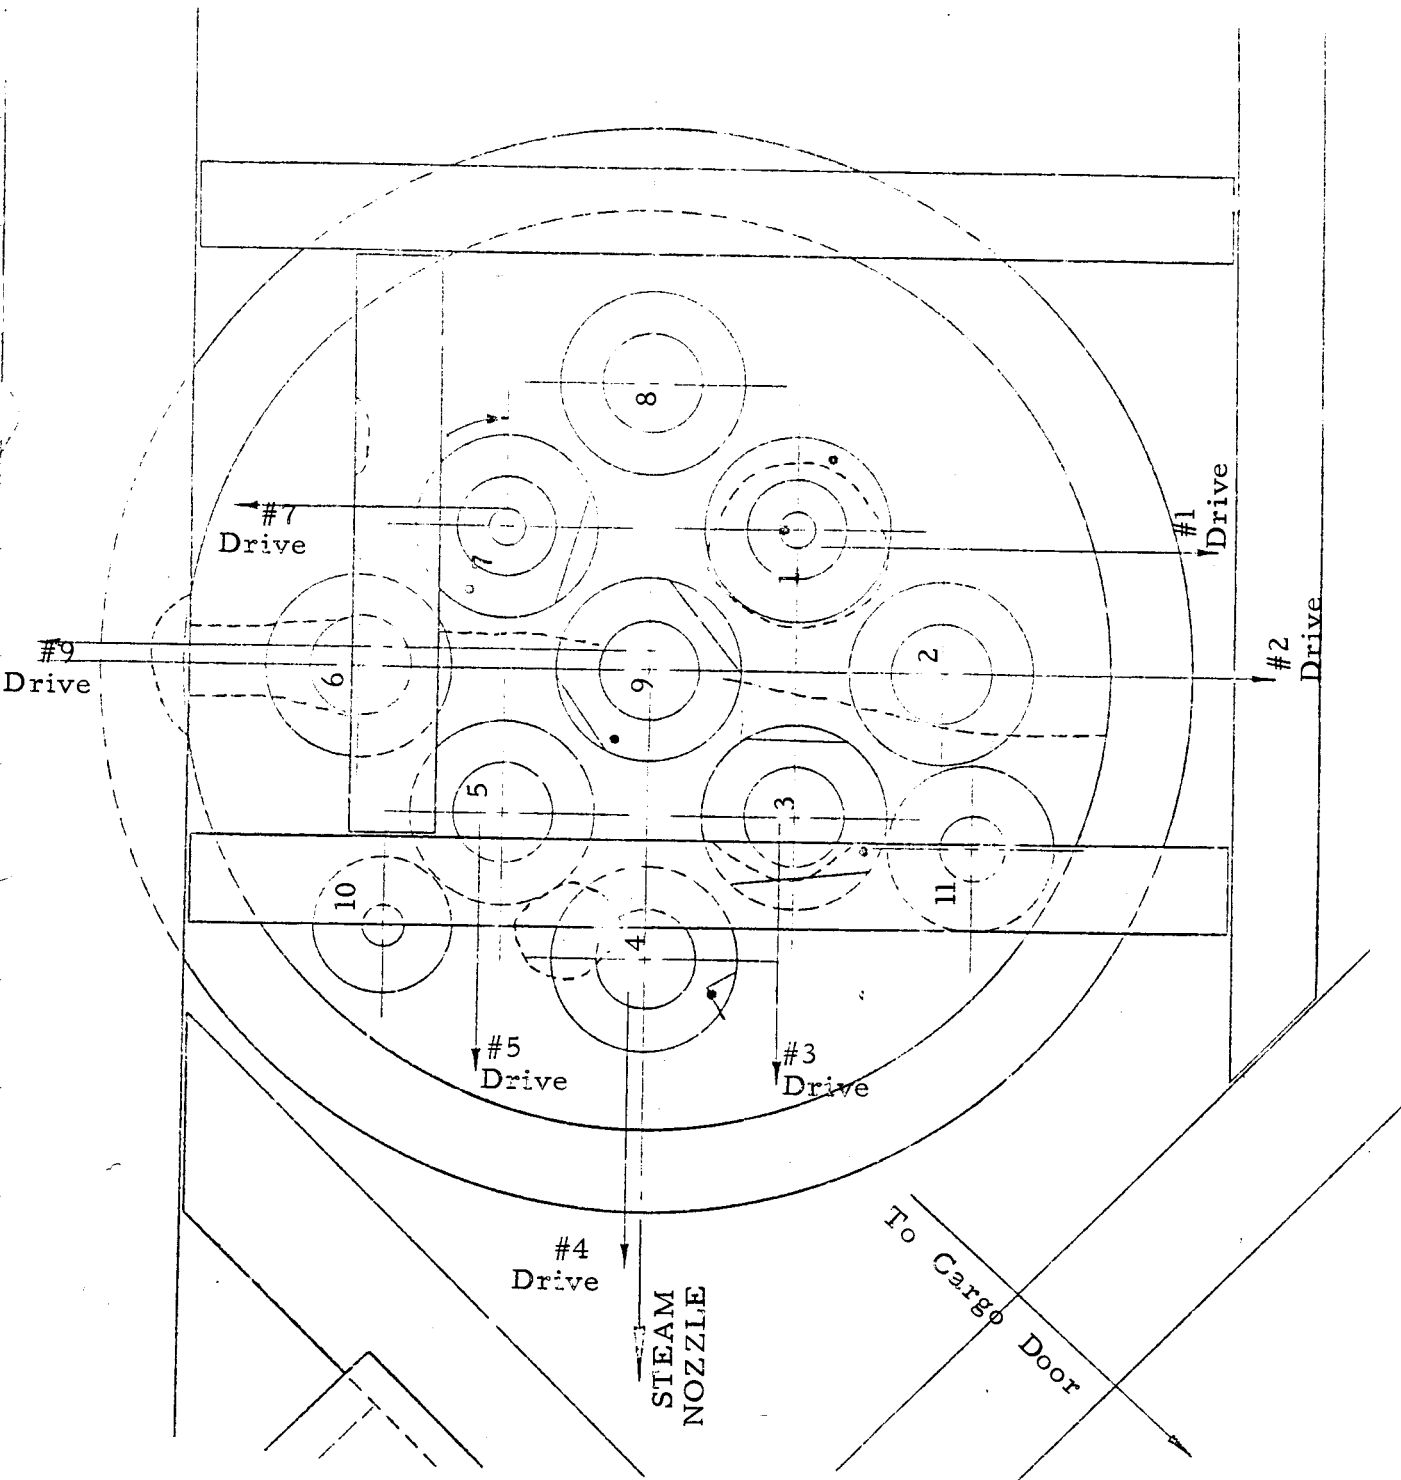
Figure III-28 Superimposition Fan Room Floor Section on Reactor Head.

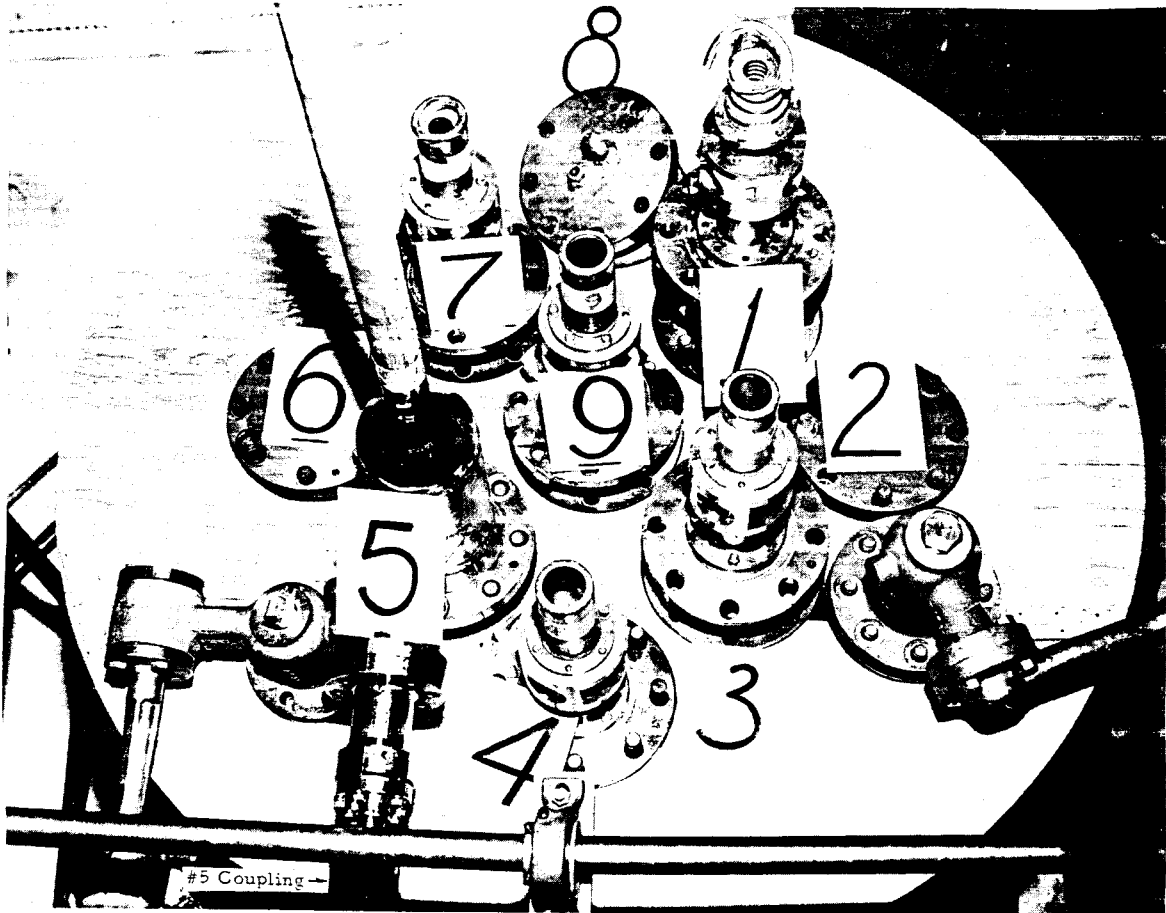
Figure III-29 Reconstruction of reactor head and plug assemblies

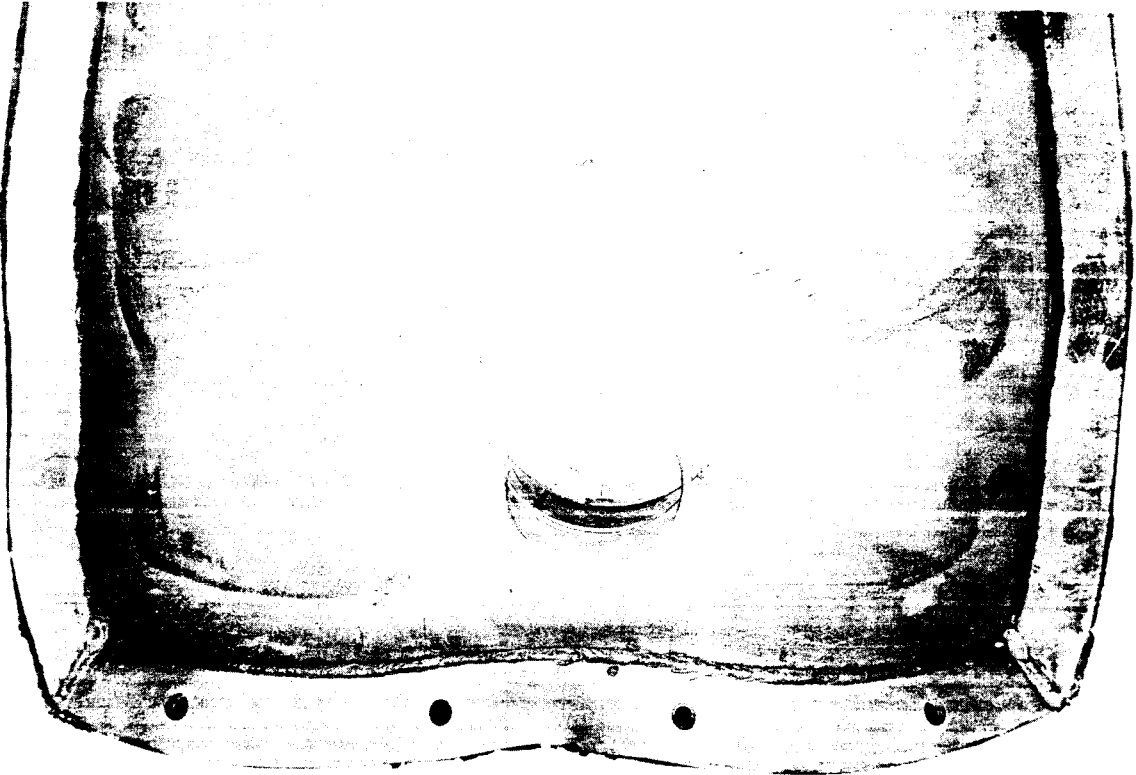
Fig. III-32, Baffle plate showing areas of impact and deformation.

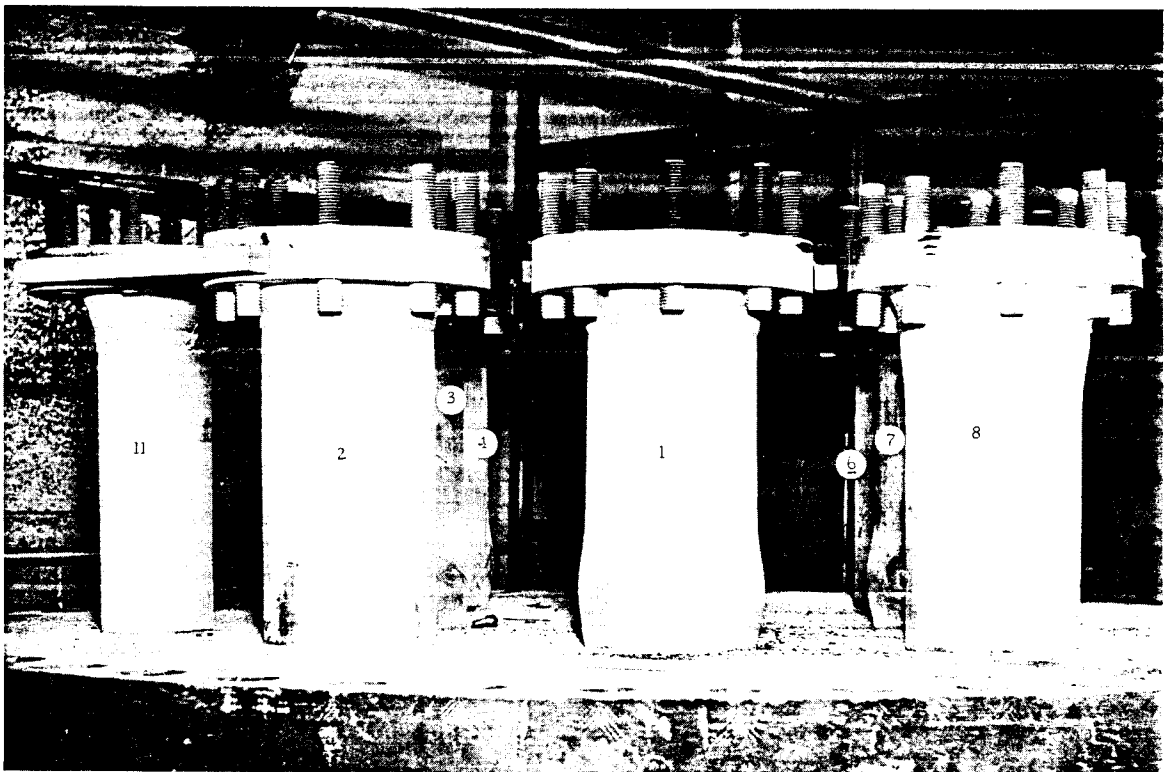
Figure III-38 Deformation of pressure vessel head nozzles
