**TYPE A ACCIDENT INVESTIGATION BOARD REPORT
OF THE JULY 28, 1998
FATALITY AND MULTIPLE INJURIES
RESULTING FROM RELEASE OF CARBON DIOXIDE
AT BUILDING 648, TEST REACTOR AREA
IDAHO NATIONAL ENGINEERING AND ENVIRONMENTAL LABORATORY**

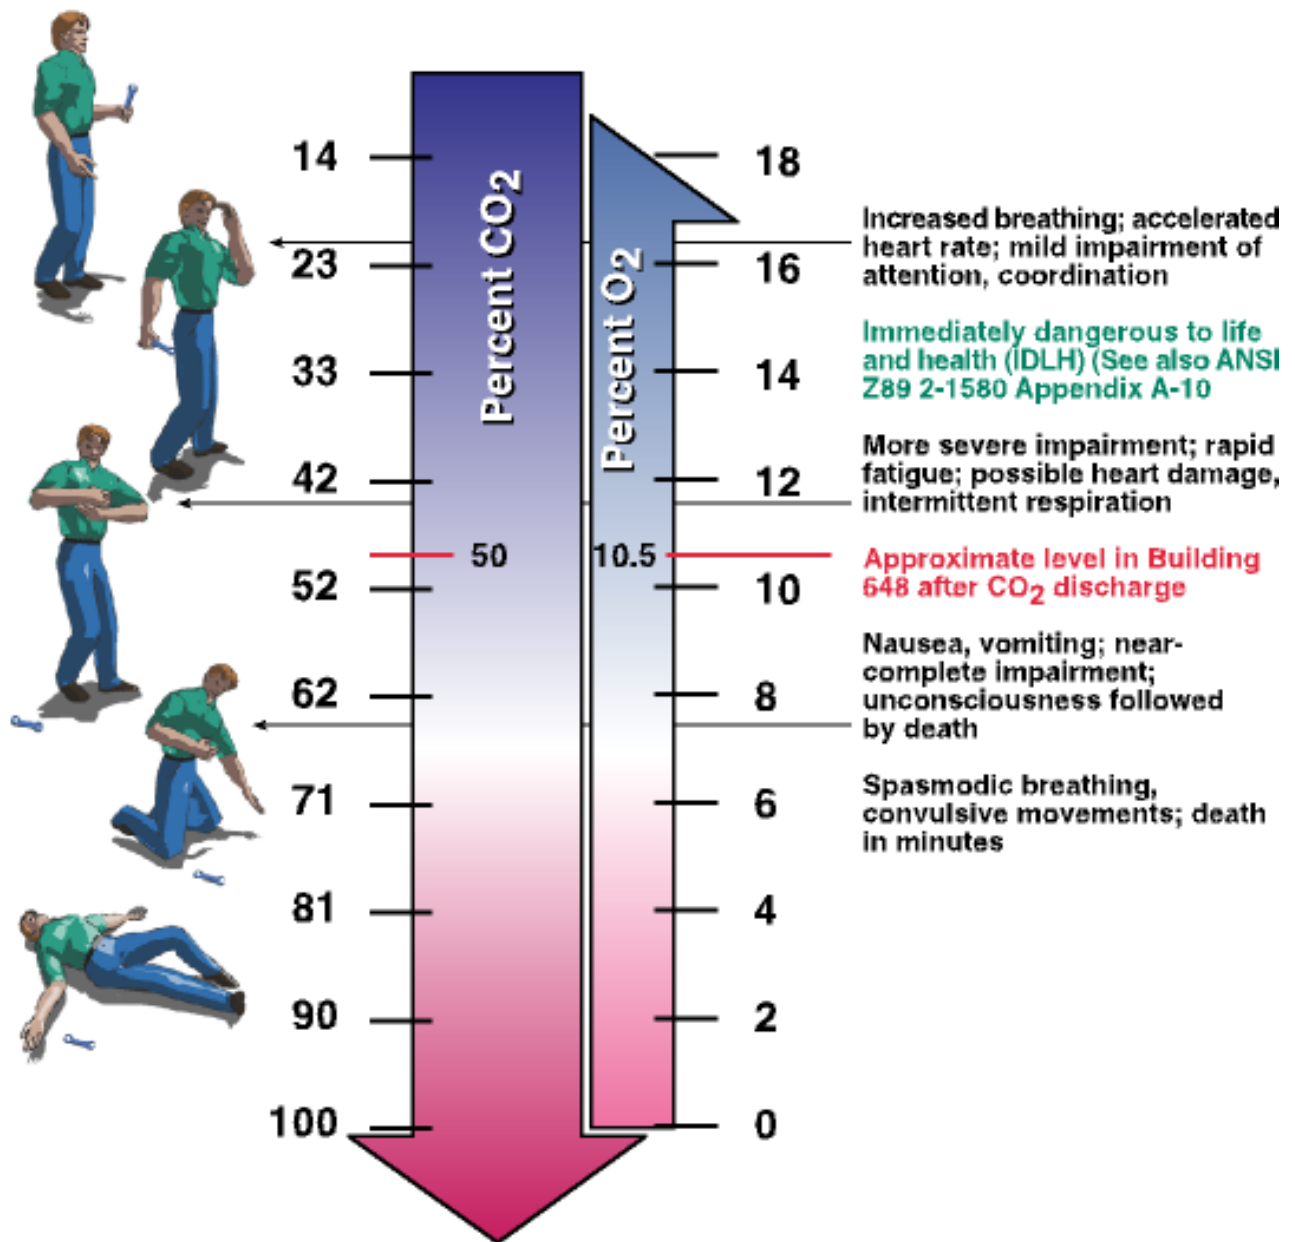
Figure 2-1. Physiological Effects of CO₂ Exposure

The percentage of CO₂ in the building following the accidental initiation of the fire suppression system was estimated at approximately 50 percent. This is well above the 30 percent minimum concentration necessary for fire protection and is lethal to occupants or individuals, as shown in Figure 2-1. At 50 percent CO₂, the oxygen levels within the building would be approximately 10.5 percent, well below that needed to sustain life. This atmosphere can result in symptoms of nausea; vomiting; near-complete impairment; unconsciousness followed by death and spasmodic breathing; convulsive movements; and death in

- The use of CO₂ is limited primarily by the factors influencing method of application and its intrinsic health hazards.
- At the minimum design concentration (30 percent) for its use as a total flooding fire suppressant, CO₂ is lethal.

minutes. The personnel in the building during the accident experienced vomiting, impairment of actions, spasmodic breathing seizures, and unconsciousness, and their attempts to escape were hindered by the disorienting physiological effects of CO₂.

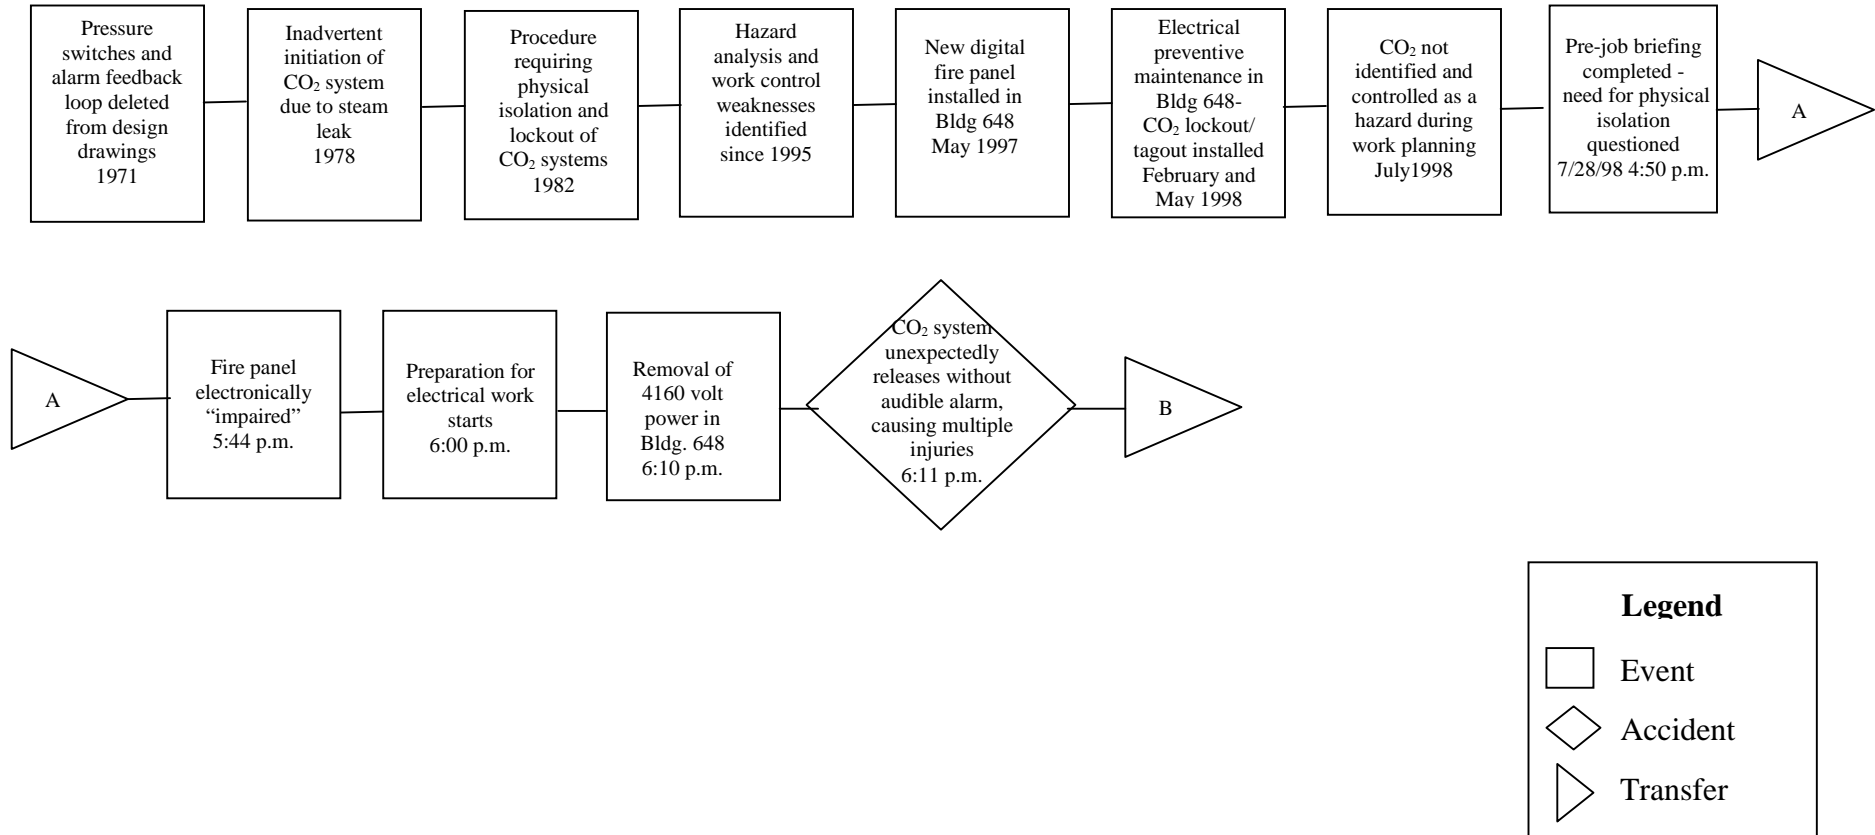
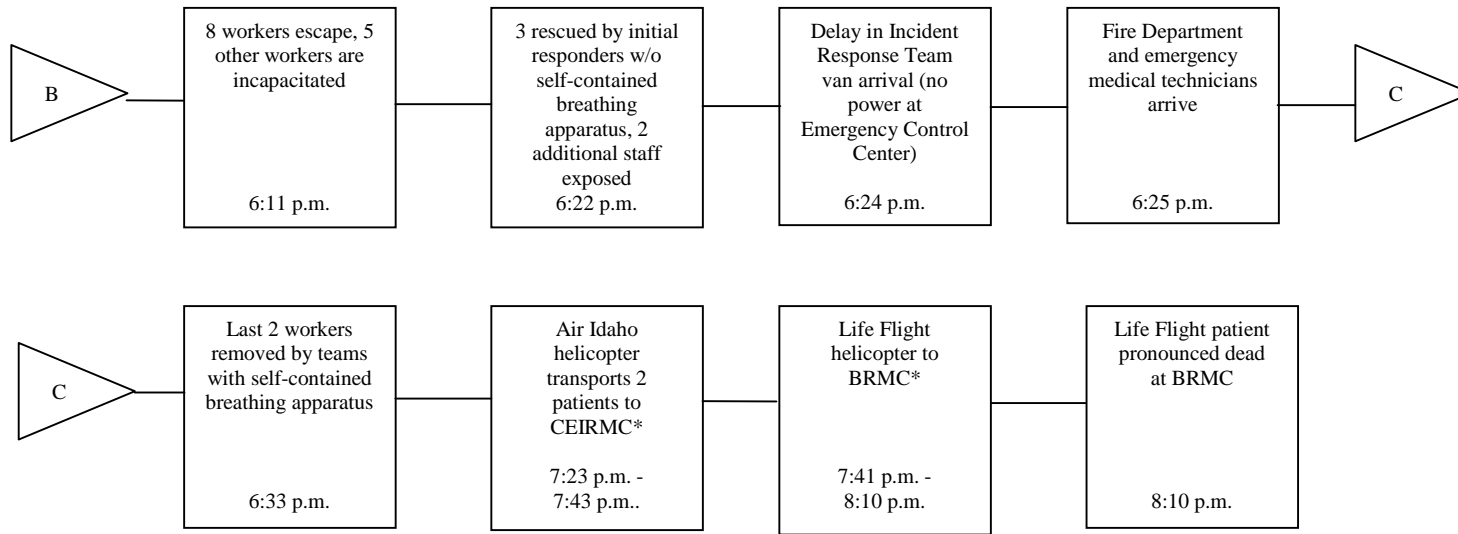
Figure 2-2. Summary Events Chart and Accident Chronology

Within seconds after the opening of the last 4160 volt breaker, the CO₂ fire suppression system unexpectedly discharged and without warning created a lethal atmosphere deprived of oxygen with near zero visibility. Witnesses described hearing a hissing sound and then a “woosh,” followed by “total whiteout” conditions within seconds, in which they could not see anything at all. Most individuals instinctively ran toward the west door by which they entered and which was still open (because cables to the lights were run through it), allowing daylight to shine into the area. Transcribed interviews revealed that escape necessitated groping along switchgear and running into and around obstacles (see Exhibit 2-2). One individual (E-2) describes running into something (perhaps the rolled out 4160 volt breaker), falling down, and then passing out as he took a breath of CO₂.
